The July 10 2000 Payatas Landfill Slope Failure

ABSTRACT: *This paper presents an investigation of the slope failure in the Payatas landfill in Quezon City, Philippines. This failure, which killed at least 330 persons, occurred July 10th 2000 after two weeks of heavy rain from two typhoons. Slope stability analyses indicate that the raised leachate level, existence of landfill gas created by natural aerobic and anaerobic degradation, and a significantly over-steepened slope contributed to the slope failure. The Hydrologic Evaluation of Landfill Performance (HELP) model was used to predict the location of the leachate level in the waste at the time of the slope failure for analysis purposes. This paper presents a description of the geological and environmental conditions, identification of the critical failure surface, and slope stability analyses to better understand the failure and present recommendations for other landfills in tropical areas. In addition, this case history is used to evaluate uncertainty in parameters used in back-analysis of a landfill slope failure.*

Reference: Jafari, N. H., Stark, T. D., and Merry, S. (2013). *The July 10 2000 Payatas Landfill Slope Failure

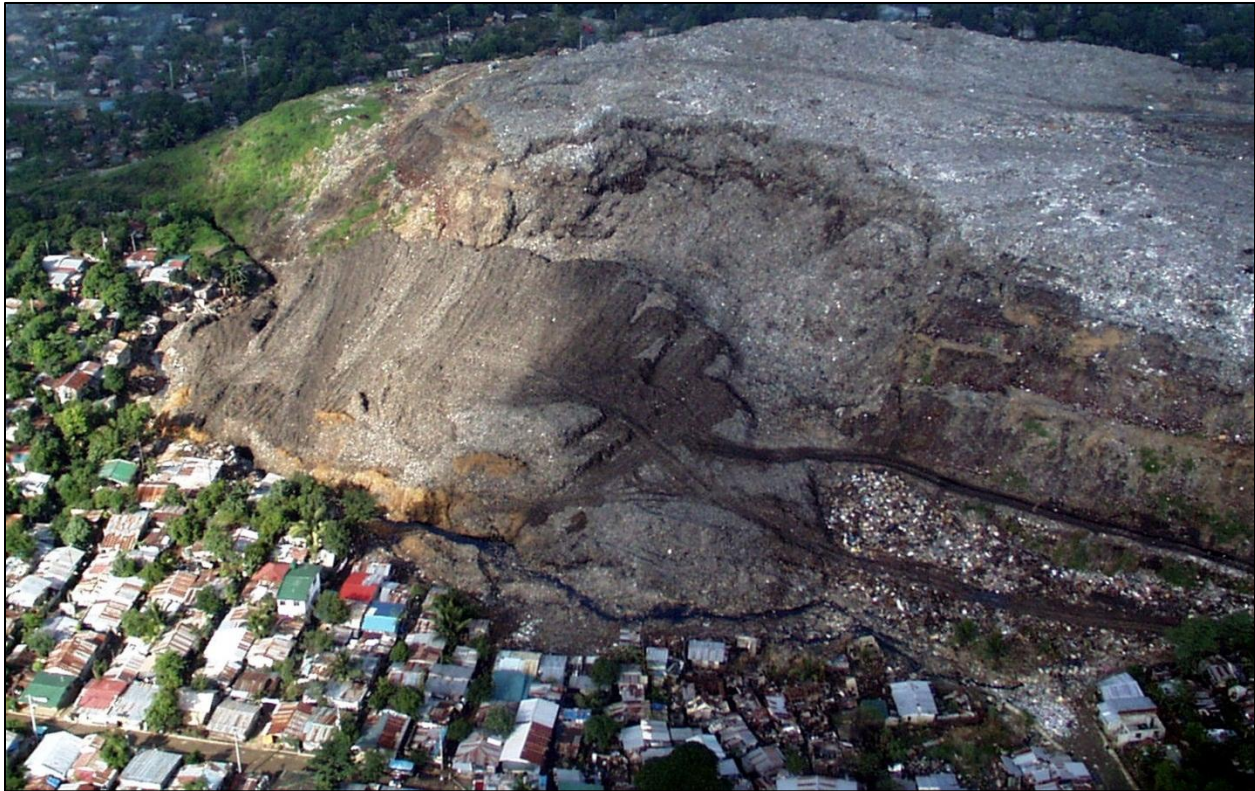
Figure 2. Aerial view of 12.7-hectare Payatas Landfill with slope failure and homes visible in foreground (photo by S.M. Merry).

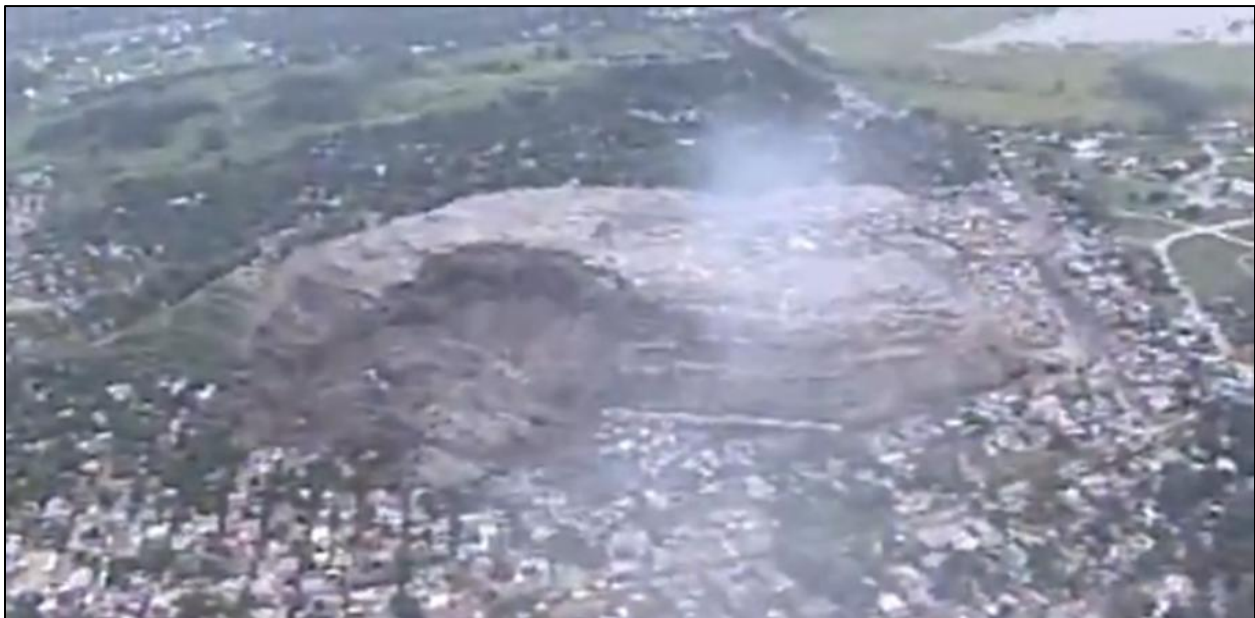
Figure. 3 Aerial view of waste slide from news video before regrading of slide mass (Baua, 2011).

The failure surfaces shown in Figure 11 were estimated from photographs in Figures 2, 3, 5, and 6 and consist of a shallow circular and shallow planar failure surface through only the MSW. From Figure 3, the authors surmise that the failure surface is shallow in nature, and the waste mass slid down the side slope as a mass, i.e., a slab or sliver slide. Subsequently, ledges developed along the main scarp formed from vertical blocks toppling over or sliding down (see Figure 3). Therefore, it was concluded that the failure surface passed from the crest of the slope through the MSW, and exited at the slope toe without entering the underlying brown native clayey silt.

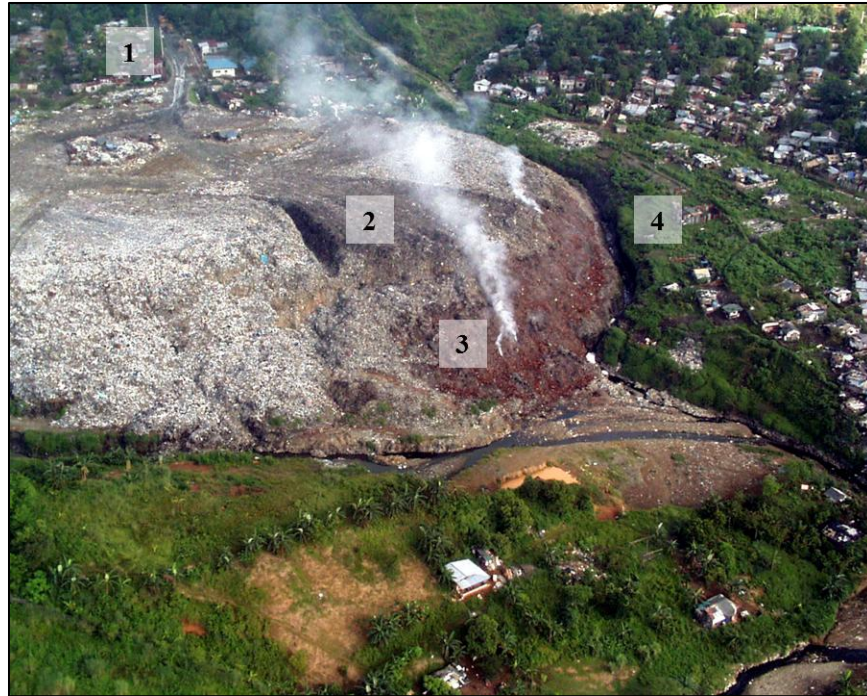
This section describes observations of a smaller landfill immediately southeast of the waste failure that helps interpret the waste slide. These observations are based on both site reconnaissance and photos. Figure 4 shows the slopes at this smaller landfill, which did not fail after both typhoon events although both facilities followed the same landfill operation procedures. The following bulleted sections discuss in numerical order the labels shown in Figure 4:

1. The access road to the landfill is a street through a residential neighborhood. Most likely, waste disposal consisted of dumping at the edge of the road and subsequent pushing down the slightly sloped terrain. The waste height eventually reached the same elevation as the surrounding residential area and waste trucks drove upslope the resulting waste slope for unloading;

2. A deep, man-made trench at the slope crest was excavated to collect and channel surface precipitation. Although this trench did not result in slope failure, a similar trench was observed near the failed waste mass. The trench is believed to have acted as a water-filled tension crack, where the failure plane intersects the bottom of the crack. The tension crack depth increased with frequency of precipitation and subsequent waste erosion. Also, the trench provides a direct conduit of water to lower depths of the landfill, thereby decreasing effective stress in the waste. This landfill, like the landfill with the slope failure, did not have a soil cover on the top of the facility, which allowed for faster infiltrate of precipitation over a large area of the landfill;

3. A combination of steam and smoke is emanating from the slope in the foreground. It is common for steam or smoke to be present because of the large area of uncovered MSW that can result in spontaneous combustion. Residents living downslope of the failure heard a loud explosion before the waste failure (Merry et al., 2005). The explosion may have been facilitated by elevated gas pressures due to MSW degradation and steam or smoke due to spontaneous combustion of the exposed MSW;

4. A leachate collection trench surrounds the landfill periphery and is used to collect and remove leachate seeping from the waste pile.

Figure 4. Stable landfill south of Payatas Landfill with waste slide showing smoke plumes (photo by S.M. Merry).

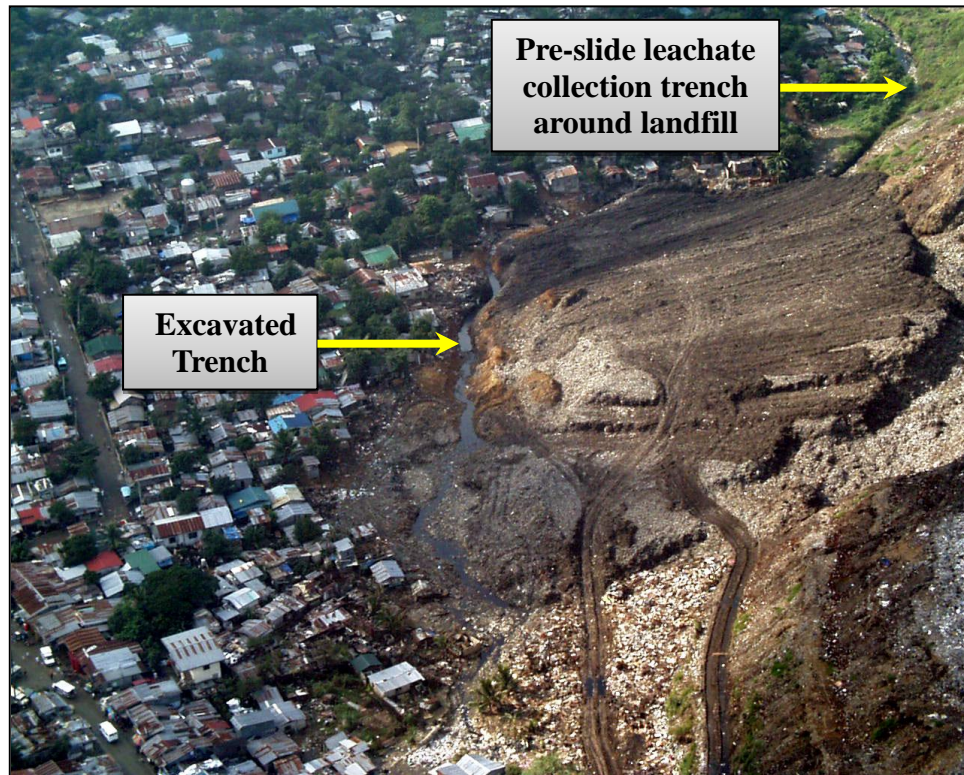
Figure 5 shows a close-up of the slope failure area and scarp in Payatas Landfill. Regrading of the slide mass had started shortly after the failure, which is shown in Figure 5. A leachate collection trench was excavated along the toe of the slide mass and is highlighted by the arrow and text box in Figure 5. The native brown soil underlying the waste and residential area is visible along the toe and sides of this excavated leachate collection trench. Leachate seepage existed prior to and shortly after the slope failure; however, the exact leachate level in the landfill just prior to failure is not known. A smaller landfill leachate collection trench was present along the slope toe prior to the slide and was similar to the trench shown in Figure 4. The leachate collection trench as it existed prior to the slide was covered by the slide mass and hence, is not visible (see the central portion of Figure 5). However, it was visible along the toe of the north-facing slope of the landfill east of the slide mass (see the top of Figure 5 where a small trench separates homes from the landfill toe and is highlighted by an arrow and text box). In summary, Figure 5 indicates that the leachate trench in front of the slide mass was constructed after the slide to collect leachate exiting the slide mass and a considerable volume of leachate existed in the landfill prior to failure but the exact leachate level at failure is not known.

Figure 5. Slope failure showing new and existing leachate trenches along slope toe (photo by S.M. Merry).

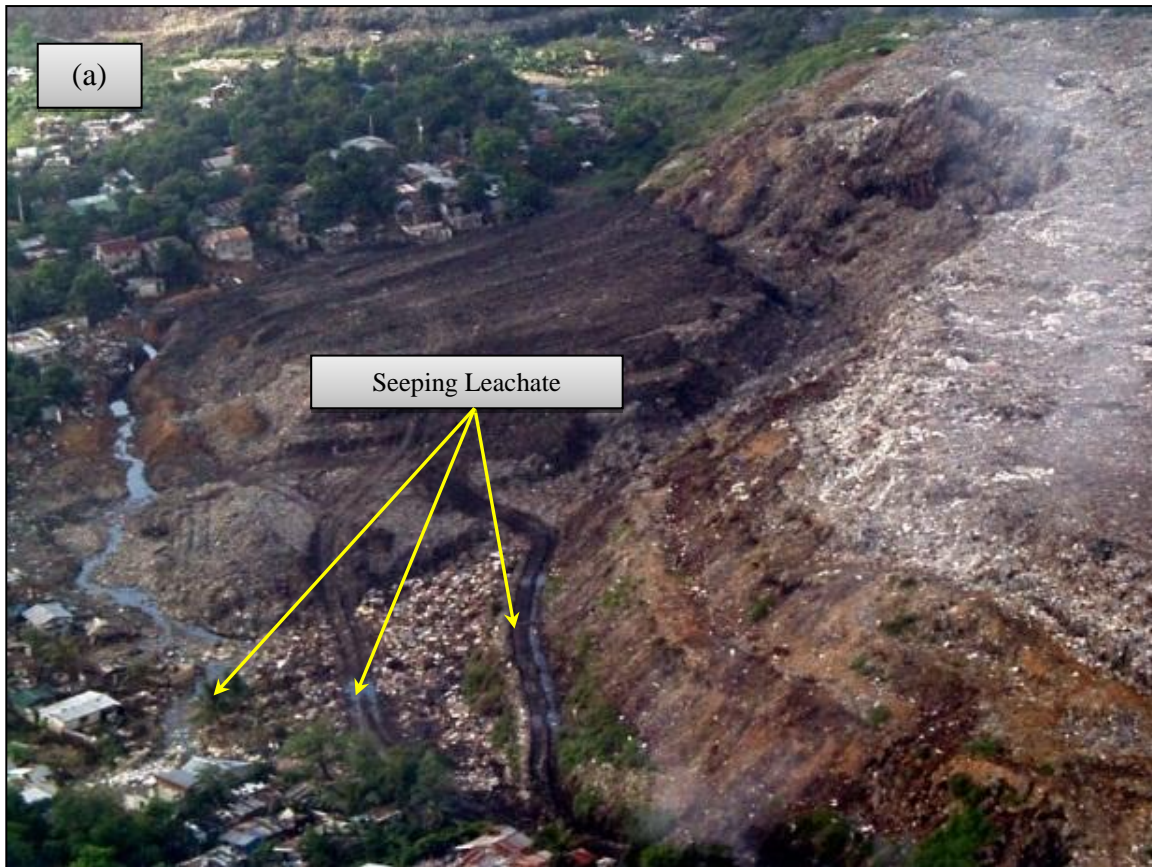
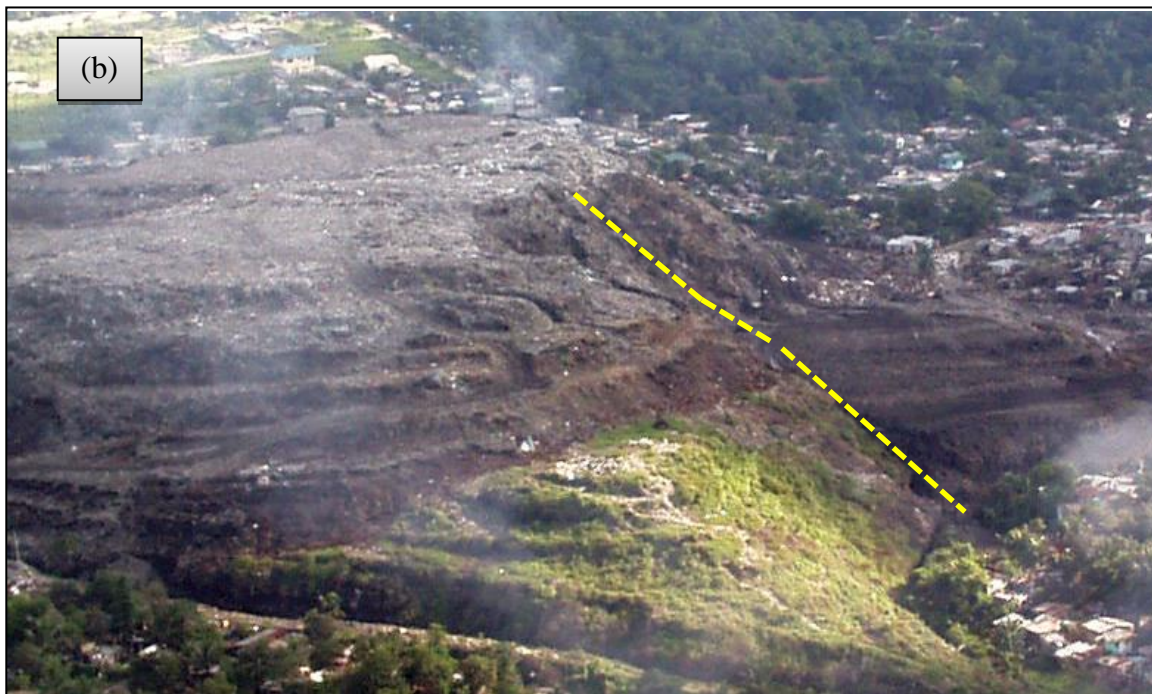
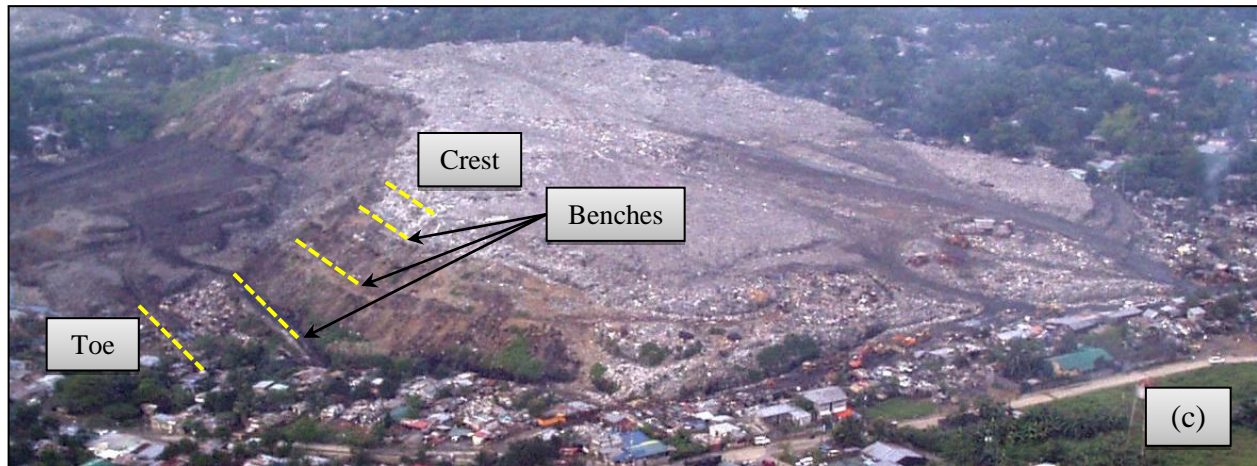
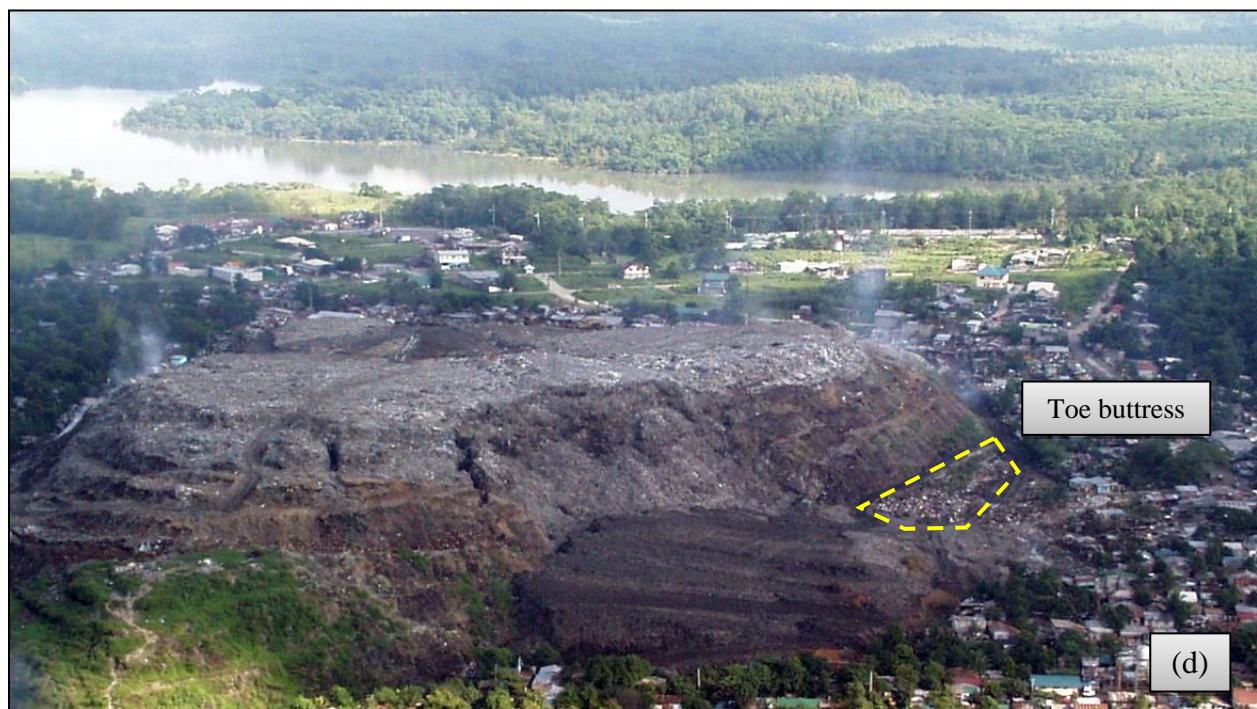
Figure 6 shows a series of aerial views of the waste slide area that were used to understand the failure surface for use in the stability analyses. Figures 6(a) and 6(b) provide side views from the southeast and northwest direction, respectively, of the waste slide. Figure 6(c) highlights benches in the landfill slope, and Figure 6(d) delineates a mildly sloped toe buttress. Digital measurements from these photographs were used to create the cross-section shown in Figure 7. These measurements indicate toe buttress slope angles in the slide area of 1.4H:1V ($\sim 35^\circ$) to 0.84H:1V ($\sim 50^\circ$) and steeper side slopes above the buttress that range from 60° to 70° (Bautista, 2007; UNFCCC, 2007). Additionally, site reconnaissance and pictures both indicate that leachate was seeping from this toe buttress.

Figure 6. Slope geometry and failure surface after failure (a) evidence of seeping leachate, (b) representative slope inclination, (c) location of slope benches, (d) toe buttress (photos by S.M. Merry).

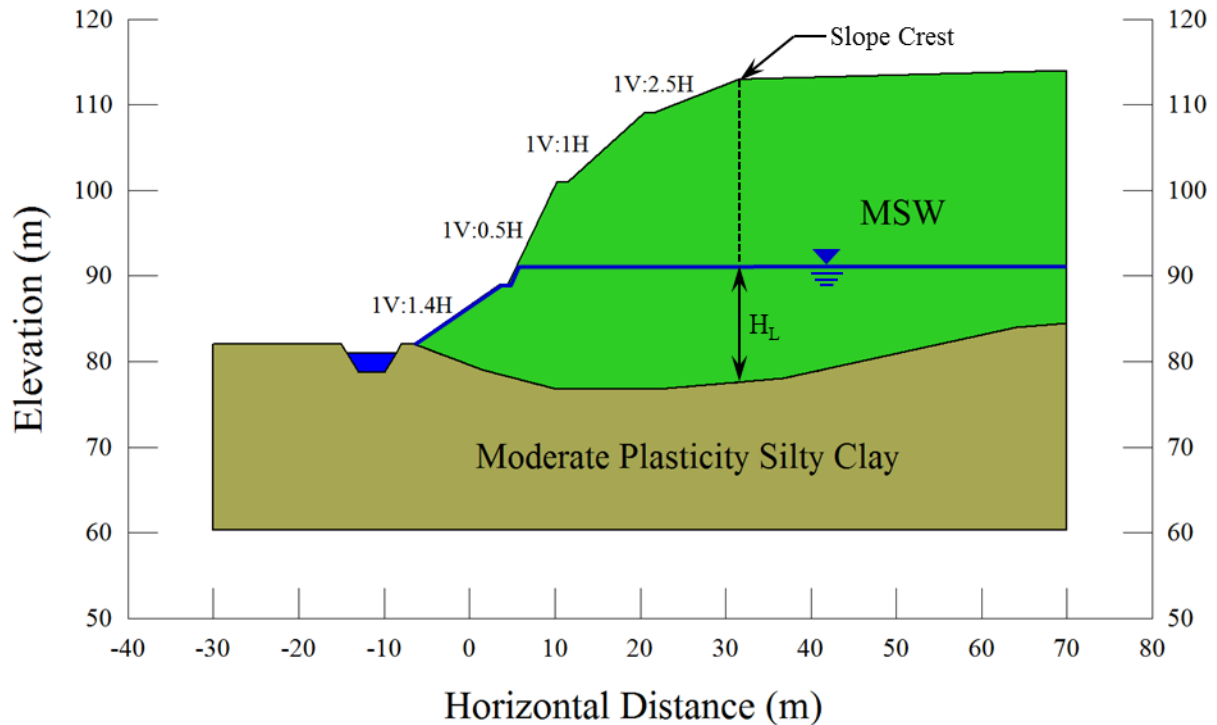
The waste is underlain by a native hard, brown fine-grained loam or adobe, which is a moderate plasticity silty clay (Seman and Rydgergren, 1992). In this study, the failure surface was deemed not to have passed into the native brown silty clay because photographs in Figures 2, 5, and 6(c) indicate that the failure surface is relatively shallow and exits the slide mass near the toe of the MSW. This is indicative of a slab or sliver of MSW sliding off the surface of the landfill. In addition, the brown native silty clay is sloped upward (see Figure 7) near the slope toe because waste was initially placed in this depressed area.

Figure 7. Two dimensional cross-section of failed waste slope.

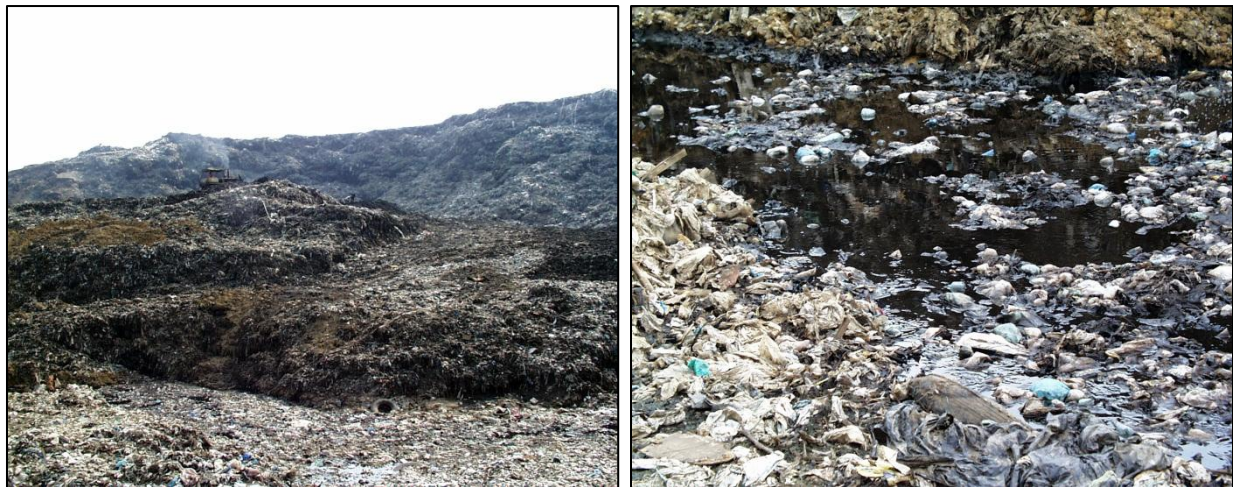
Koelsch (2005) visited the Payatas landfill four weeks after the waste slide and observed that the waste composition included a high concentration of plastics and organics and an absence of certain other materials (e.g., paper, glass, metals). The waste composition in Manila is typical for an urban area in a developing and emerging economy, which results from a large consumption of plastics as package material, a lack of recycling for organic waste, and an outstanding recycling rate for reusable materials, such as aluminum, glass, and paper. As a result, scavengers live nearby collecting cans, scrap metals, bottles, and newspapers for recycling. The waste composition of the slide mass (see Figure 8) consists of large shaped plastic particles intermixed with organic matter. Also, little or no soil cover is evident from Figure 8. Table 1 presents typical waste composition from a solid waste feasibility study for metropolitan Manila (Townsend and Associates, 1989). In this case, the water content, or mass ratio of water to dry waste, is about 82.5%.

Figure 8. Composition of waste mass in slide area with no soil cover (photos by S.M. Merry).

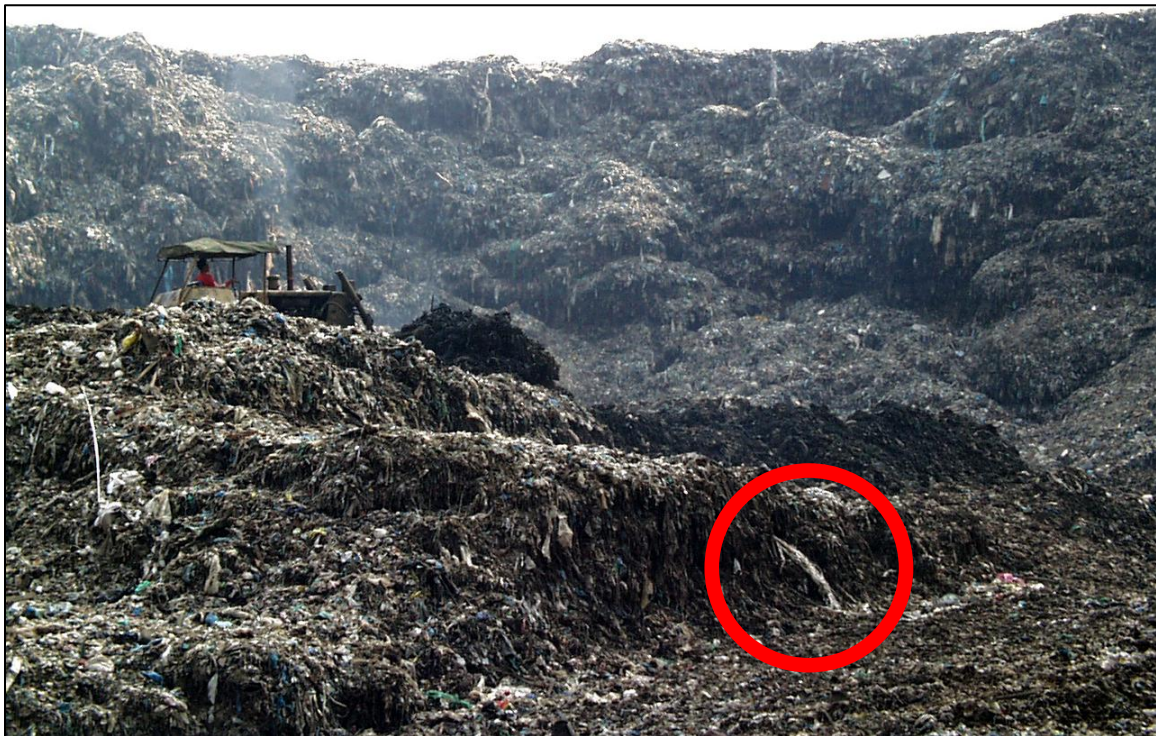
Figure 9. View of the back-scarp of waste slide and leachate flowing from the exposed MSW (photo by S.M. Merry).

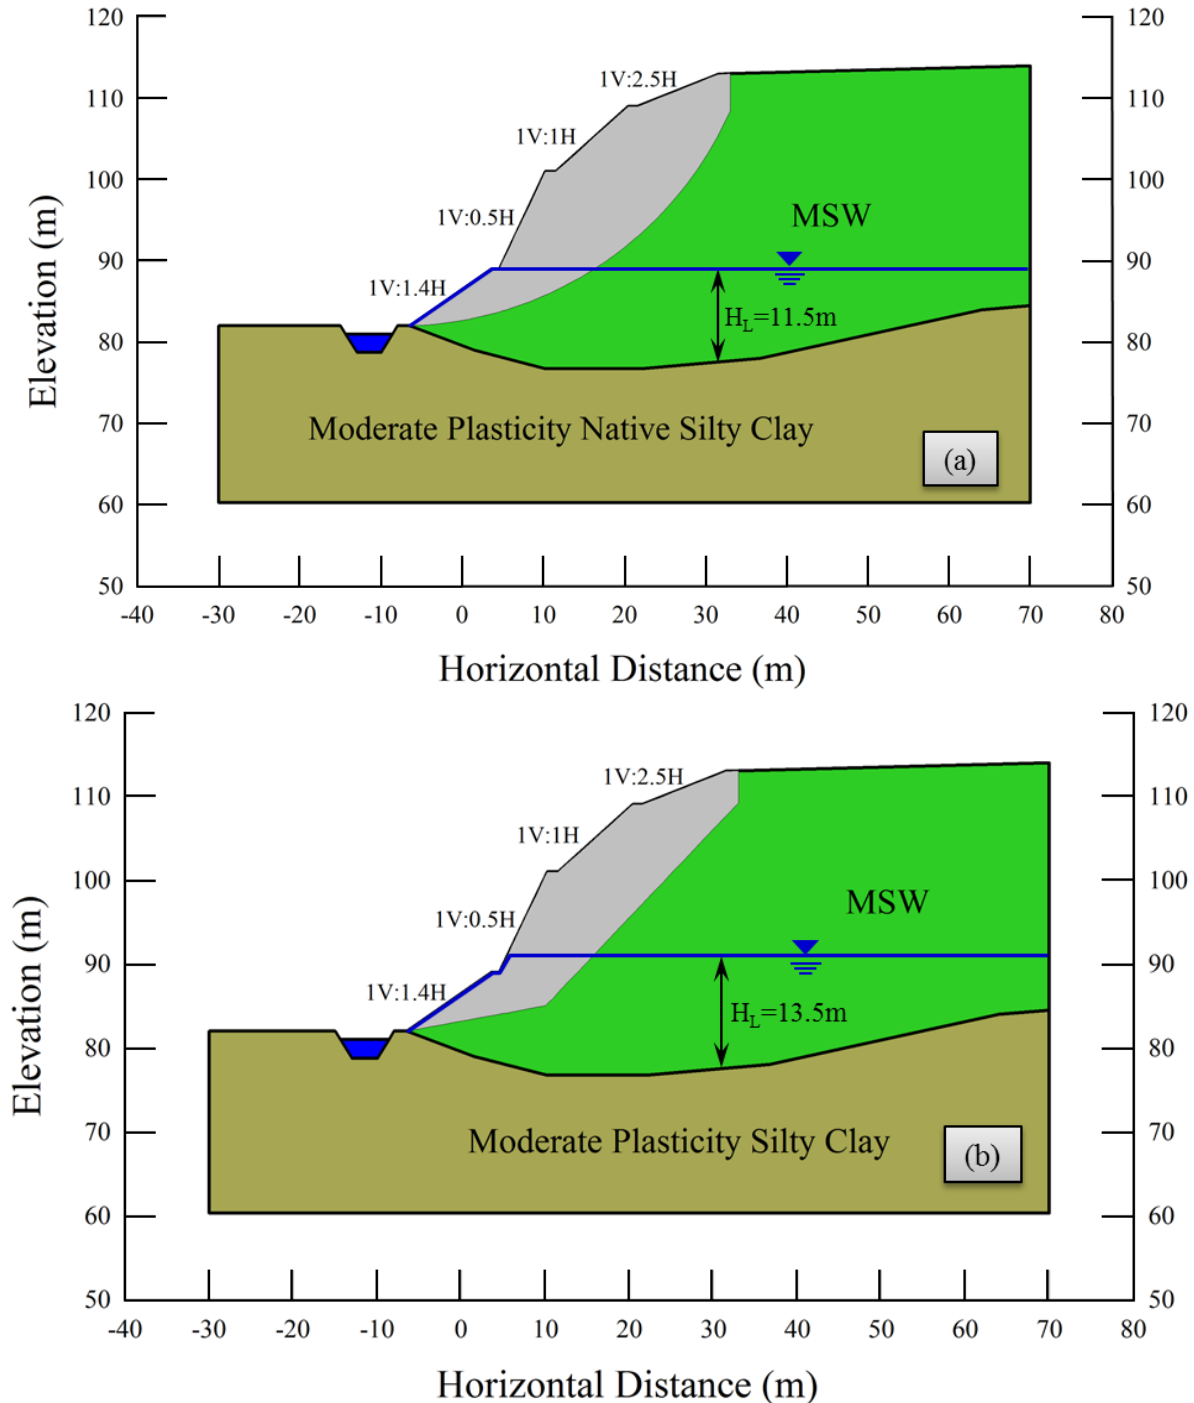
The cross section in Figures 11(a) and 11(b) show the estimated circular and planar failure surface, respectively, based on available photographs (see Figures 2, 3, 5, and 6) and site reconnaissance. The cross sections show the MSW is approximately 31 m thick and is underlain by the brown native clayey silt that slope downward towards the center of the landfill. A leachate trench is shown at the toe of the slope to model the pre-failure slope condition. These cross-sections were used in the inverse analysis described below.

Figure 11. Cross- sections showing location of (a) circular and (b) planar failure surfaces.

Although a circular failure surface indicates a homogenous material, a planar failure surface starting at the toe and daylighting at the top of the landfill was also analyzed. Because the exact location of the failure surface at the crest is not known, the scarp of the waste slide was used to estimate the location of the failure surface at the top of slope that yielded the lowest factor of safety. Furthermore, after the waste slide, the waste was regraded (see Figures 2 and 5) such that the actual slide mass geometry does not represent the possible progression of failure. A helicopter video from a news report (<http://www.abs-cbnnews.com/video/nation/metro-manila/07/10/11/payatas-tragedy-commemorated>) shows an aerial view of the landfill prior to regrading, which was also helpful in estimating the location and geometry of the failure surface. From this video, the failure progresses from the main slide mass and regressing from the initial head scarp to a final scarp that is about 5 m behind the slope crest. Then, an ensuing block of waste toppled from the scarp creating the final geometry shown in Figure 2. Merry et al. (2005) report that a steep (vertical at the top) head scarp remained above the area where heavy machinery had reworked the waste mass.
