# PART III

## CASE STUDIES AND INCIDENTS

### SELECTION 15 Fire Investigation Report: World Trade Center Explosion and Fire, New York, New York, February 26, 1993

MICHAEL S. ISNER AND THOMAS J. KLEM

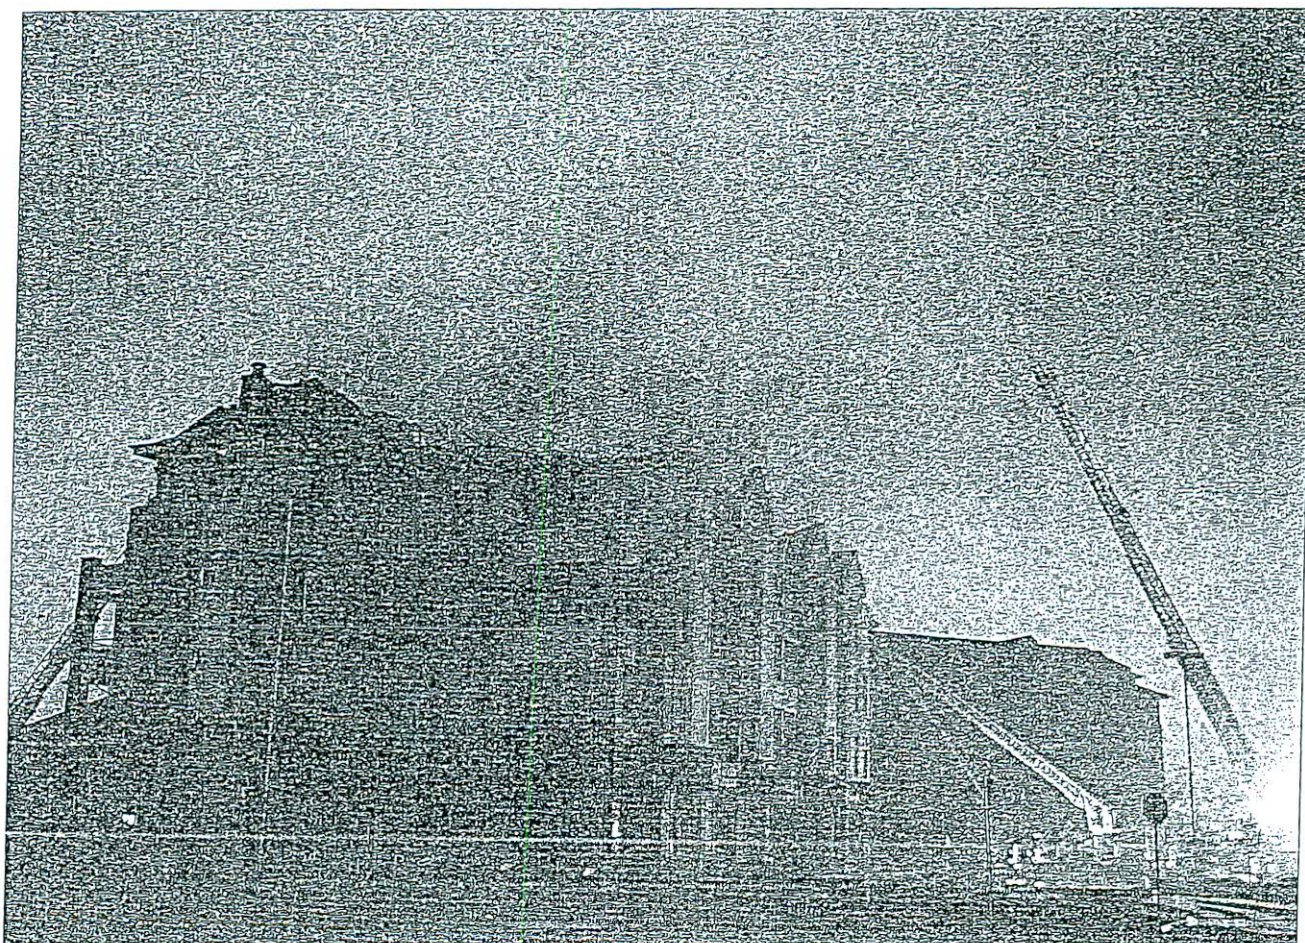
An apartment building suffered \$2 million in damage when a leaking propane gas grill on a fourth-floor balcony caused a fire that quickly spread to the roof.

Investigators determined that the fire began when a propane gas leak was ignited by the grill's burners. The fire then spread to combustible wood framing and roof supports, through the vinyl and aluminum covered soffits. The residential sprinkler system in the apartment operated, but the fire spread in the attic. Eventually, the ceiling collapsed. Fire spread from the deck into the fourth floor was reduced by the sprinkler system, which didn't extend to the attic and roof.

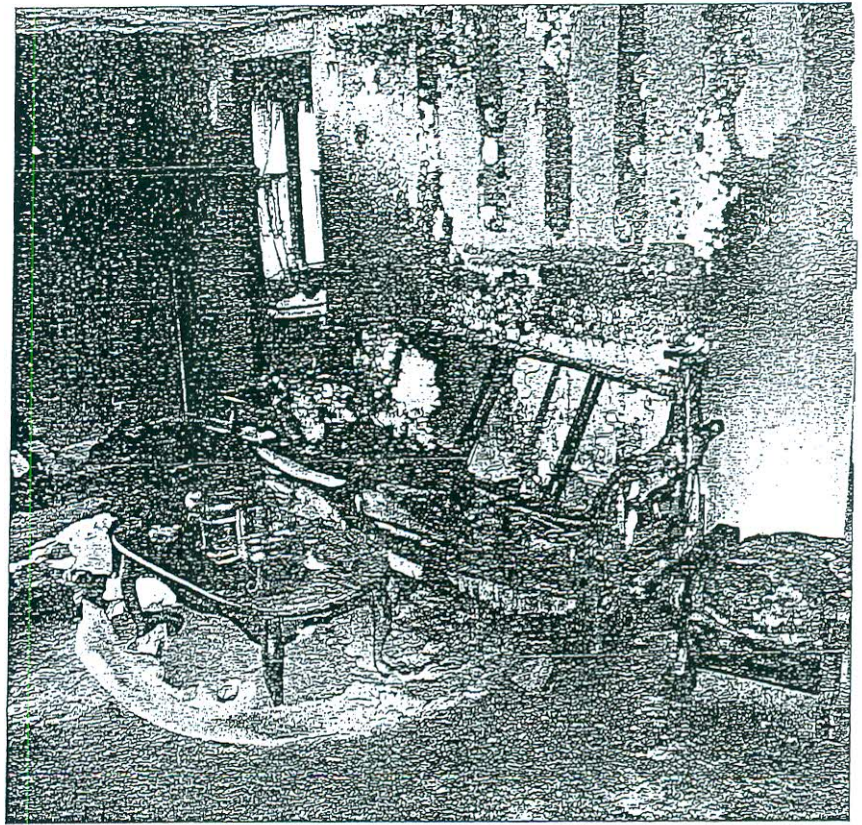
*A young unsupervised child playing with a lighter started a fire that killed him and his parents.*

The child was alone in the living room eating breakfast, while his mother and father were in their bedroom with the door closed. Using a lighter, he ignited an upholstered chair, then tried to extinguish the fire using a lightweight nylon jacket. Investigators believe that the boy's efforts not only failed, but ignited the jacket, which he threw onto the sofa, which also ignited. The boy alerted his parents by banging on the bedroom door before he was overcome by smoke.

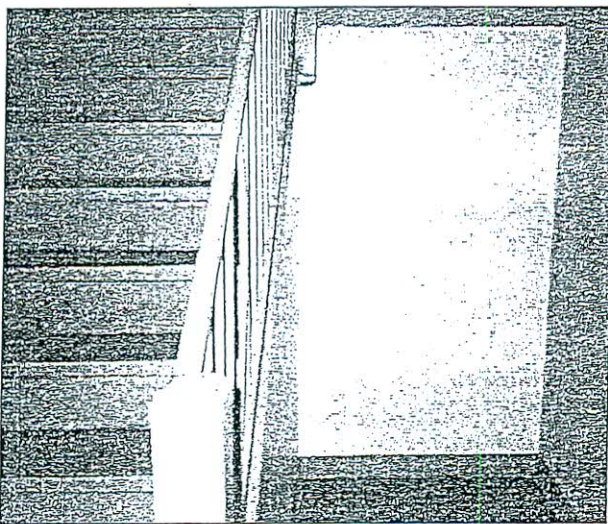
*At crossover points in some of the stairwells, evacuees walked into blank walls and were forced to feel their way along exit paths.*

Since the 1993 incident, exit paths in the stairwells have been marked for safety with phosphorescent paint.

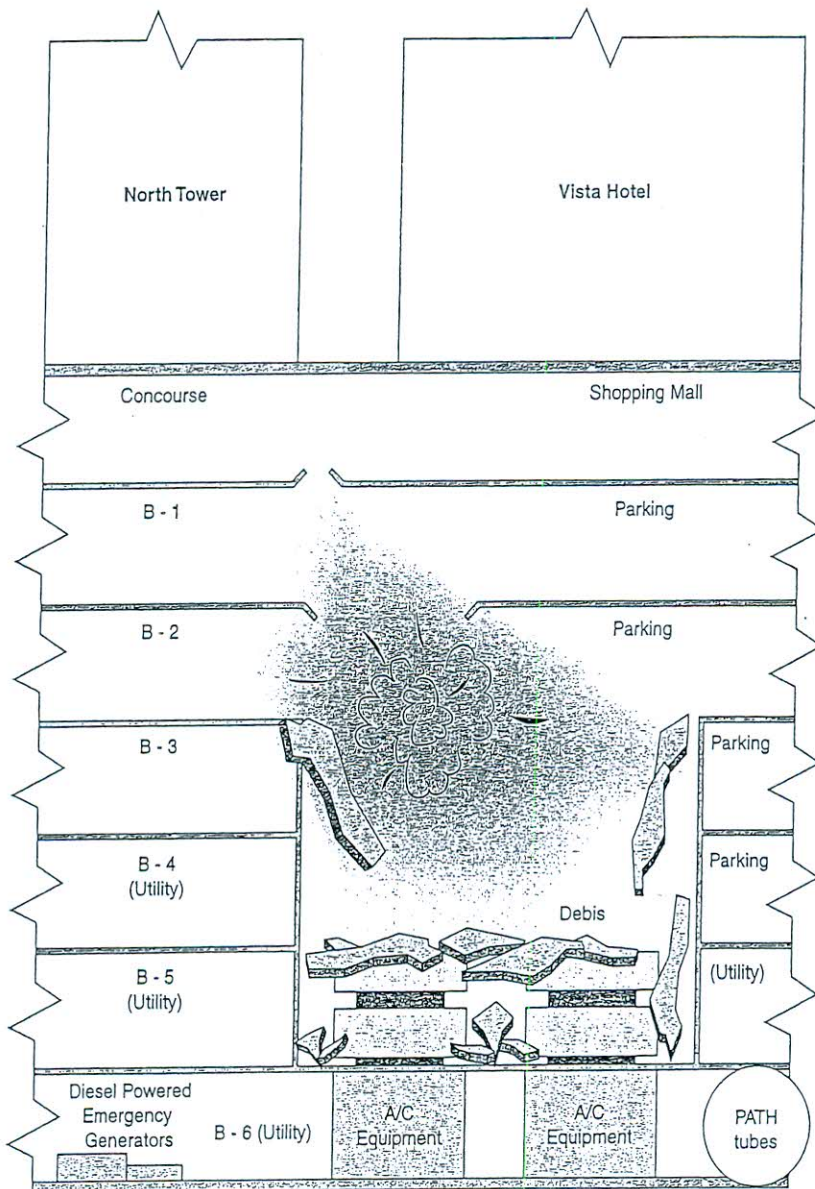
FIGURE 8 Concourse & Basement Levels

The explosion resulted in a large crater involving six levels of the complex. (See Figure 8.) The top-most point of the crater was a 10-ft by 10-ft section of the Plaza floor slab which was cracked and deflected upward. On the next level down, the Concourse level, a plaster-on-metal-lath ceiling collapsed in the Vista Hotel function room, and directly below the collapse, there was an approximately 18-ft by 22-ft hole in the floor slab caused by the explosion below. On the B1 level there was an approximately 50-ft by 80-ft hole where the floor slab had also collapsed. The largest floor slab collapse occurred on the B2 level. On this level, the collapse area was approximately 130 ft by 130 ft. (See Figure 9.) There were no floor slabs at the B3 and B4 levels directly below the explosion area. As a result, debris from the explosion area and the collapsing floor slabs dropped down to the B5 level, where this material landed on the large refrigeration equipment:

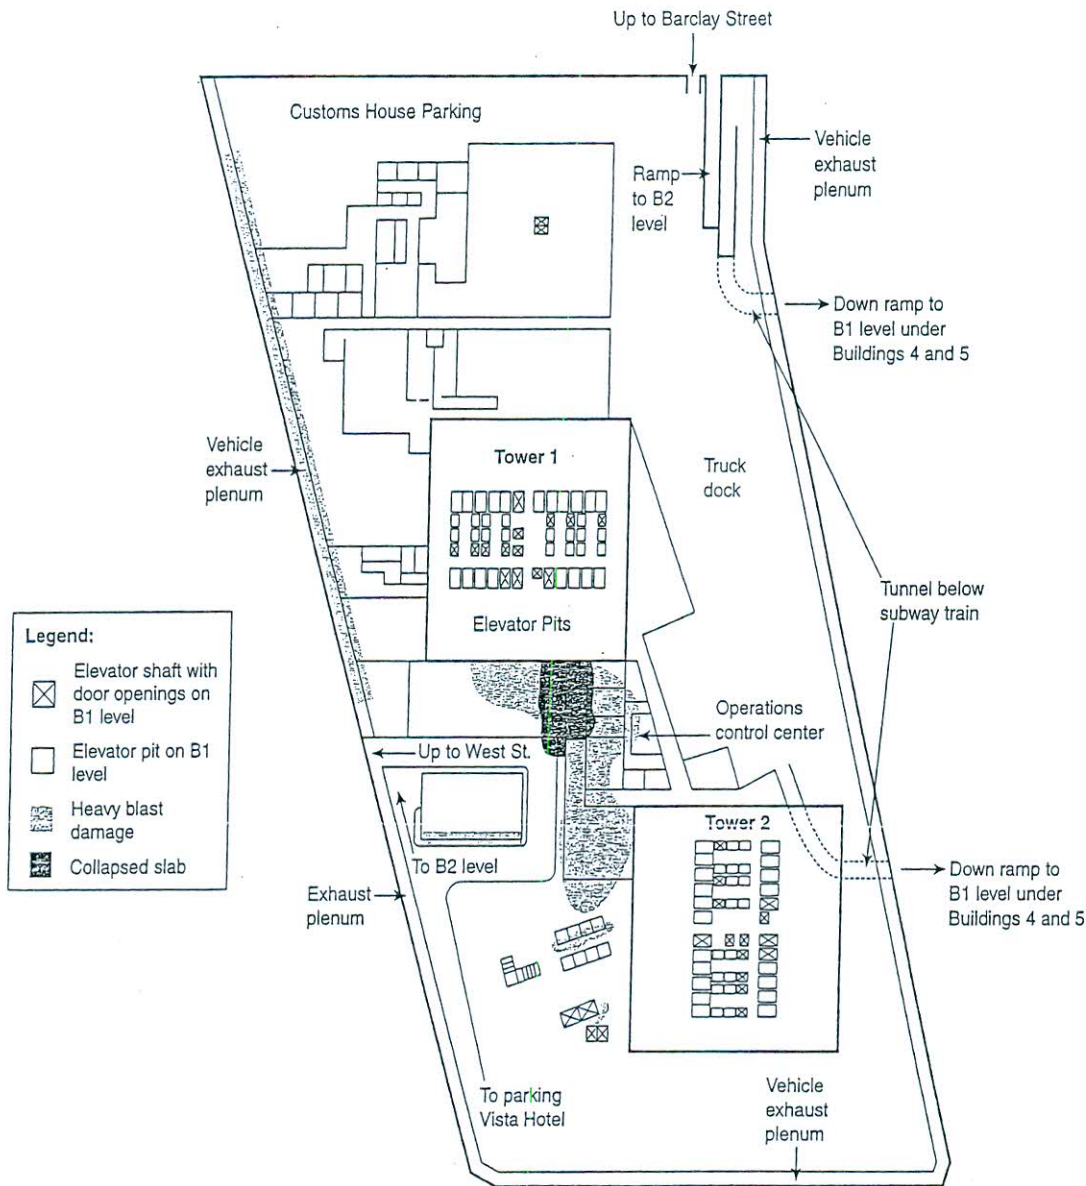
FIGURE 10 Explosion Damage, B1 Level

The explosion damage also extended to areas well beyond the immediate crater. Concrete block walls on the B1 level were damaged to the point that they needed to be replaced. The damaged walls included numerous nonbearing walls enclosing rooms adjacent to the area of the explosion, and some of the walls formed a vehicle exhaust plenum along the perimeter of that level. (See Figure 10.)

In addition to the damage to concrete block walls, many metal doors were bent and distorted, and some doors were blown out of their frames by the explosion forces. For example, on the B2 level the elevator doors for a service elevator (Car 50) which had openings on all floors of Tower 1 was blown out of its frame and fell into the elevator shaft. Similarly, in Tower 2 (B2 level) the access door to the service pit of two express elevators (Cars 22 and 23) servicing the 78th floor was blown into the elevator shaft. Other damaged doors included doors enclosing stairways and doors providing access to the exhaust plenum along the basement's perimeter walls. Some of the damaged doors were located in areas where little or no wall damage had occurred, such as the areas on the B1 level below the Customs House.

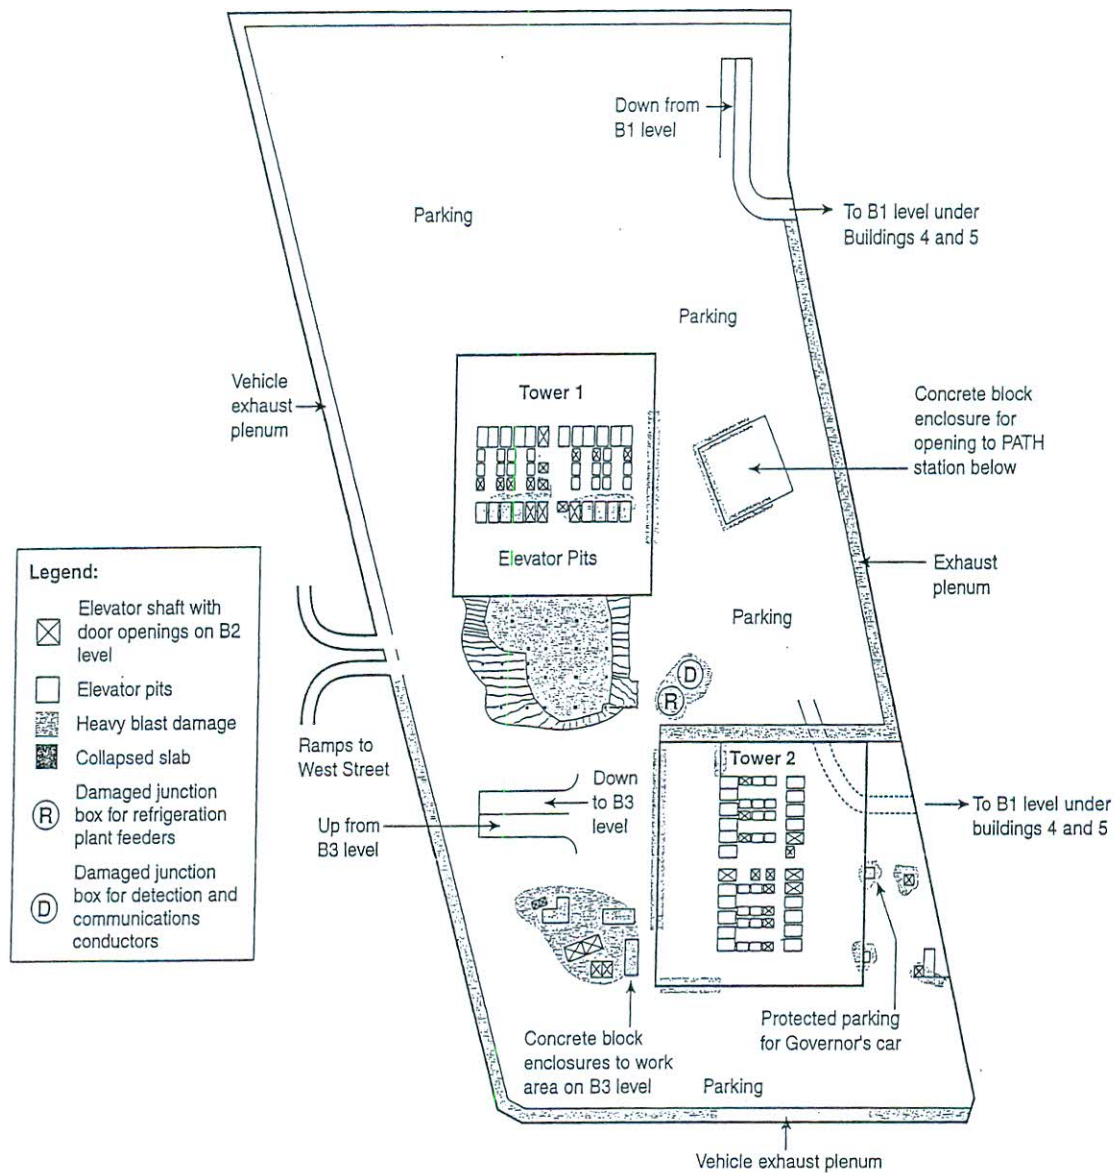
FIGURE 11 Explosion Damage, B2 Level

An estimated 200 cars parked in areas adjacent to the explosion crater were heavily damaged. The damage to cars closest to the explosion included their being rolled over, ripped apart and/or dented on all surfaces, and many of these cars burned. Cars more than 100 feet from the edge of the crater were also dented but to a lesser degree.

Similar to the damage to the cars, the most severe flame damage occurred within the crater and in areas immediately adjacent to the crater. The Vista Hotel function room directly above the explosion area was the only area on the Concourse level that sustained heavy flame and heat damage. In these areas, carbon deposits were burned off the wall, ceiling, and other surfaces, and combustible materials were completely consumed by the fire.

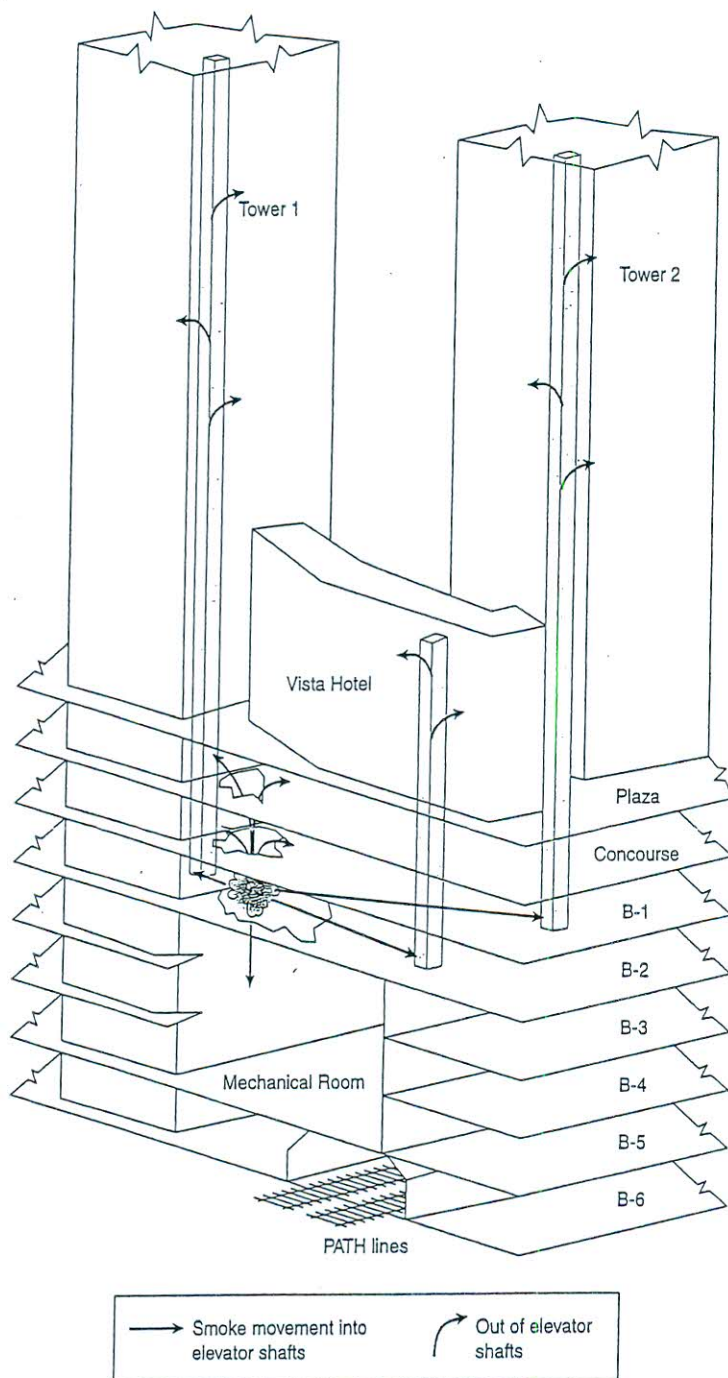
FIGURE 12 *World Trade Center*

The explosive forces influencing the movement of smoke quickly subsided, and natural forces became the primary factors affecting smoke movement. In the immediate area of the fire, forces associated with the fire plumes and the natural buoyancy of the hot gases moved the smoke. However, as the smoke traveled away from the fire area, another natural force—stack effect—primarily influenced smoke movement.

According to the NFPA's *Fire Protection Handbook*, stack effect is characterized by a strong draft from the ground floor to the roof of a tall building. This phenomenon is like the natural draft up a chimney and is best illustrated by the smoke spread through Tower 1, which was one of the tallest buildings and where extreme amounts of smoke accumulated. The magnitude of stack effect is a function of the building height, the airtightness of the exterior walls, the air leakage between floors of the building, and the temperature difference between the inside and outside of the building. Two of these factors, i.e., building height and temperature differential, were significant contributors to the stack effect in the complex on the day of the explosion. Leakage between floors, another factor affecting stack effect, occurs through all vertical openings in a building. These openings can be as small as a crack in the floor and wall assemblies; as subtle as

an electrical conduit or busway, or as large and obvious as the holes in the floor slabs, elevator shafts, and stairways made by the explosion.

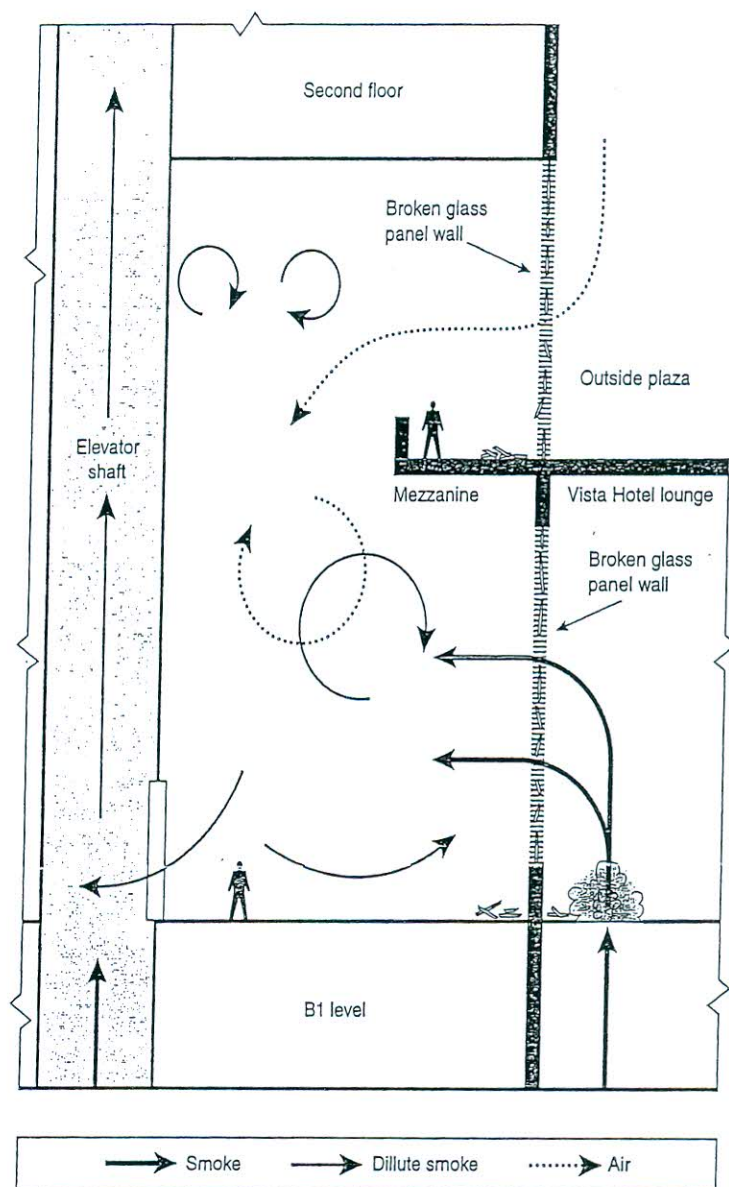
FIGURE 13 Lobby: North Tower  
Smoke Dillution and Movement

Investigators believe that the dilution of the smoke was a major factor contributing to the survival of occupants. Even though the fires and explosion seemingly involved a large area of the complex, the area was, in reality, a very small part of the complex's total area. As a result, large quantities of air were available in the facility and were drawn into the smoke even before it spread out of the sub-levels. More air was entrained as the smoke moved up through the buildings. For example, the collapsed section of floor slabs allowed smoke and fire in the sub-levels to spread vertically into the Vista Hotel function room. Smoke from this area spread to other areas of the Vista Hotel and spread through broken windows into the lobby of Tower 1. (See Figure 13.) Outside air entering the lobby through broken glass panel walls in the mezzanine mixed with the smoke and probably pushed smoke accumulating in the lobby down to the floor where it could enter elevator shafts that had doors in that area.

The smoke continued to entrain large amounts of fresh air from countless sources as it moved higher into all of the buildings. Even though the smoke was diluted, it still obscured egress paths and caused severe respiratory irritation for many of the escaping occupants. More importantly, the smoke appears to have caused significant concern on the part of many occupants and may have increased the confusion during the evacuation.
