SHM on Cultural Heritage Structures

University of Zagreb, Faculty of Civil Engineering
Department of Engineering Mechanics

03.02.2016.

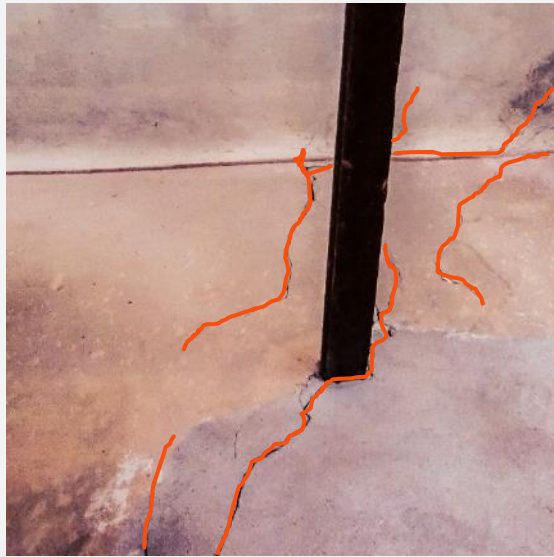
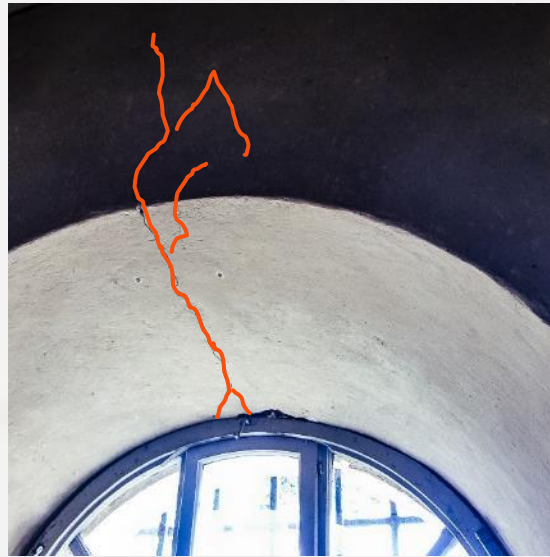
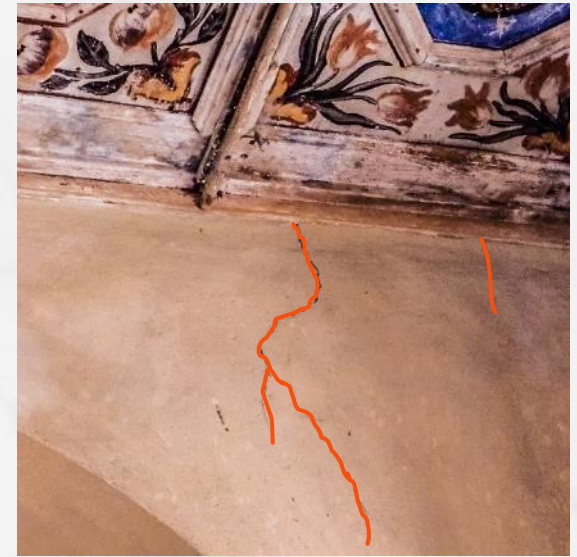
As a result of subsidence of foundations, the cracks of the main load bearing wall appeared.

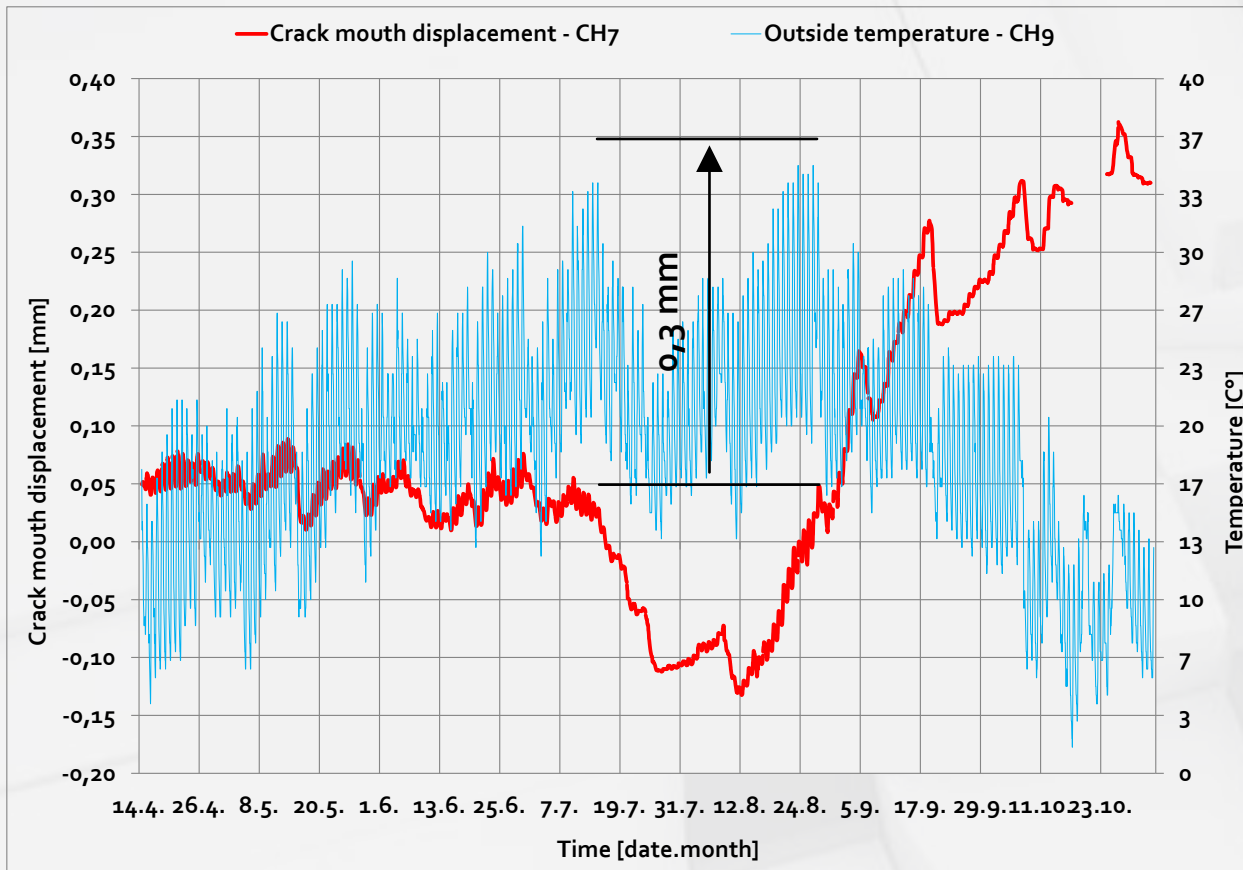
Increasing of the crack mouth displacement on south load bearing wall was detected.

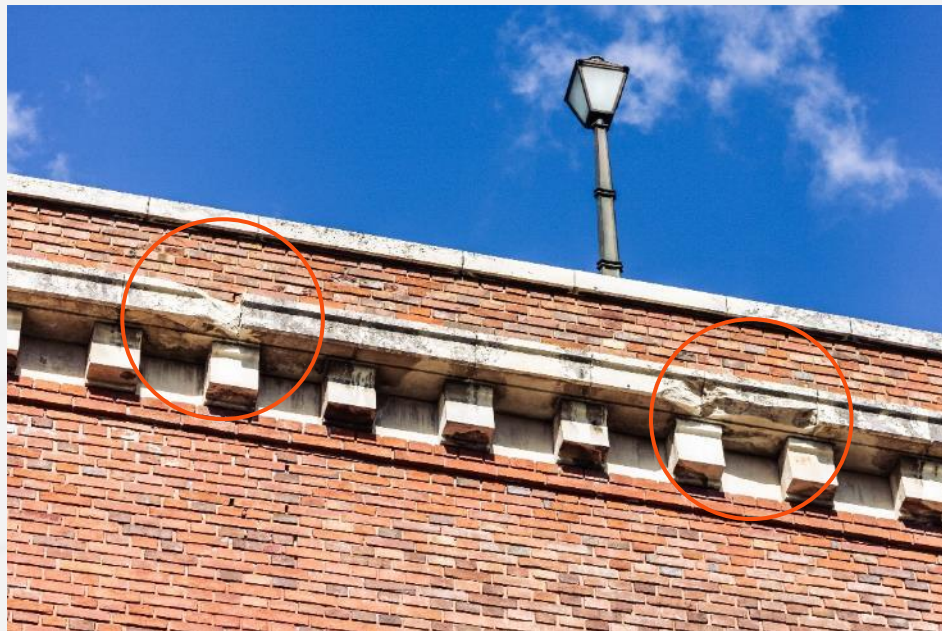
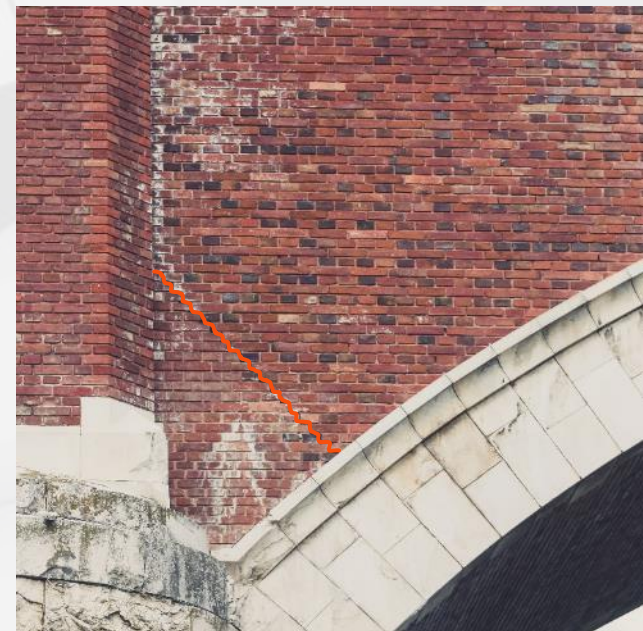
Extensive damage of non load bearing elements were observed especially visible on the heads of the columns and on the edge of the arch. Stability and durability of the structure were threatened with the direct penetration of precipitation from the road surface into the interior structure of the bridge. Another important phenomenon that threatened the sustainability and stability of the structure was condensation in the form of droplets of water on the surfaces of load bearing elements of the bridge structure.

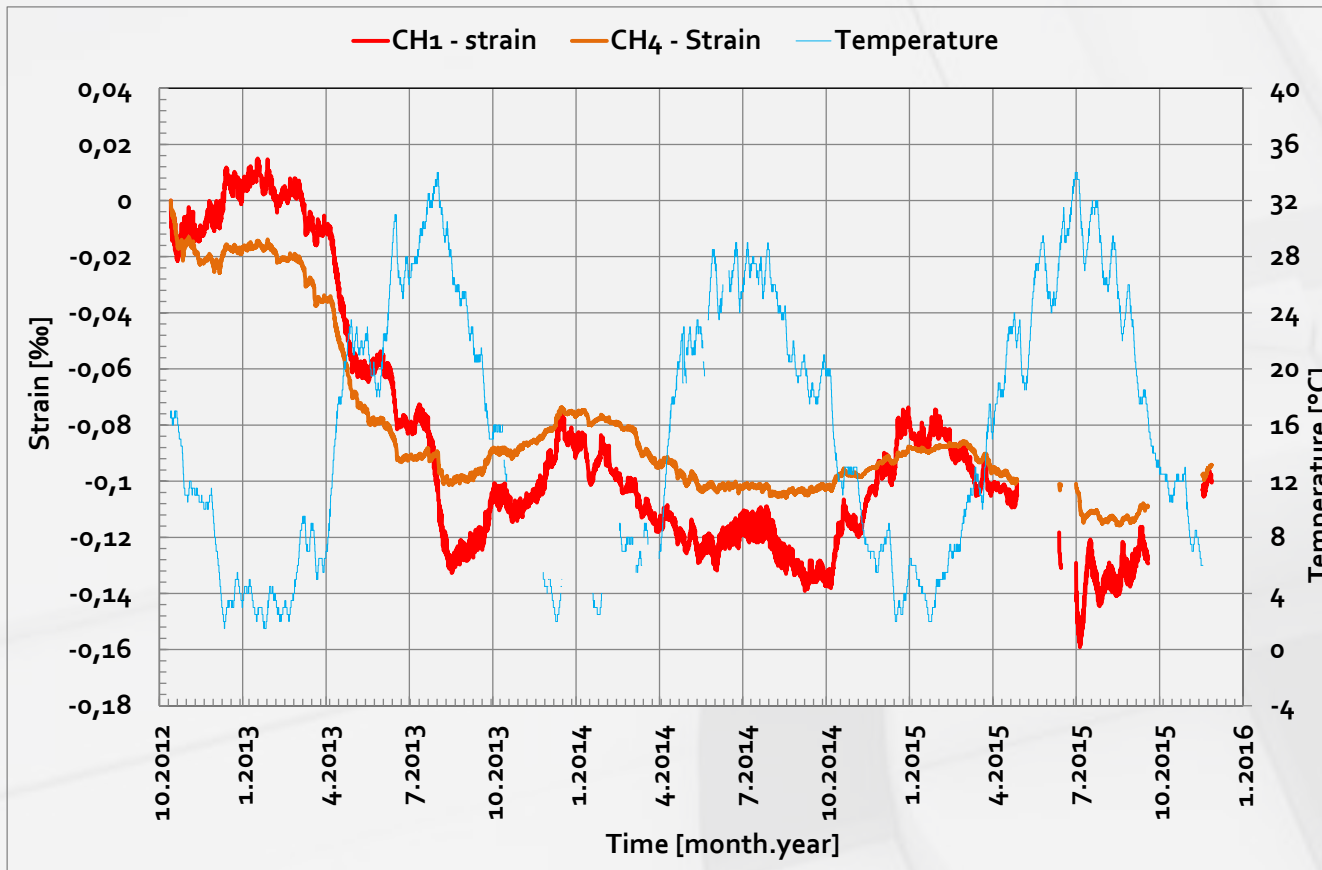
Measured strain values are low.

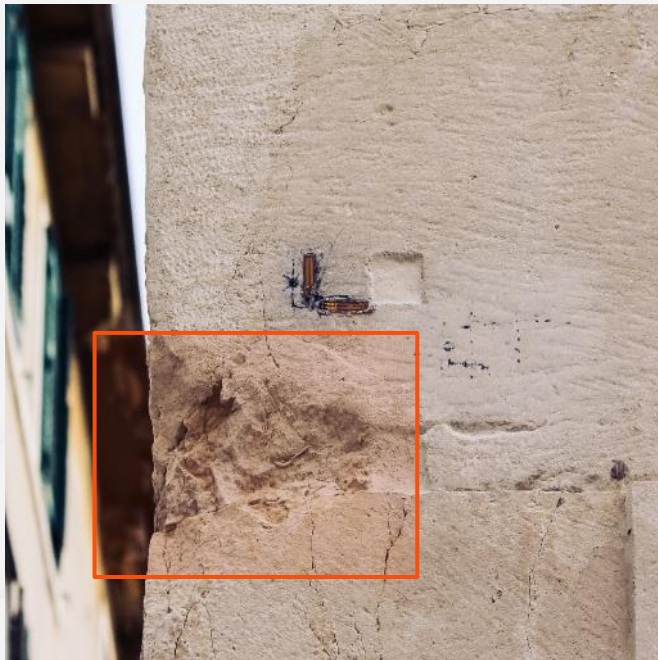
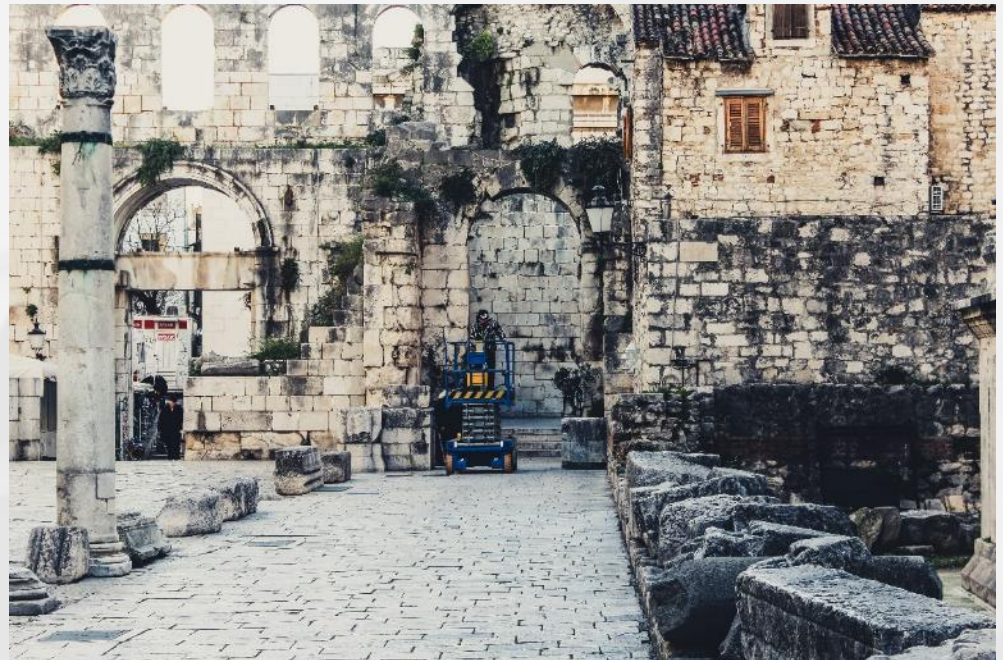
The damages on masonry structures mainly relate to cracks, foundation settlements, material degradation and structural deformations. There are many techniques which are capable to detect and locate damages even if they are not visible on the surface of the structure. These limitations can be overcome by implementing monitoring system for measuring behaviour of the structure.

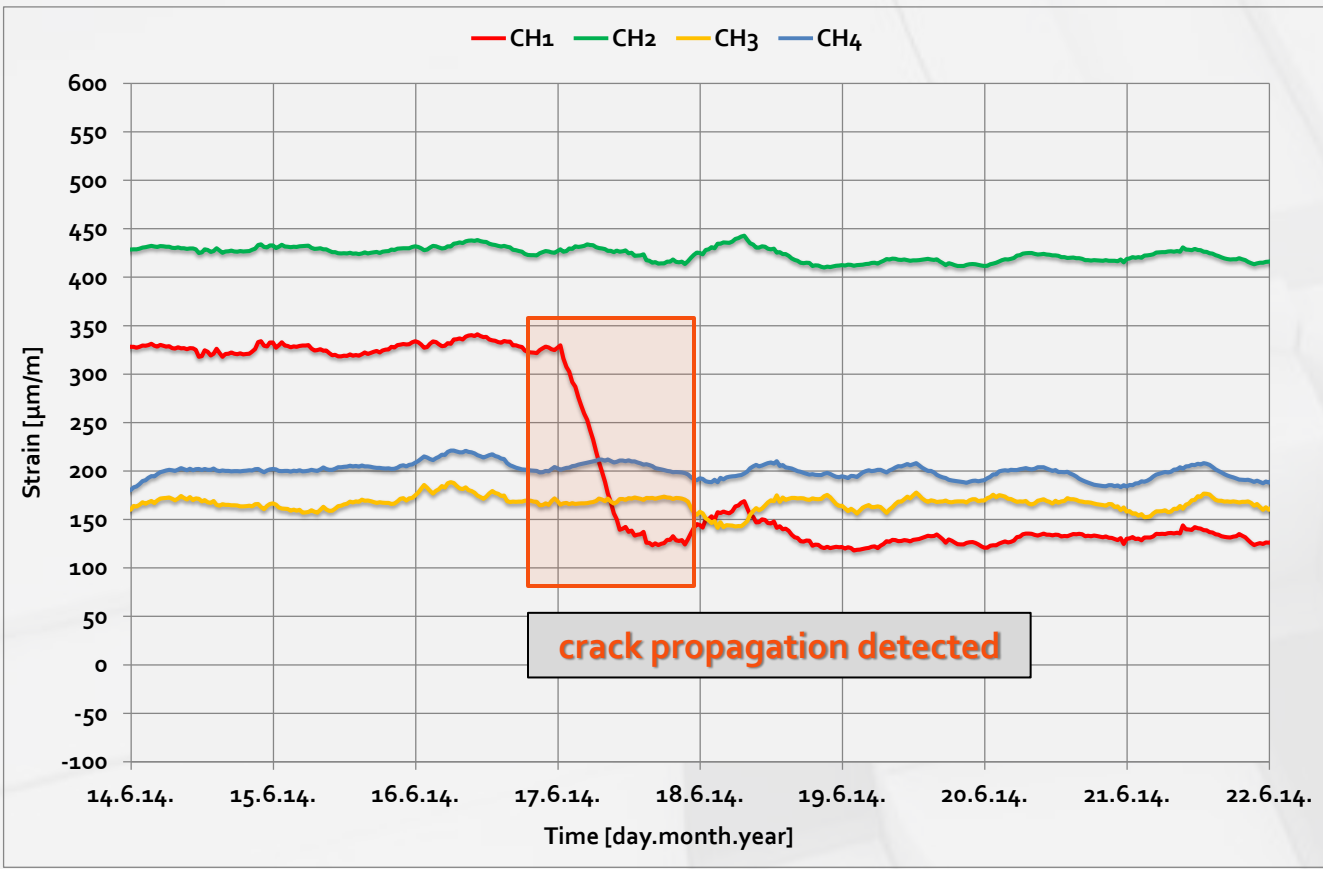
Current state of the structure is stable.

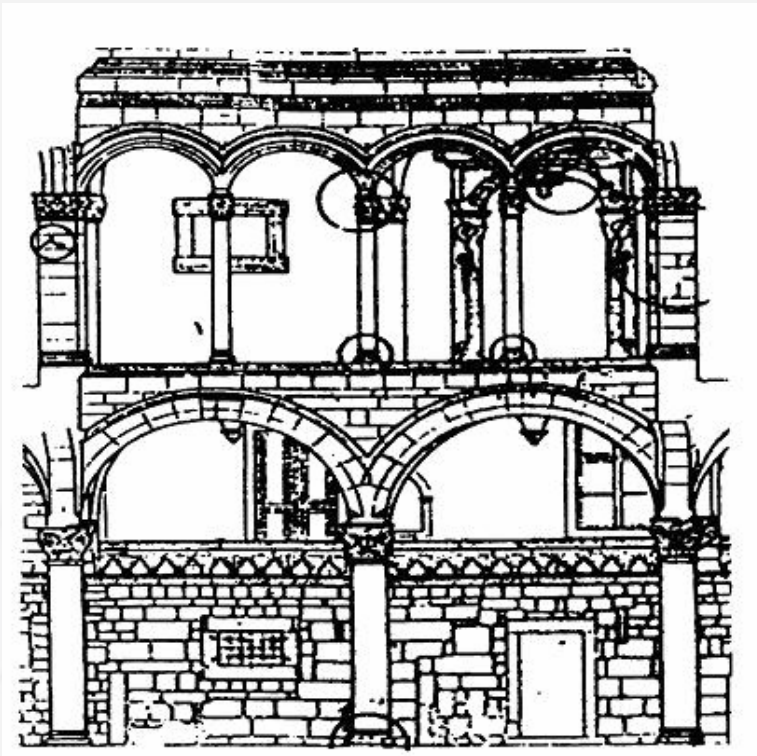
Disastrous earthquake of 1667 damaged the building's interior (columns and archer of the courtyard and the galleries). Last reconstruction took place in 1982/84 following the earthquake of 1979.

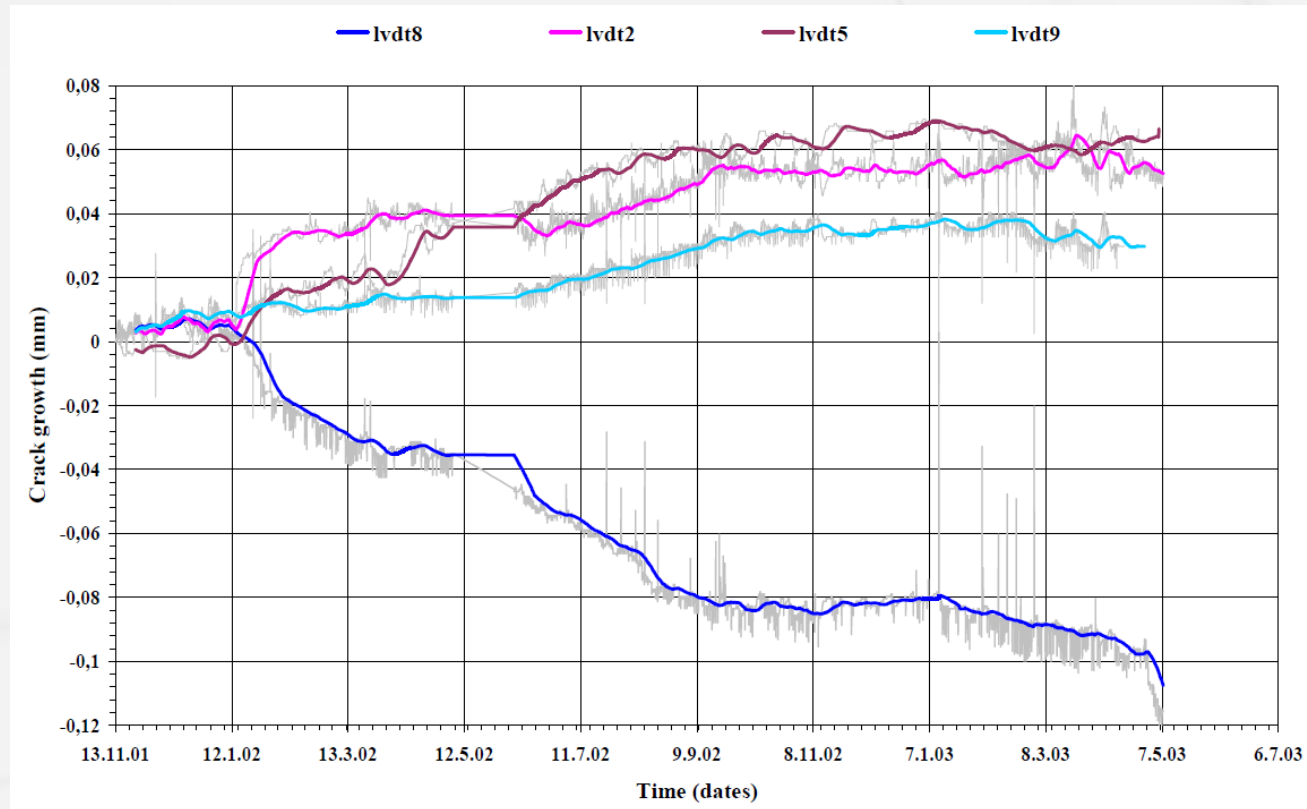
Diagrams of crack growth for sensors 2, 5, 8 and 9

The aim of continuous long period monitoring of Rector's Palace structure behavior is to determine boundary conditions in order to create reliable numerical model of the structure for analysis which will define construction works needed to preserve stability of the structure.

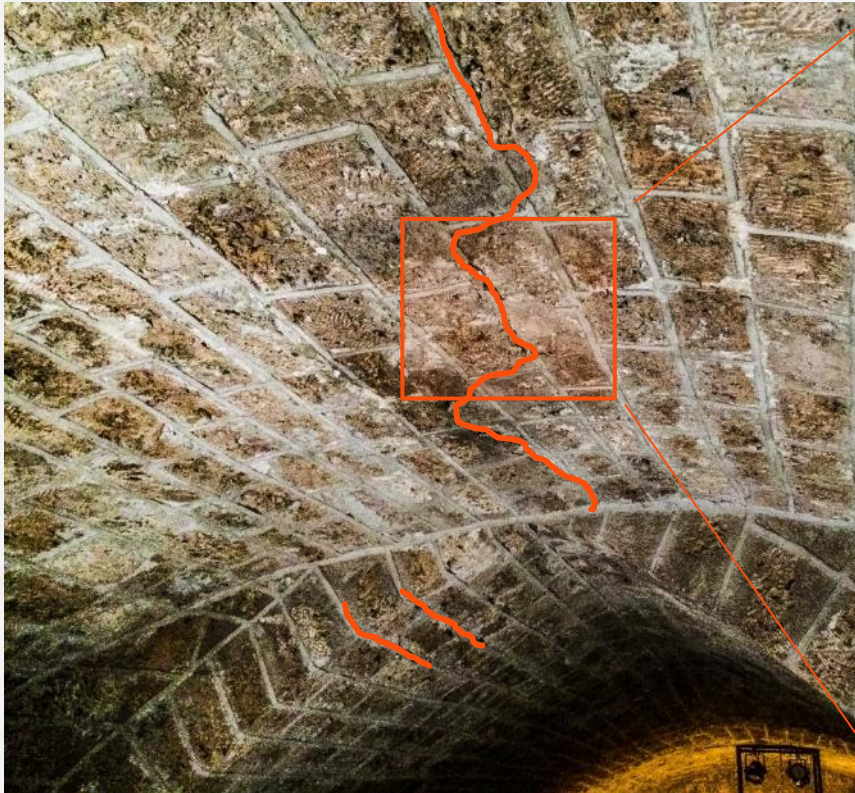
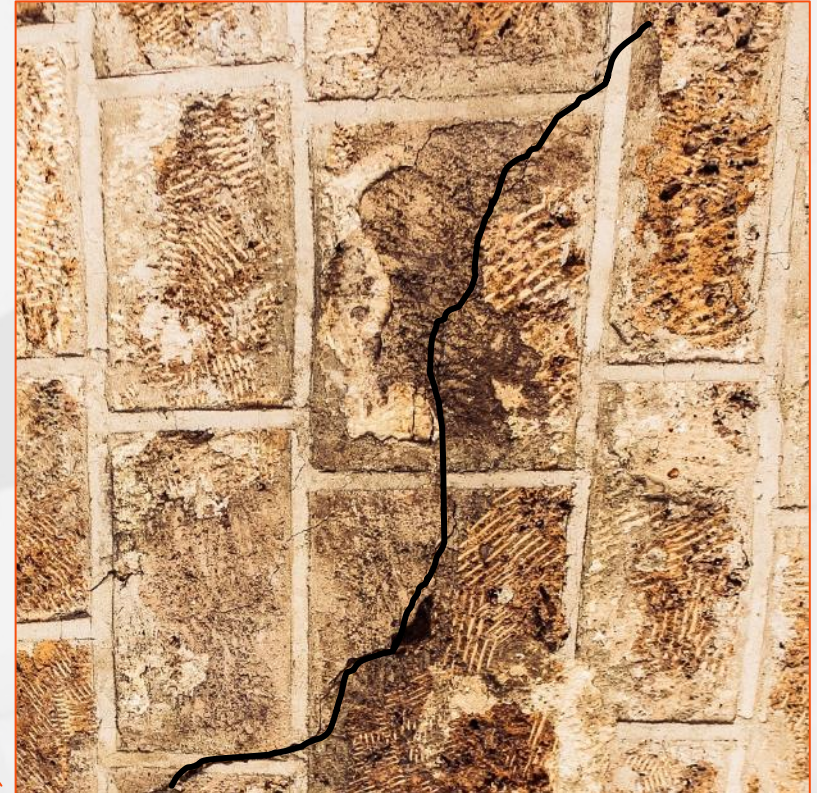
On the vaults of the hall of Revelin fortress cracks appeared, time and cause of crack appearance is unknown.
