PRESS RELEASE

Façades can significantly affect the spread of fire

The large scale fire test: completely identical samples at first sight

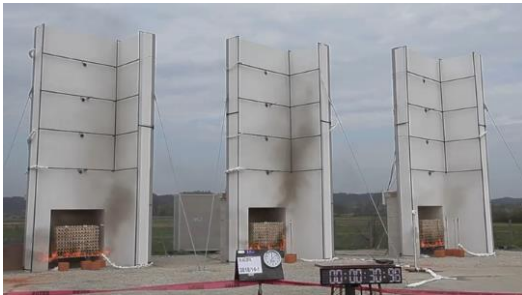
Sample 1 classified system with combustible isolation (EPS), B s2 d0, **sample 2** classified system with combustible isolation (EPS), B s2 d0 + 20 cm horizontal fire barrier made of stone wool and **sample 3** classified system with non-combustible insulation (stone wool), A2 s1 d0. All other components are identical in all three samples.

The photo shows the very beginning of the test (00:30) when the furnaces that simulate an apartment fire are lit, all at the same time. A few minutes later fire is coming out of the

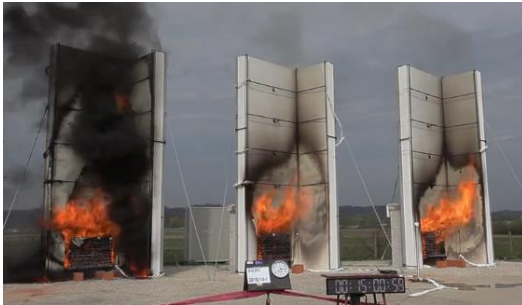
15 minutes after the start of a fire:

Sample 1 is completely caught by fire while it emits large quantities of smoke and gases. Flaming droplets of the burning insulation are increasing the area affected by fire.

At this point there is no greater difference between the reactions of the **sample 2** and **sample 3**

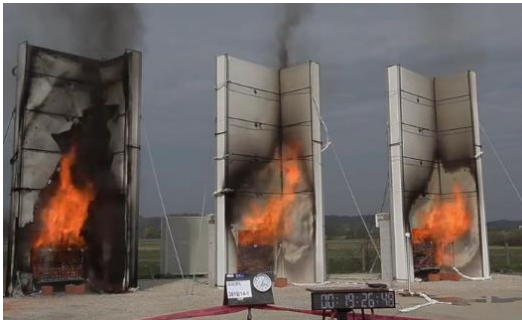
19 minutes after the start of a fire:

Sample 1 is still emitting large quantities of smoke and gases.

On **sample 2** the fire jumped over the fire barrier placed above the window frame and caught the combustible insulation (EPS). The evidence is black smoke at the top of the wall. On **sample 3** the fire has not caught the insulation.

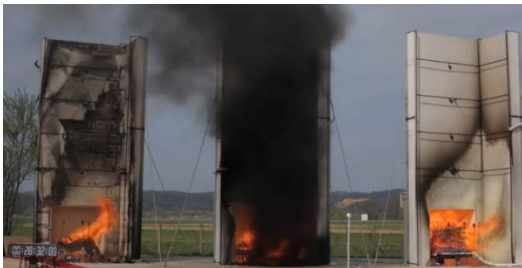
28 minutes after the start of a fire:

Sample 1 the system has burned out, there is only fire in furnace. The steel frame with sensors prevents parts of final decorative plaster from falling.

On **sample 2** the fire spread entirely on the combustible insulation which now emits large quantities of smoke. The situation on the **sample 3** is unchanged.

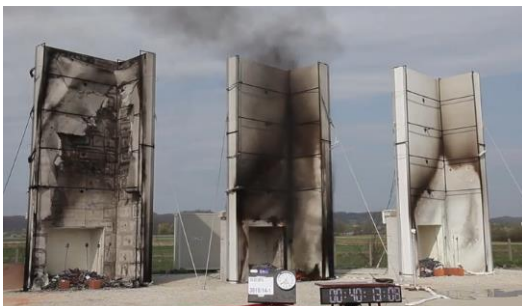
40 minutes after the start of a fire:

Sample 2 is still burning and emitting smoke, even though the fire is not visible. The horizontal stone wool fire barrier above the window frame has delayed escalation of fire for about 10 minutes, but also extended the time of burning of the insulation and emission of gases. The fire in the furnace of **sample 3** extinguished on its own. Unlike **samples 1** and **2**, the façade on the third sample is not structurally damaged.
