Research
Geotechnical Engineering—Article

Mechanism of the December 2015 Catastrophic Landslide at the Shenzhen Landfill and Controlling Geotechnical Risks of Urbanization

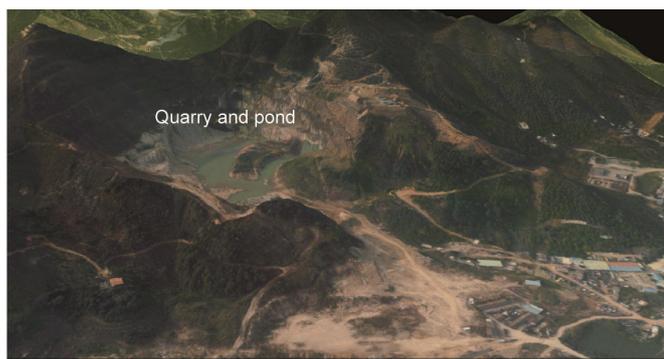
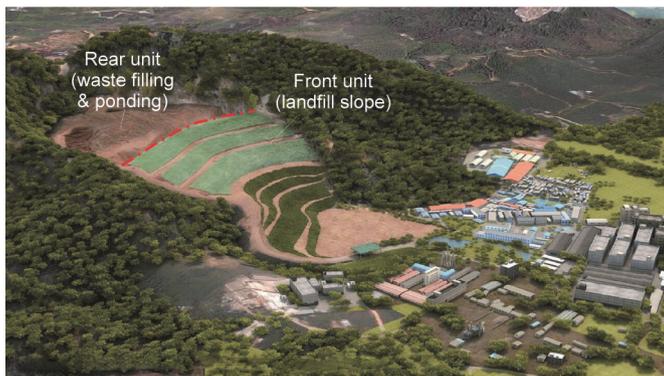
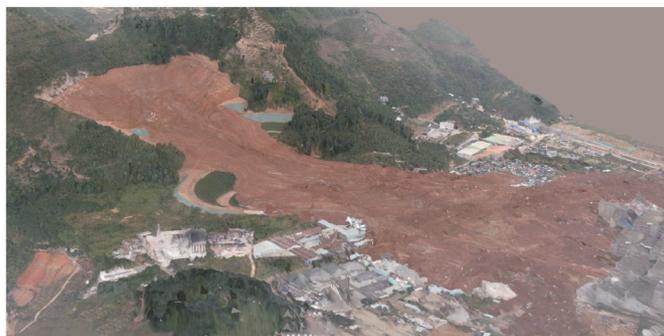
Fig. 2. Comparison of images showing the location, landfill, and landslide. (a) Remote-sensing image three months before the placement of CSW, taken on December 31, 2013; (b) remote-sensing-based effect image two days before sliding of landfill landslide, taken on December 18, 2015; (c) aerial view one day after the landfill landslide, taken on December 21, 2015 from an unmanned aerial vehicle (UAV).

Based on a comparison of remote-sensing images from December 18, 2015 with digital elevation model (DEM) data from December 30, 2013 (before the construction of the landfill), the landfill had a volume of about $5.83 \times 10^6 \text{ m}^3$ CSW before sliding. On the afternoon of December 21, 2015, the day after sliding, a UAV drone took aerial photos, shown in Fig. 2(c). The source

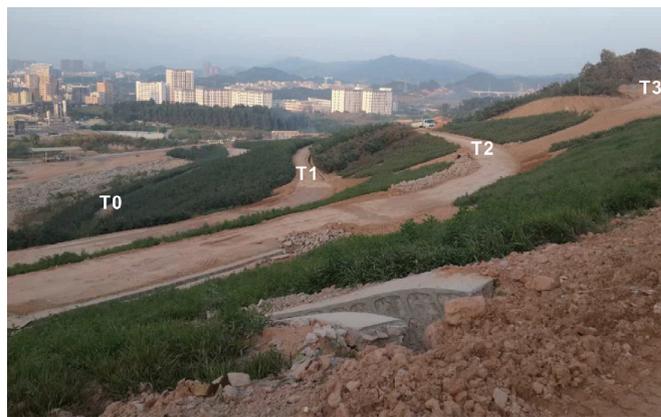
Fig. 3. Photograph of the engineered slope and terraces in the front of the landfill taken on October 10, 2015. The surface drainage had been constructed.

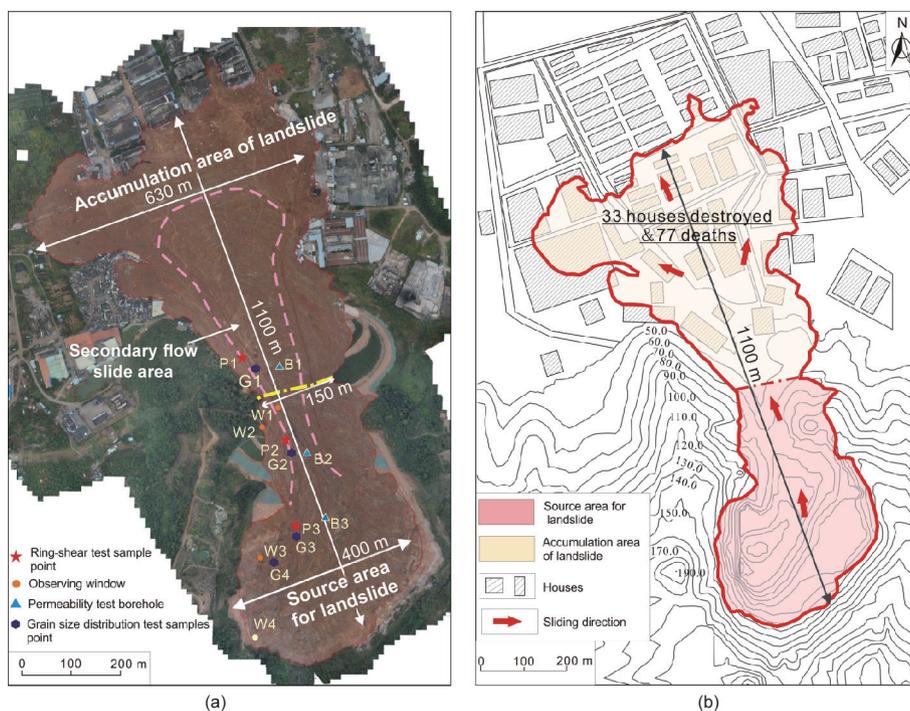
Fig. 4. Zoning map of the landslide at the Shenzhen landfill. (a) Image showing the zones of the sliding source and accumulation area. The sampling sites for the ring-shear test, component observation *in situ*, and boreholes for permeability are indicated. (b) Topographical contour map showing the destroyed houses at the front of landslide.

of the layered soil of the landfill obtained by static cone penetration tests (CPTs) in the field (also see Fig. 4(a)). Specifically, the hydraulic conductivity of borehole B1 in terrace T1 was between 1.0×10^{-10} – 1.0×10^{-7} m·s⁻¹; this sample mainly consisted of a clay layer, with a weighted average value of 2.7×10^{-8} m·s⁻¹, belonging to an extremely weak permeable layer (Table 5). The hydraulic conductivity of borehole B2 in terrace T3 was 1.0×10^{-10} – 1.0×10^{-3} m·s⁻¹; this sample consisted of a highly permeable sand

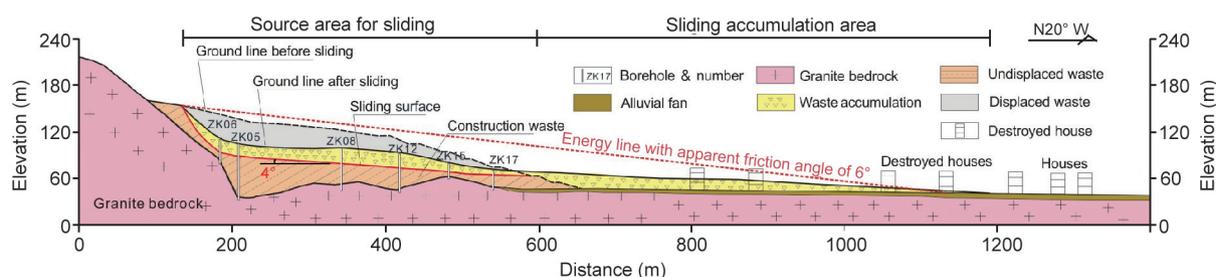
Fig. 5. Longitudinal profile of the landslide at the Shenzhen landfill. The energy line is indicated from scar of landslide to the front of accumulation with an angle of 6° and the drilling holes after sliding reveal that the slip zone is translational with an angle of 4°. The landslide is exited at the terrace T1.

In the open pit, the CSW soil was saturated due to rich groundwater. The ZK5 and ZK17 boreholes (also see Fig. 5) that were drilled after the landslide revealed that the main components of CSW in the open pit were cohesive soil, quartz sand, gravel, and granite breccia, with a poor grading and no separation. The drill core was hard to form into a pile shape, and easily loosened and deformed due to the degree of saturation of the soil. The natural moisture content of the deep red clay ranged from 45.9% to 46.9%, and the degree of saturation ranged from 94.4% to 94.5%. The natural moisture content of the greyish brown sandy clay ranged from 21.5% to 23.1%, and the degree of saturation ranged from 69.0% to 69.4%. If classified by water content, the moisture of the CSW ranged from “wet” to “very wet”; by degree of saturation, the moisture of the CSW ranged from “wet” to “saturated.” The gradual loading from the upper CSW placement caused consolidation of the lower soil mass with high water content and resulted in excess pore water pressure. Chen [13] referred to such pore water pressure as infiltration-induced pore pressure and external load-induced pore pressure, and discussed the addition of pore pressures. Li [14] expanded on Chen’s viewpoint. We adopted their thinking, which suggested that the infiltration-induced pore pressure was higher than the external load-induced pore pressure.

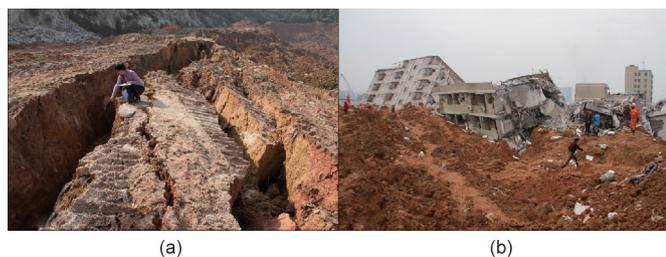
Fig. 6. Photographs taken two days after the landslide. (a) Residual unstable waste mass at the back; (b) destroyed buildings in front and the flow-like landslide accumulation with abundant water.

area was located at the part of the CSW landfill that was under construction. The exiting position was at T1, with an elevation of 63 m. Based on a comparison of UAV drone aerial photos from December 21, 2015 (the day after the landslide) with DEM data from December 18, 2015, the sliding area covered 0.116 km² and had a south-north length of 374 m and an east-west width of 400 m. The total volume of the landslide was 2.51×10^6 m³, and its thickness ranged from 10–50 m, with an average of 30 m. There were dozens of cracks along the rear of the landfill defining a deforming mass of more than 1×10^5 m³ in volume, shown in Fig. 6(a).

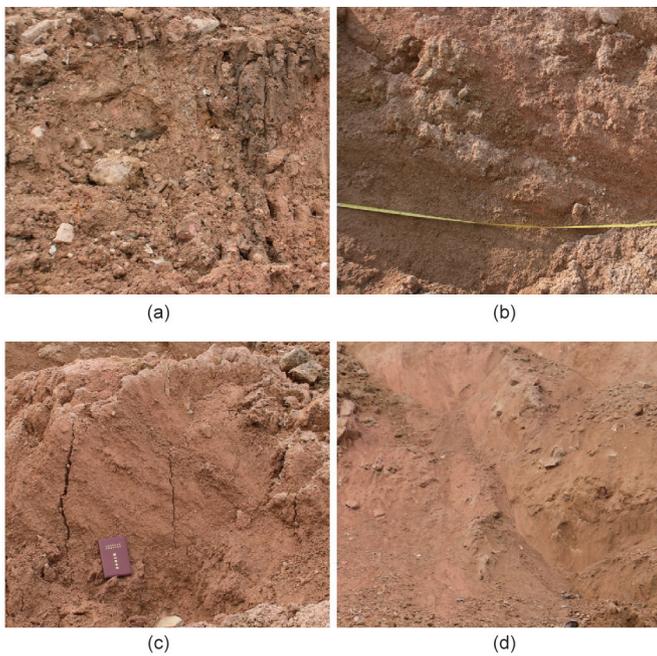
Fig. 7. Photographs of the material components of the CSW from statistic windows *in situ* after the landslide. The CSW was derived from the constructing metro.

No. 1: The sampling window was located at the exit of the landslide source. It was composed of tawny sandy clay, taupe clay, and broken stone. The proportion of broken stone and taupe clay were about 5% and 12%, respectively, and the rest was tawny sandy clay (Fig. 7(a)).

No. 3: The sampling window was located at the west middle side of the landslide source area, with relatively clear sliding traces on the surface. It consisted of 2% CSW, such as broken stone, rubble, and steel. The rest was almost all red sandy clay with about 30% fine sand and 2–3 mm gravel particles (Fig. 7(c)).

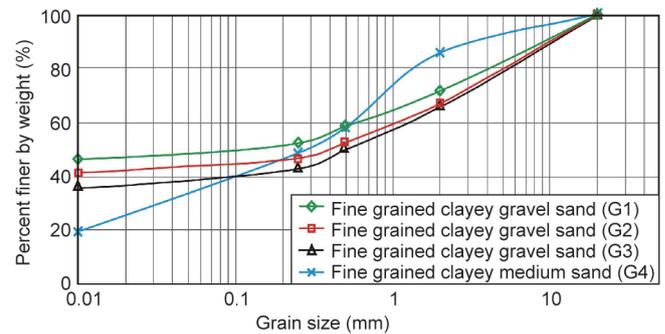
An analysis of sample grains from the sliding plane, the accumulation, and the residual mass of the source revealed the following (Fig. 8):

Fig. 8. Grain size distribution of samples taken from the landslide.

(1) Silt and clay grain (< 0.075 mm): The proportions of total weight were 41.0%–46.3%, 35.3%, and 19.2%, respectively.

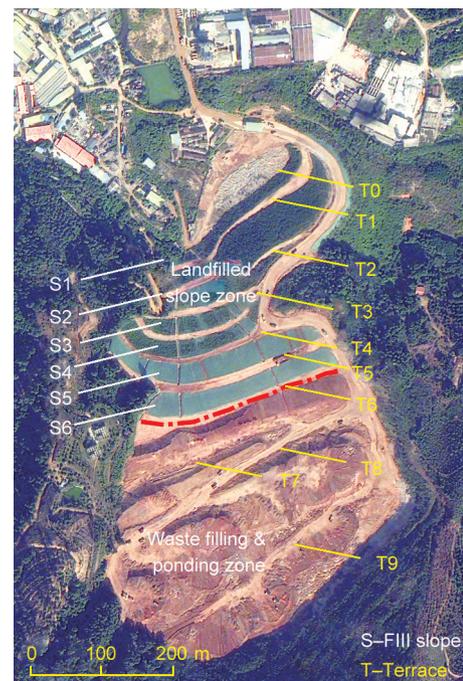
Fig. 9. Remote-sensing image showing the landfill, terraces, and engineered slope on December 18, 2015. The landfill was divided into two units: the front landfilled slope unit with low water-bearing CSW, and the rear placing and ponding unit with rich water-bearing CSW.

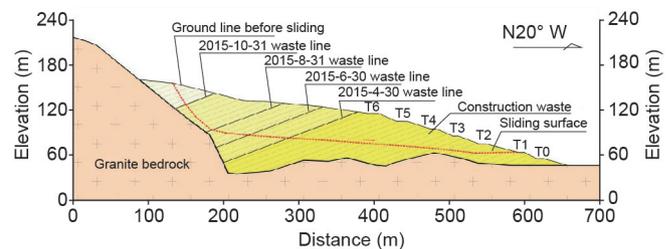
Fig. 10. Longitudinal profile showing the placing phases and the landfill slope structures. The rear slope with terraces T0 to T6 had been shaped prior to April 31, 2015, and the rear pond was gradually filled from May to December of 2015 with a volume of near $1 \times 10^6 \text{ m}^3$. The surface water during the rainfall at back was directly runoff to the pond due to low permeability of the slope.

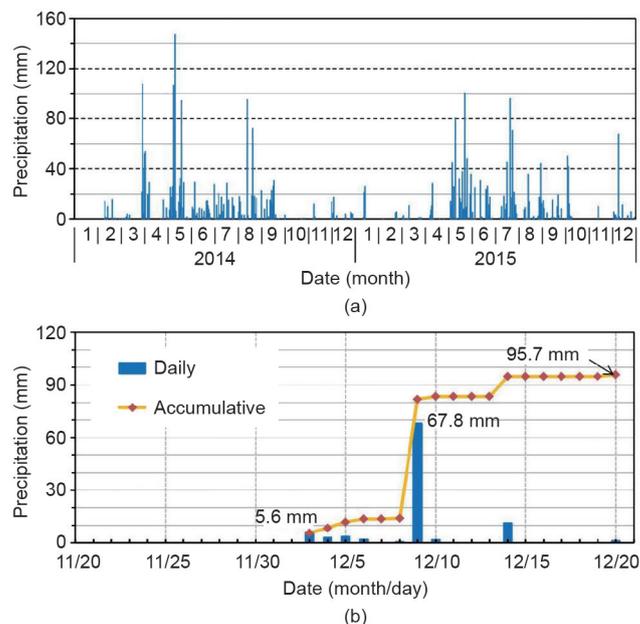
Fig. 11. Graphs of precipitation at the Shenzhen landfill. (a) From January 1, 2014 to December 31, 2015, the concentrating period of rainfall was in May and August of 2014 and in May and July of 2015; (b) one month prior to the landslide, a heavy rainfall with an amount of 67.8 mm occurred on December 9, 2015, only 11 days before landslide.

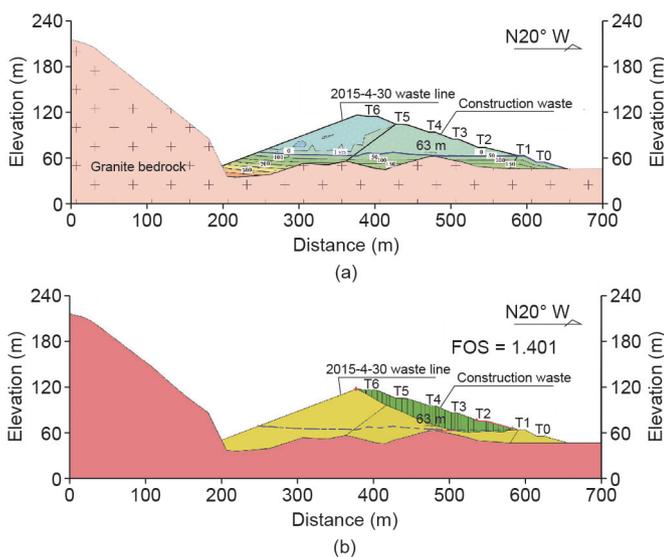
Fig. 12. The first stage of CSW placement. (a) Geo-Studio simulation of seepage in the landfill. The seepage is simulated to show a pore pressure distribution. The level is assumed less than bedrock peak with an elevation of 63 m. (b) FOS of possible failure slope. The FOS is high due to the level is under the potential sliding plane.

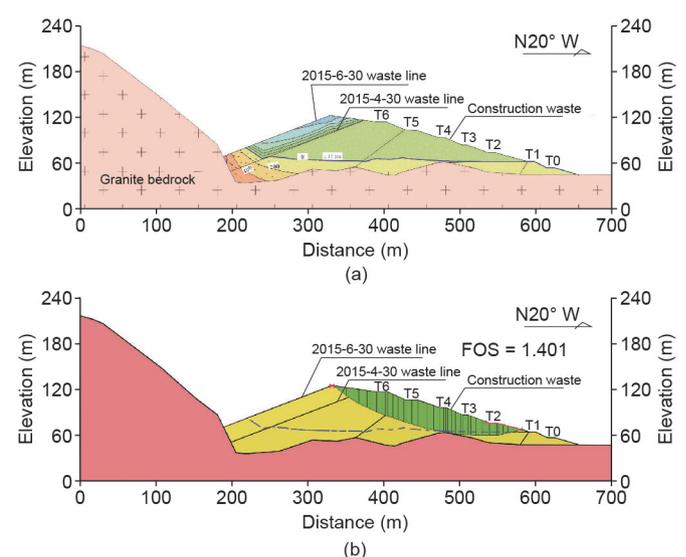
Fig. 13. The second stage of CSW placement. (a) Geo-Studio simulation of seepage in the landfill. The groundwater level is rising at the rear due to infiltration of surface water, but slightly changes in the front slope due to the low hydraulic conductivity. (b) FOS of possible failure slope. The FOS is slightly declined due to the water level is only approach to the sliding zone.

The second placing stage was from May 1, 2015 to June 31, 2015, lasting 61 days, during which nearly $2.2 \times 10^5 \text{ m}^3$ of CSW was placed. The front slope of the landfill reached an elevation of 115.7 m, causing a pond to form at the lower rear of the landfill. Runoff from rain flowed directly from two gullies to the pond and infiltrated the CSW landfill. The volume of surface water was about $5.68 \times 10^4 \text{ m}^3$; that is, about $393.96 \text{ m}^3 \cdot \text{d}^{-1}$ on average. Because the hydraulic conductivity of the front slope was low, the groundwater in the north of terrace T3 could not drain effectively. The existing groundwater was plentiful in the first stage. The addition of the exiting water and the surface water caused a backwater effect in the ponding area at the rear of the landfill. The piezometric level apparently rose from 63 m to 81 m, and the pore water pressure was generally 200 kPa, with a maximum ranging from 400 kPa to 600 kPa (Fig. 13). The groundwater level in the front slope did not change, and the FOS of the possible failure slope was the same as in the first stage, FOS = 1.401. The stability was good.

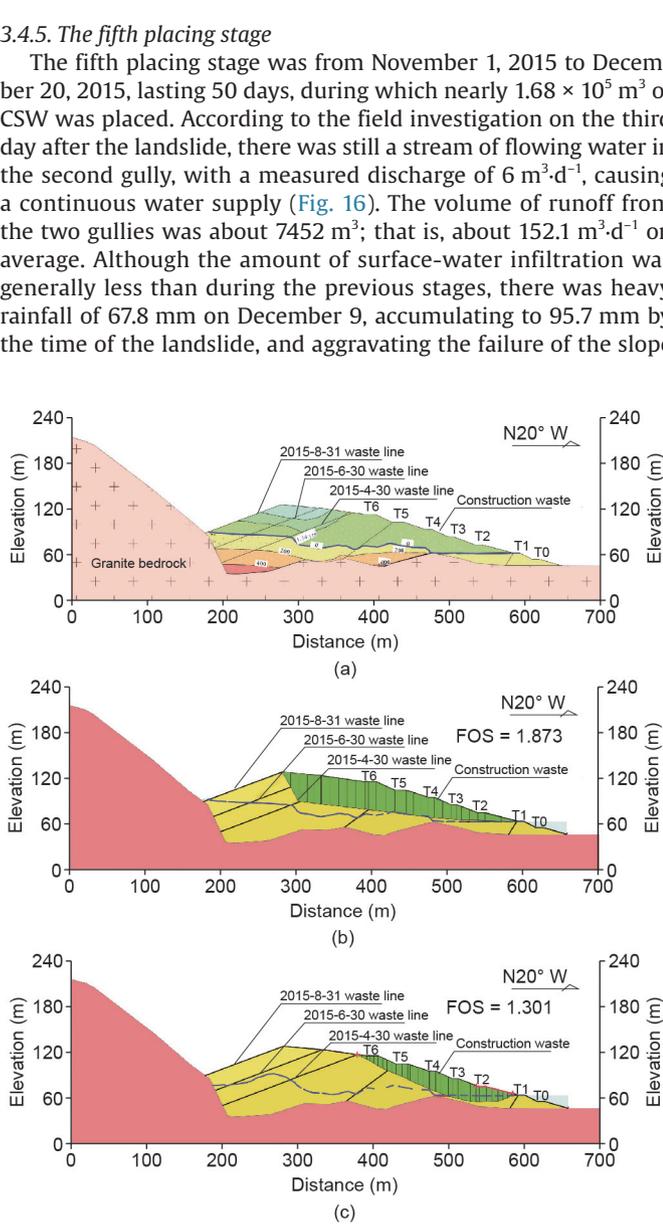
Fig. 14. The third stage of CSW placement. (a) Geo-Studio simulation of seepage in the landfill; (b) FOS of whole possible failure slope; (c) FOS of front possible failure slope.

Therefore, in the rear of the landfill, the piezometric level rose from 81 m to 86 m, and the pore pressure was about 400 kPa, with a maximum from 400 kPa to 500 kPa. In the middle of the landfill, the piezometric level rose from 65 m to 75 m, and the pore pressure reached 400 kPa. In the front landfill slope, the groundwater level did not change, remaining at 63 m (Fig. 14(a)). The FOS of the future failure slope decreased slightly, to 1.301. The stability was still good (Fig. 14(b)).

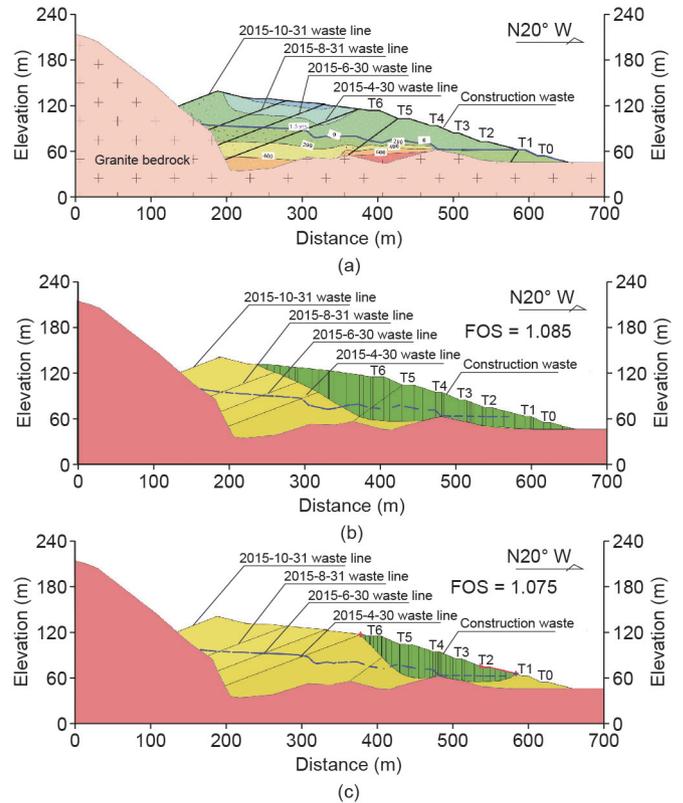
Fig. 15. The fourth stage of CSW placement. (a) Geo-Studio simulation of seepage in the landfill; (b) FOS of whole possible failure slope; (c) FOS of front possible failure slope.

In the rear of the landfill, the piezometric level rose from 86 m to 97 m, and the pore pressure changed slightly; it was generally 400 kPa, with a maximum from 400 kPa to 500 kPa (Fig. 15(a)). In the middle of the landfill, the groundwater level rose from 75 m to 81 m. The elevation at the position of the infiltration area was above 121 m, forming a water head difference of at least 40 m with the middle groundwater level, and causing excess pore water pressure, from 600 kPa to 700 kPa. In the front of the landfill, the groundwater level rose slightly, to about 65 m. Due to the rising groundwater level in the middle and front slope, a new potential slide area formed in the northern part of terrace T6. The FOS of the possible failure slope decreased markedly, to 1.075. The stability decreased, coming close to a critical state (Fig. 15(b)).

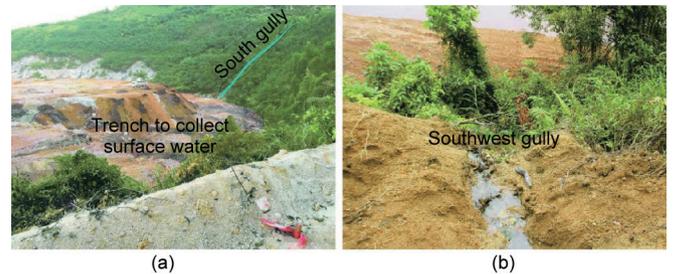
Fig. 16. Gully runoff due to rainfall and continual infiltration to the fresh landfill waste mass at the rear of the landfill. (a) South gully and trench at back, taken on November 24, 2015; (b) permanent discharge of southwest gully to landfill, taken on December 21, 2015.

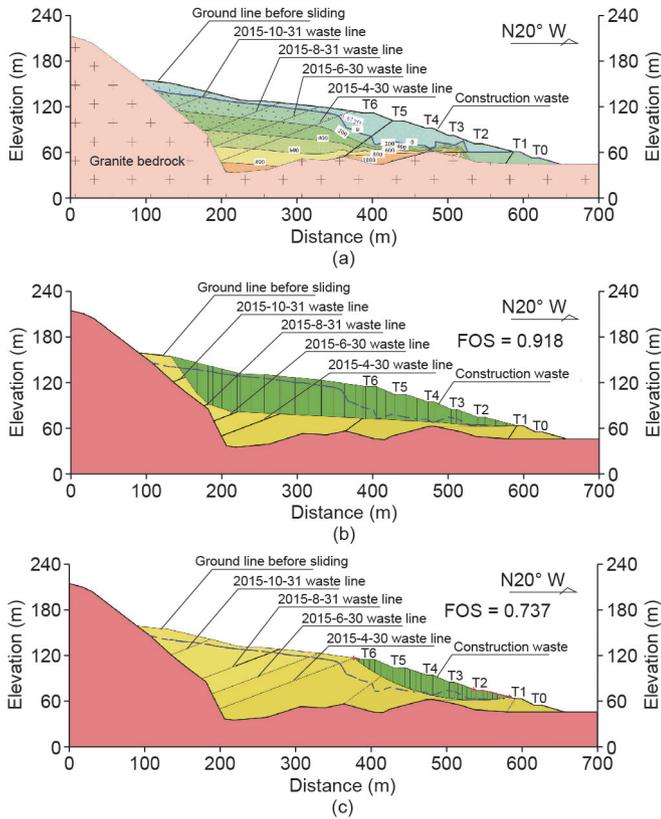
Fig. 17. The fifth stage of CSW placement. (a) Geo-Studio simulation of seepage in the landfill; (b) FOS of whole possible failure slope; (c) FOS of front possible failure slope.

In the rear of the landfill, the piezometric level rose from 97 m to 147 m; in the middle, it lowered to 112 m (Fig. 17(a)). The excess pore pressure increased dramatically, to a maximum of 800 kPa. In the middle of the landfill, the groundwater level change caused a hydraulic jump. The piezometric level decreased from 112 m to 68 m, and the groundwater head difference was 44 m, creating excess pore water pressure of 800–1000 kPa. In contrast to the first four stages, the piezometric head in the front of the landfill slope rose from 65 m to 78 m, resulting in a significant increase of pore water pressure. The simulated result of the existence of a piezometric water head in the landfill was confirmed by drilling two days after the landslide, when artesian water flowed from all four drill holes on terrace T3. The depths of these four holes, respectively, were 7.0 m, 9.4 m, 10.5 m, and 19.5 m (Fig. 18, also see Fig. 4(a)).

the consolidation-induced seepage of the CSW in the lower part formed the driving source of the sliding. Meanwhile, in the middle and front of the landfill, both the infiltration and the external load induced a marked increase in pore pressure, resulting in a decrease of the resisting force in the front area. Calculation shows that the FOS of the possible failure slope was 0.918, suggesting that the landslide possibly had started (also see Fig. 17(b)).

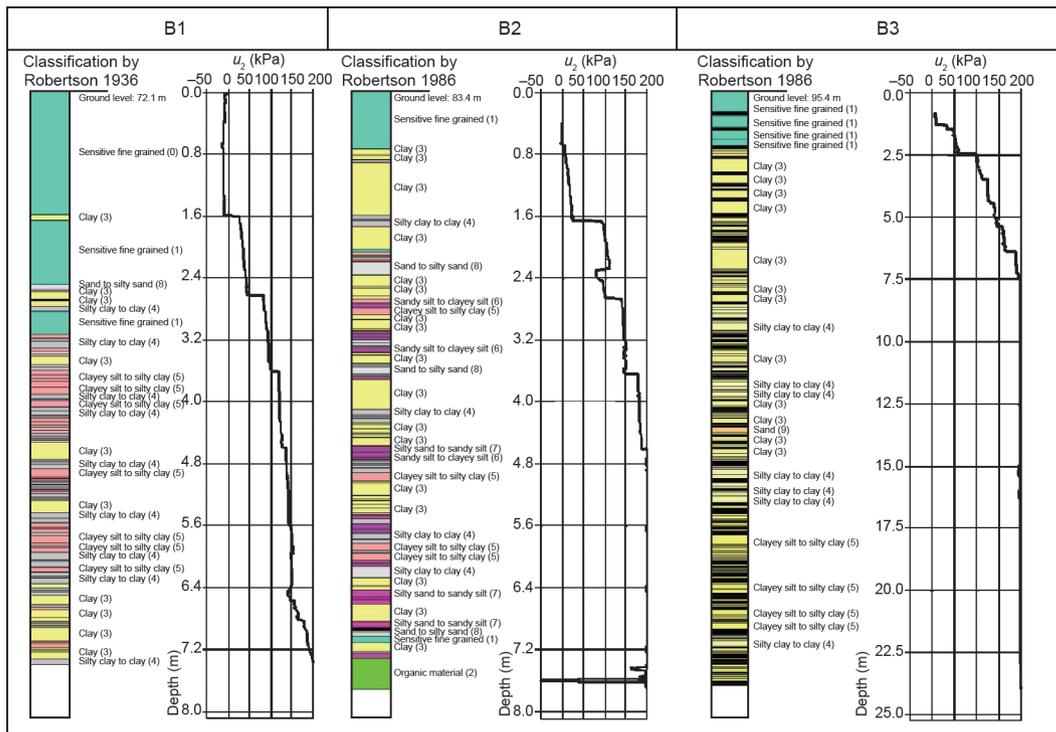
Fig. 18. Measured curves of pore water pressure in the landfill and landslide after sliding. The position of boreholes to measure pore water pressure can be seen in Fig. 4(a).

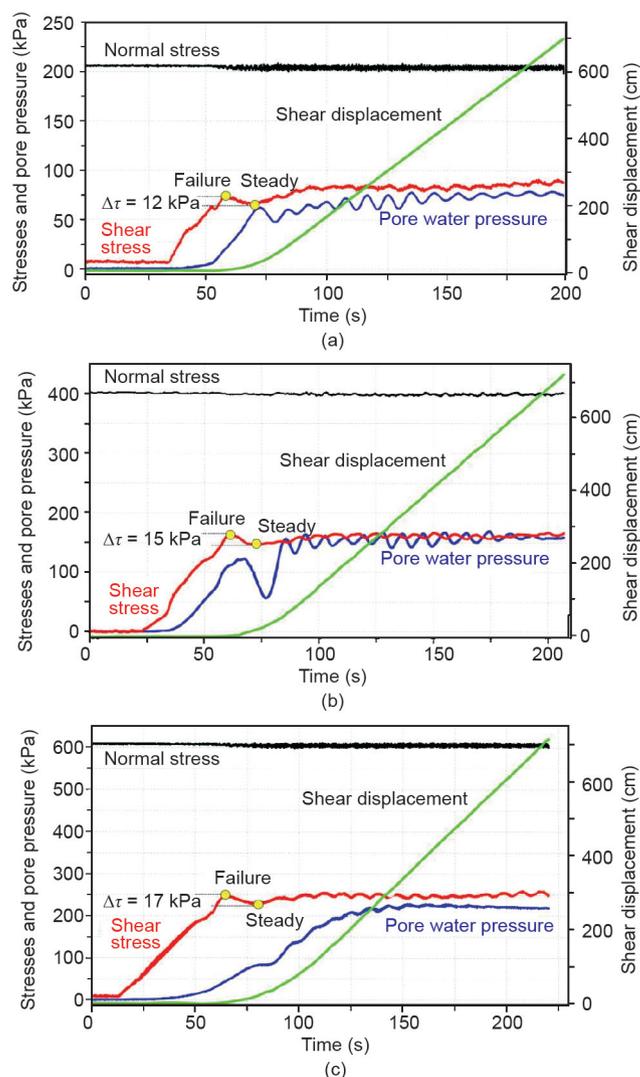
Fig. 19. Results of undrained ring-shear tests on saturated sample: shear stress, pore water pressure, and shear displacement versus elapsed time under normal stress (a) 200 kPa, (b) 400 kPa, and (c) 600 kPa.

Representative undrained ring-shear test results and the effective stress path for the tested landslide materials are shown in Figs. 19 and 20, respectively. Fig. 19 shows the curves of shear stress and pore water pressure as a function of shear duration for different normal stresses. The tests indicated that the normal stress had little effect on the undrained shear behavior, which generally exhibited Skempton's softened characteristics.

First, with increasing shear stress at the controlled loading rate (2 kPa·s⁻¹), pore water pressure gradually increased at relatively small displacements of millimeters. This result was mainly attributed to the reason that the collapse of a metastable structure can induce a build-up of pore water pressure before the occurrence

Second, with the progress of loading to failure (see the marked points in Fig. 19), the shear strength dropped by tens of kilopascal after the failure of the sample when initially softened. This strength loss generally appeared to be a slight positive tendency of normal stress, and accompanied the increase of pore water pressure.

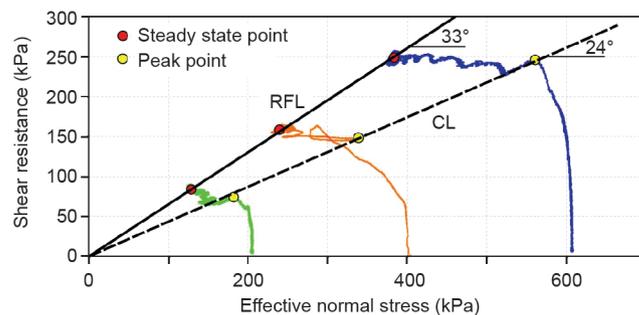
Fig. 20. Results of undrained ring-shear tests on saturated sample: effective stress path. Initial densities are, respectively, 1.70 g·cm⁻³, 1.75 g·cm⁻³, and 1.82 g·cm⁻³ under normal stresses from 200 kPa, 400 kPa, and 600 kPa. CL—collapse line; RFL—residual failure line.

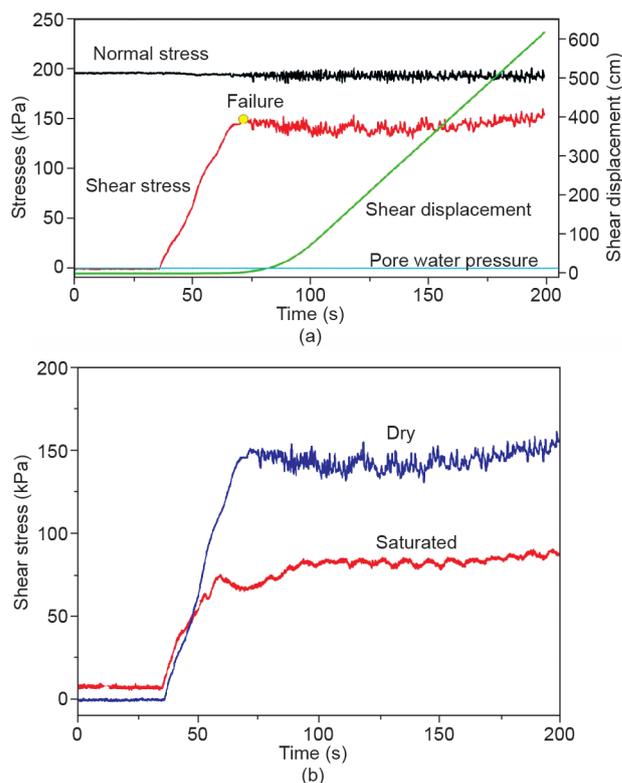
Fig. 21. Results of ring-shear tests: effective stress path under normal stress of 200 kPa. (a) Result of ring-shear test on dry sample; (b) comparison of curve between dry and saturated samples.

Because the field conditions of the landslide were rather perplexing, another comparative trial was conducted under dry conditions in order to explore the possible role of water lubrication during sliding. This was done because the field evidence showed that the landslide materials had high water content. As shown in Fig. 21, the strength spectra for the dry sample, including peak and residual, were nearly twice as high as for the saturated sample. This result supported the assumption that the landslide was lubricated by the abundant pore water at the base of the landslide. A comparison of the ring-shear test results with those from studies of less mobile landslides suggested that the observed strength loss was not sufficient to fully explain the landslide's mobility. A more detailed geomorphological reconstruction of the landslide event and tests on other materials, including more sandy parts of the landfill materials, may be needed in order to better understand the mechanisms contributing to the landslide's mobility.

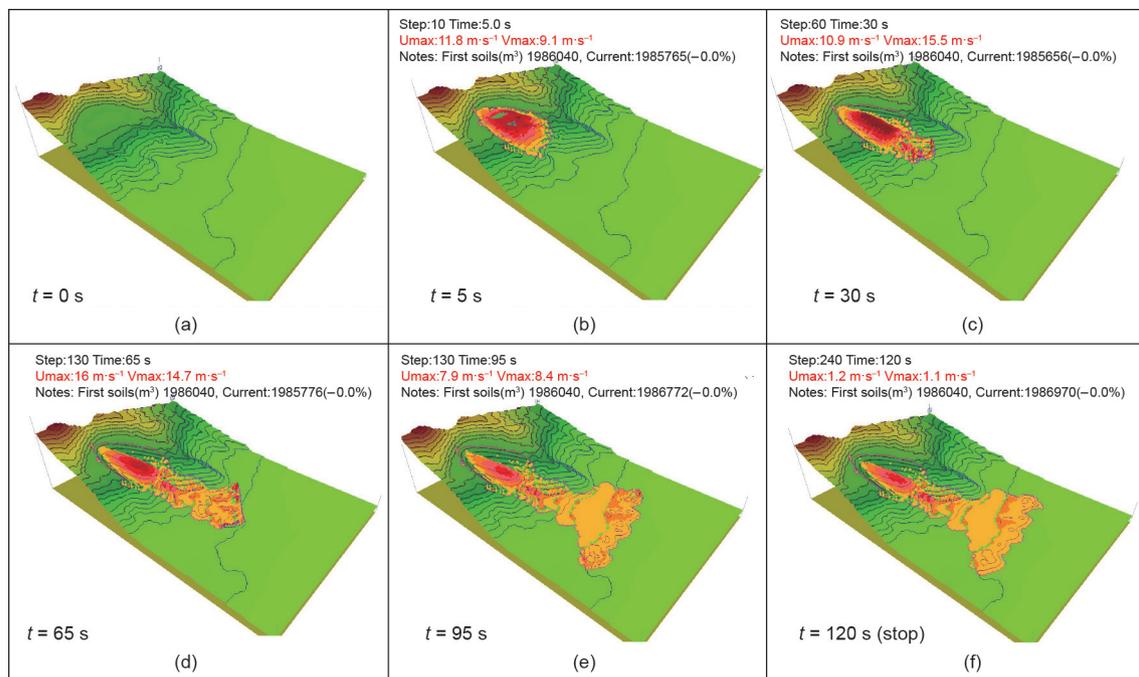
Fig. 22. Simulation result of the long run-out of the landslide at the Shenzhen landfill with LS-RAPID.

Fig. 22(a) at 0 s represents the initial state of the landslide, and embodies the morphological characteristics before the landslide failure.

Fig. 22(b) at 5 s represents the launch of the landslide. The whole slope failure starts to move downward, with a speed of $14 \text{ m}\cdot\text{s}^{-1}$ and a movement distance of 480 m.

Fig. 22(e) at 95 s represents the decelerated motion stage. The accumulation is changing constantly, with a maximum speed of $11.5 \text{ m}\cdot\text{s}^{-1}$ and a movement distance of 920 m.

Fig. 22(f) at 120 s represents the front accumulation stage. After dispersing over flat ground, the accumulation is still changing, with a maximum speed of 1.4 m·s⁻¹ and a movement distance of 1060 m.

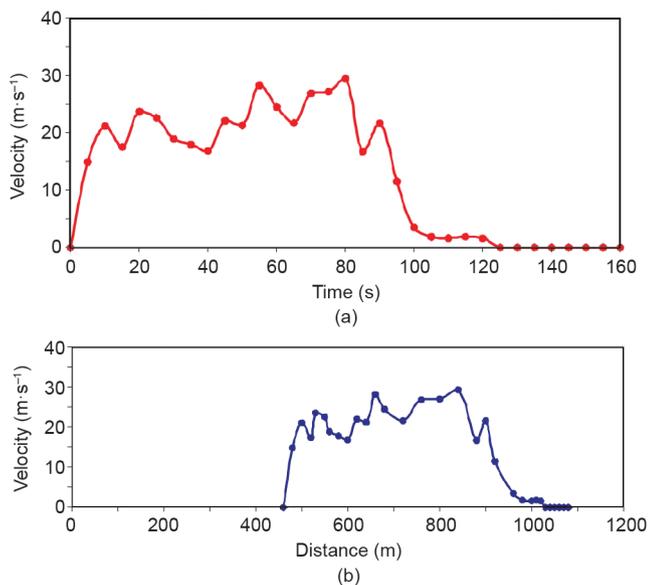
Fig. 23. Simulation result of the run-out velocity of the landslide at the Shenzhen landfill with LS-RAPID. (a) Velocity vs. time; (b) velocity vs. distance.

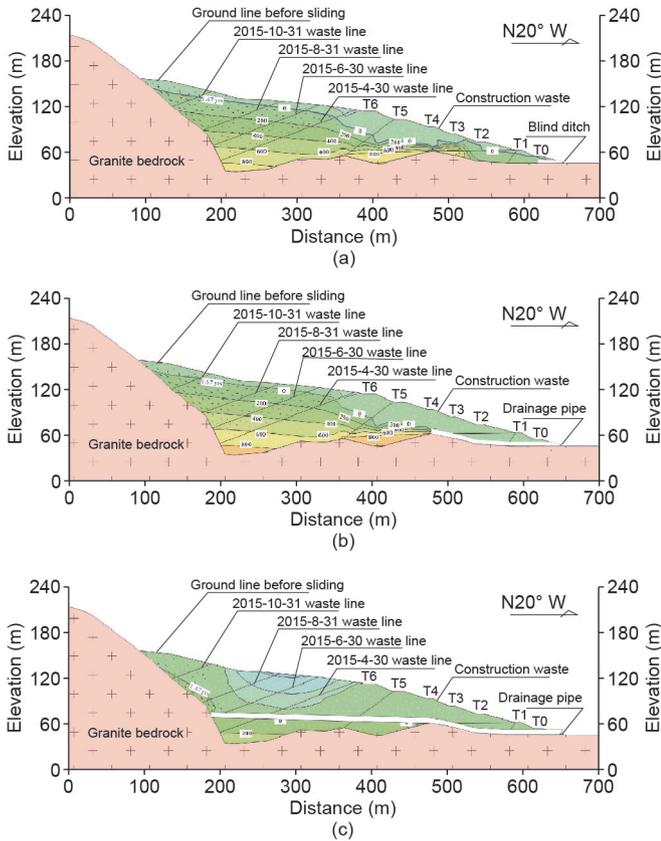
Fig. 24. Scenario assuming various drainages of groundwater: simulation result of seepage in the Shenzhen landfill before sliding. (a) Blind ditch on the surface of the slope; (b) drainage pipe in the front of the slope; (c) drainage pipe from the rear of the landfill.

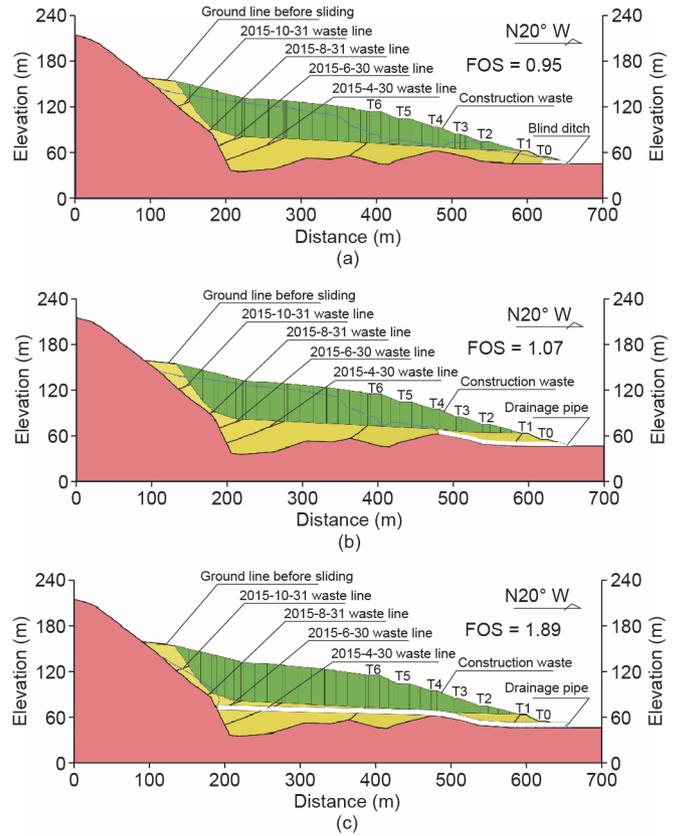
Fig. 25. Scenario assuming various drainages of groundwater: simulation result of FOS of possible failure slope in the Shenzhen landfill before sliding. (a) Blind ditch on the surface of the slope; (b) drainage pipe in the front of the slope; (c) drainage pipe from the rear of the landfill.

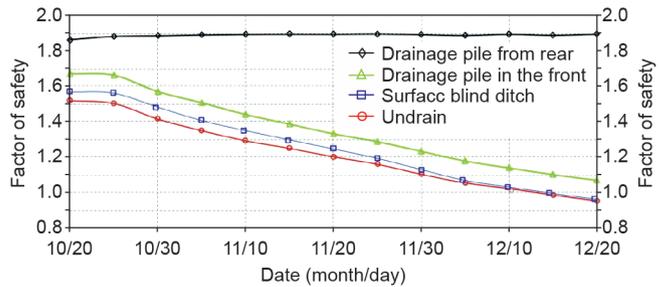
Fig. 26. Comparison of FOS of possible failure slope between undrain and scenario assuming various drainage of groundwater in the Shenzhen landfill before sliding.
