**Proceedings of the
International Conference
on Sustainable Materials,
Systems and Structures
(SMSS2019)**

**Durability, Monitoring and
Repair of Structures**

International Conference on Sustainable Materials, Systems and Structures (SMSS 2019)
Durability, Monitoring and Repair of Structures
20-22 March 2019 – Rovinj, Croatia

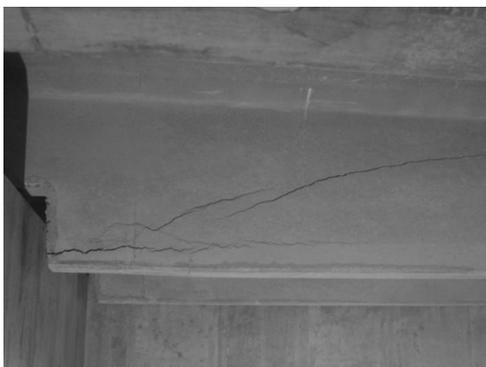
Figure 1: Diagonal shear cracking and longitudinal cracking in stem

The project included the assessment and repair of the concrete roof system of a water treatment plant which consisted of cast-in-place concrete framing supporting precast, prestressed concrete double-tee roof beams. The double tees spans measured up to seventy-two feet (22 m) over open water tanks in the treatment areas. Early in the service life of the plant, routine inspections identified wide, diagonal shear cracking in the webs of the double tees at the ends of numerous beams (Figure 1). Additionally, horizontal cracks were observed near the bottom of the stems. The most severe diagonal cracking measured approximately 50 to 100 mils (0.050 to 0.100 in.) wide and extended through the entire web thickness.

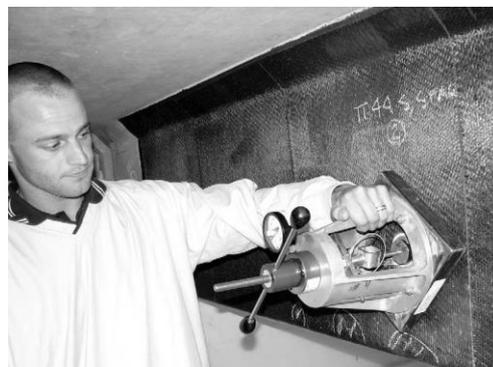
Figure 2: Tensile bond testing of the applied FRP

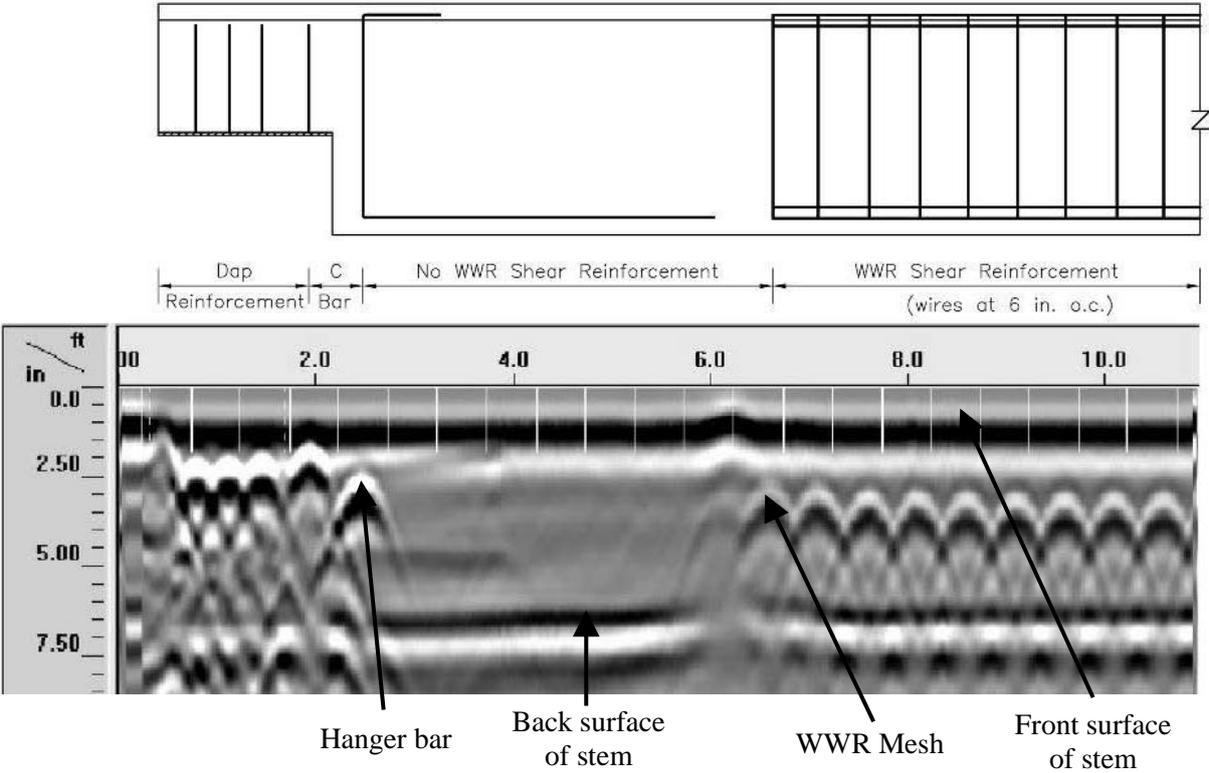
Ground-Penetrating Radar also known as pulsed radar, is a geophysical nondestructive testing technique for the evaluation of structural elements and materials. The method involves using electromagnetic waves to assess the internal characteristics of the material. GPR surveys performed on structural concrete elements allow for the detection and location of embedded objects, assessment of member geometry, and identification of internal conditions (such as poor consolidation and flaws). The technique involves the use of a high-frequency radar antenna that transmits electromagnetic radar pulses along a discrete longitudinal scan at the surface of the element. Electromagnetic signals are reflected from material interfaces of differing dielectric properties. Signals are collected by the antennae, amplified, and displayed for subsequent interpretation. An example of a horizontal GPR scan collected on the lateral face of a stem along with an elevation view of the stem showing the embedded reinforcing is provided in Figure 3. Structural calculations confirmed that shear reinforcing was required and the beams were under-strength. GPR was a cost-effective, reliable, nondestructive approach that not only identified the problem, but helped define the scope of required repairs.

Figure 3: Elevation view of double tee stem and as-built reinforcing (top) and longitudinal GPR scan

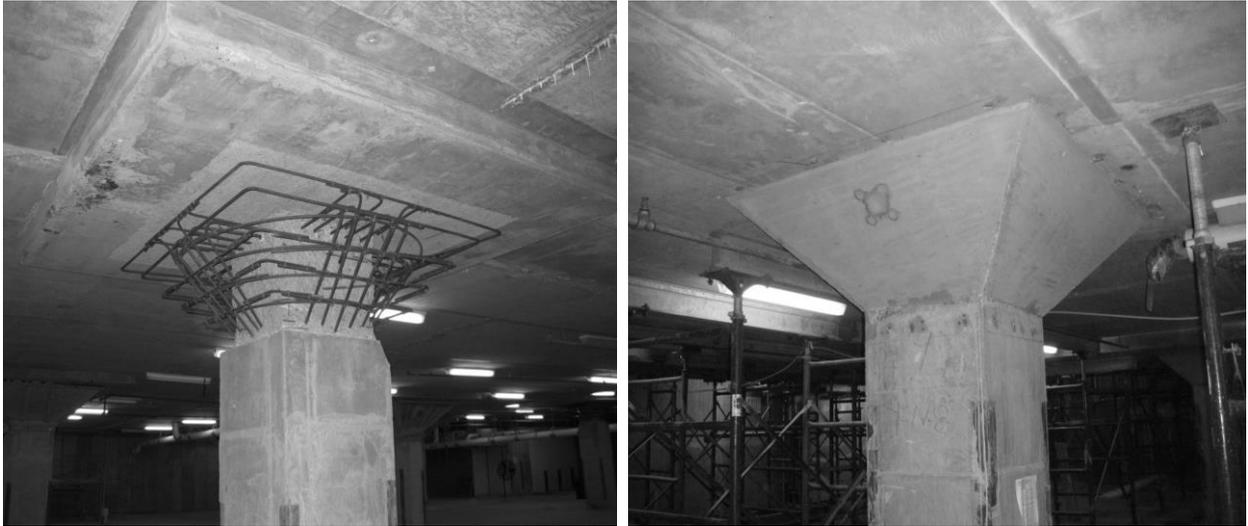
An economical repair approach incorporating supplemental concrete column capitals and drop panels at each column and strengthening of selected slab spans using FRP was selected. The conventionally-reinforced square capitals and supplemental drop panels were doweled into the top of the existing columns and were poured using a concrete mix design which allowed the repair material to be pumped into the forms from below the existing slab. Photographs of a supplemental column capital prior to and after concrete placement is shown in Figure 4.

Figure 4: Column capital prior to and after concrete placement

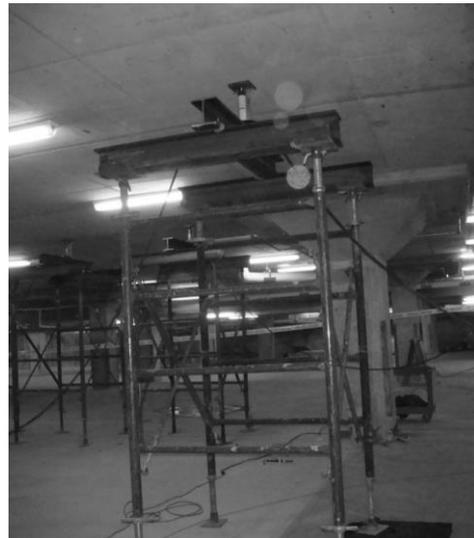
Figure 6: Load test set-up and load-deflection results after completion of slab repairs

Load testing of structural elements and systems can provide for an immediate indication of the structural capacity of system to support maximum anticipated loads. At the completion of the garage repairs, a load test was performed in a selected bay to confirm that the repair provided the required capacity to support gravity loads. The load test was performed in accordance with the code requirements. A load test set-up and load-deflection plot at one of the gage locations during this load test is shown in Figure 6. Results of the load test indicated that the maximum measured deflections and the recovery of the system were within applicable deflection limits.

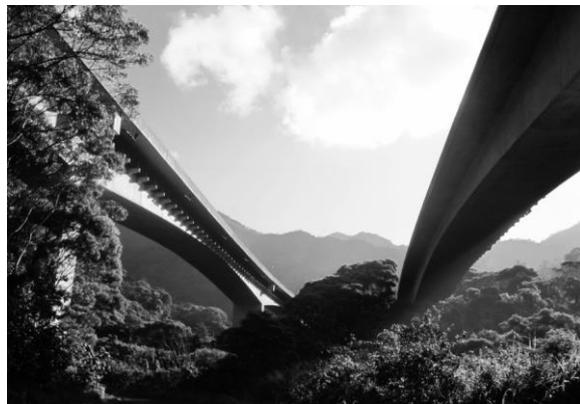
Figure 8: View from below of a post-tensioned cast-in-place box girder bridge

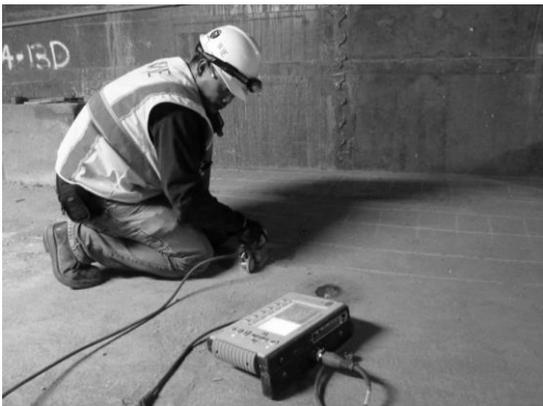
Figure 9: Location of embedded post-tensioning

Field assessment of the bridges comprised of a targeted inspection and testing program focused on evaluating the conditions of the grout and tendons at high points and anchorages within the tendon systems, locations at which there is a higher probability of grout voiding, and water intrusion and corrosion of the post-tensioning strand. Ground-penetrating radar was used to locate the embedded ducts within the walls or girders and to identify relative high points within the duct system (Figure 9). Shearwave ultrasonic testing using an early version of the MIRA Tomographer device was performed along selective lengths of the tendon duct in order to identify possible voiding within the ducts (Figure 10). The test method was able to detect significant voids within the steel tendon ducts embedded within the stem walls of precast I-girders.

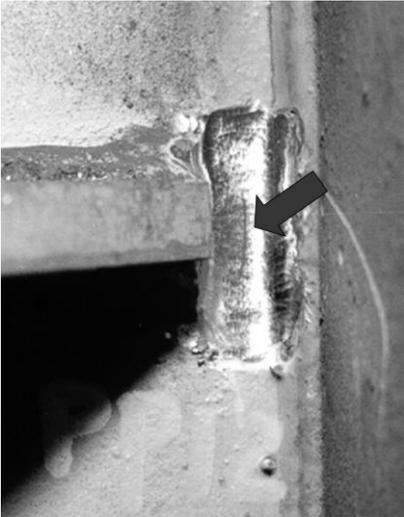
Figure 11: Highlighted fatigue crack in web gap using MT method

Magnetic particle testing (MT) utilizes a yoke to generate an electromagnetic field. A crack or defect oriented perpendicular to the flux field produces a discontinuity in the field causing iron filings sprinkled on the surface to highlight the crack or defect location. Figure 11 shows a crack highlighted by MT. MT is only applicable to ferromagnetic materials with defects greater than 3x surface roughness and approximately 0.5 mm long. It also requires more training to properly use and interpret than liquid penetrant.

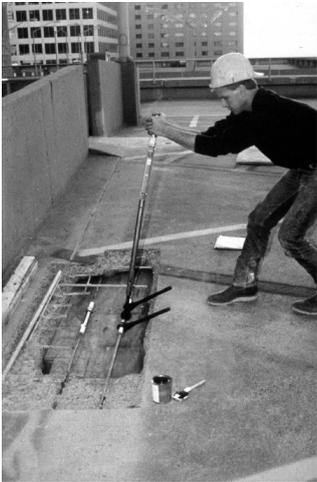
Figure 14: Calibrated torque wrench

When the tendon is already cut and spliced during the repair, the question is how to measure the force in the spliced tendon. In some cases, retensioning can be achieved by using a calibrated torque wrench (Figure 14).

In the tendon splice coupler, a hexagonal nut is turned which brings two sides of the tendon together and increases tension in both sides of the spliced tendon. The number of turns corresponds to a certain tension force which could be recorded.

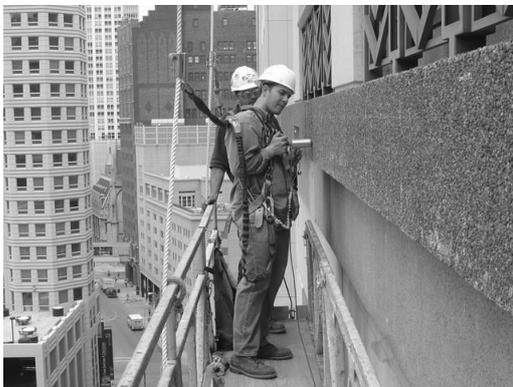
Figure 15: Impact echo test of facade panels

Impact-echo and impulse response testing was performed to identify debonding and separation of a concrete architectural mix that had been integrally cast with structural back-up (Figure 15). In a different facade evaluation project, insitu evaluation of the existing bond and contact between sandstone panels was performed. This evaluation included visual inspection, impact echo, and ultra-shear wave tomography (Figure 16). Using this approach, evaluation was performed of the existing bond and contact for approximately 3,050 panels on the building facade in about 1-1/2 days. It was determined that about 15% of the panels evaluated had inadequate bond or contact to the substrate, and that about 50 of the panels evaluated had no bond or contact and could fall from the building.

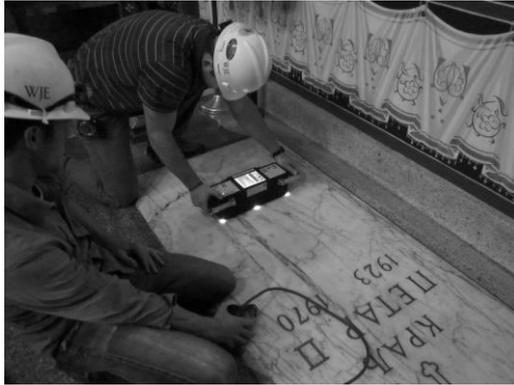
Figure 17: Determining the thickness of stone with GPR

During the exhumation of the remains of King Petar II to be transported to Serbia for state burial, GPR and MIRA systems were used to determine the thickness of the marble panel over his grave as well as to assess the thickness of the concrete slab under the marble panel (Figure 17). This information was used to determine the best method to access and recover the coffin with his body (Figure 18).

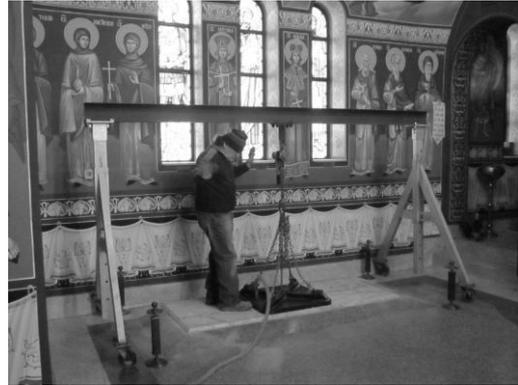
Figure 18: Use of vacuum chamber to lift the stone

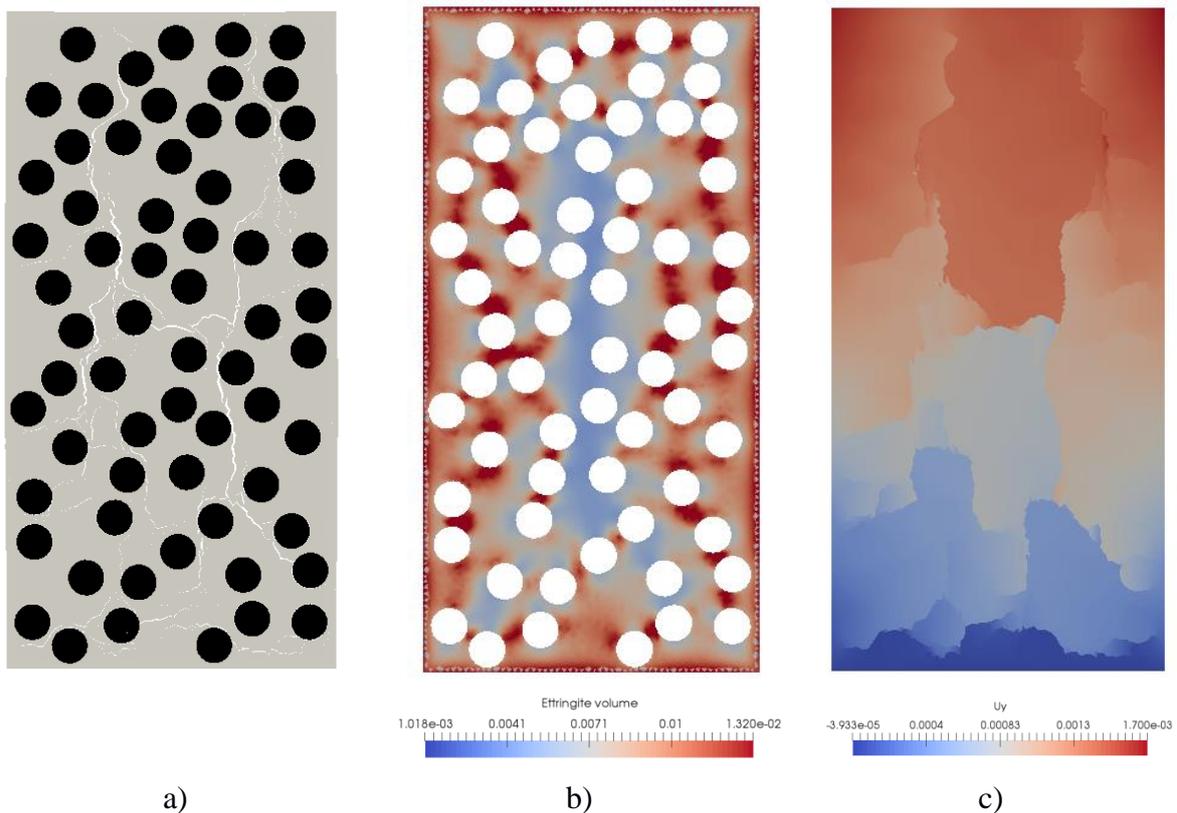
The first results show diffuse cracking due to DEF mostly at the interface between mortar and granulates, which seems to agree with experimental observations [4] (Figure 4 a). Ettringite precipitates in the entire sample (Figure 4 b). The localization of precipitation depends strongly on the microstructure: diffusion coefficient aggregates and cracks. The longitudinal displacement field depends on crack localization and boundary conditions (Figure 4 c). The swelling is thus not homogenous in the sample.

Figure 4: a) cracking profile (crack in white, mortar in gray and granulates in black), b) ettringite volume field [m³] (granulates in white) and c) longitudinal displacement [m]

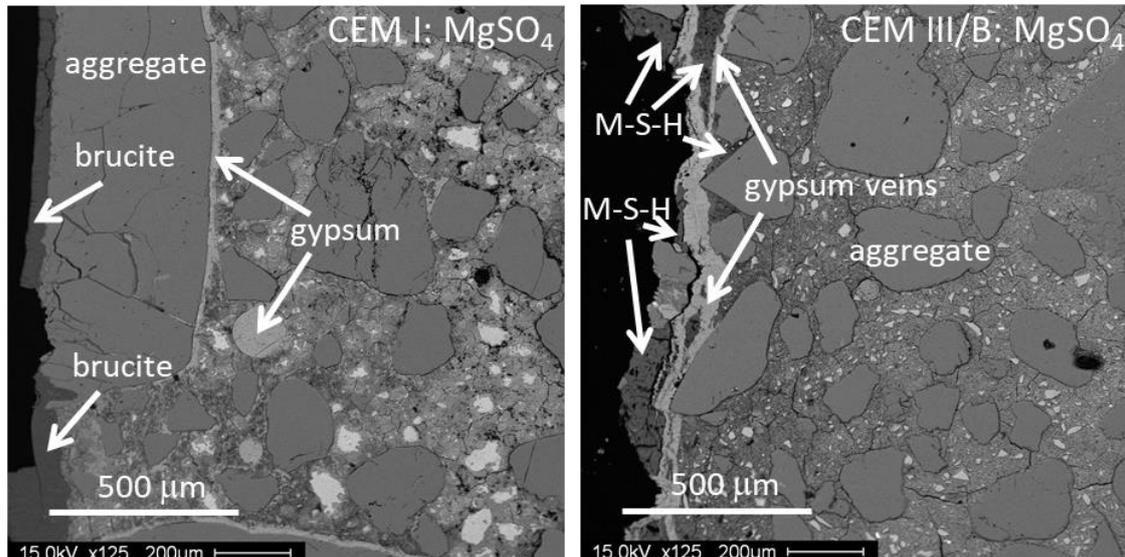
M-S-H formation is observed mainly at the surface of blended cements [5, 11, 17] as show below in Figure 3 for CEM III/B exposed to magnesium sulfate solutions, while Portland cements with their higher pH values are less affected and rather brucite than M-S-H is observed.

Figure 3: BSE micrographs of CEM I and CEM III/B mortar bars exposed to $MgSO_4$ solution (4.2 g $MgSO_4/l$ (35 mM Mg) for 2 years. Adapted from [11].

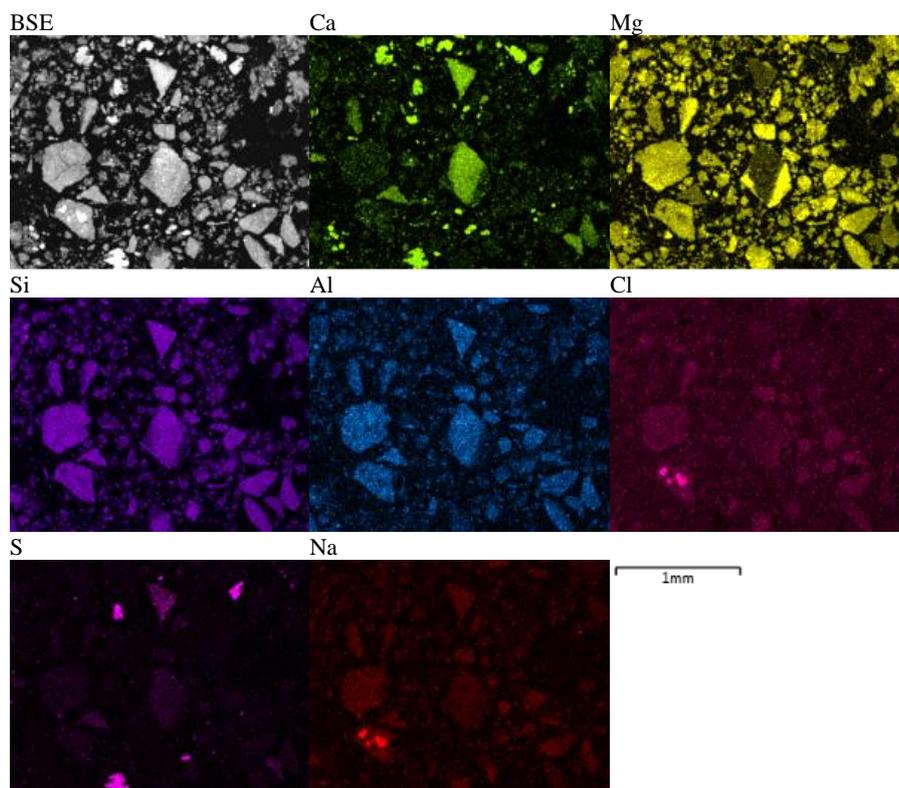
M-S-H formed due to seawater exposure was investigated in further detail on a crushed cement paste sample (50 g) which was leached by 100 l of seawater over 6 weeks [2]. The BSE image and SEM-EDS maps of the leached sample are shown in Figure 7. The Mg- and Si-rich particles consist of M-S-H. Note that the M-S-H also contains Al, Ca, Cl and Na which is in agreement with observations on synthesized M-S-H in [15, 16]. Besides M-S-H, the leached sample also contained decalcified C-S-H, calcite, gypsum, brucite and some precipitated NaCl.

Figure 7: BSE image and EDS maps of cement paste leached with seawater. The scale indicates 1 mm. The Mg and Si rich particles contain M-S-H. After [2].

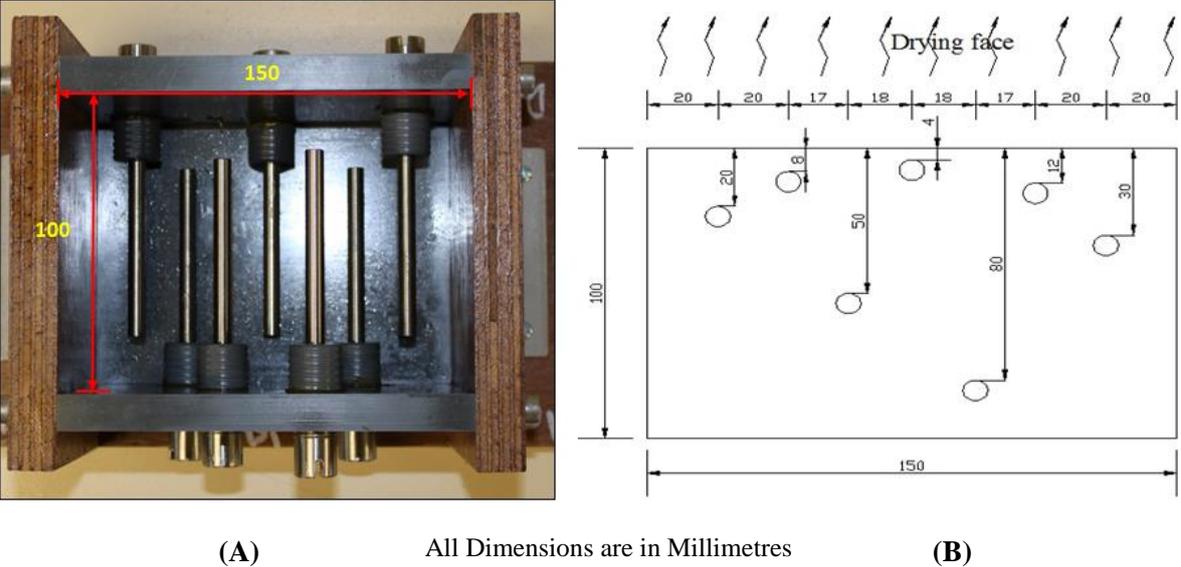
Figure 1: Arrangement of Cavities in Concrete Prism (A) Plan View of Mould used for Casting Concrete Specimens for Moisture Measurement, (B) Cross Section

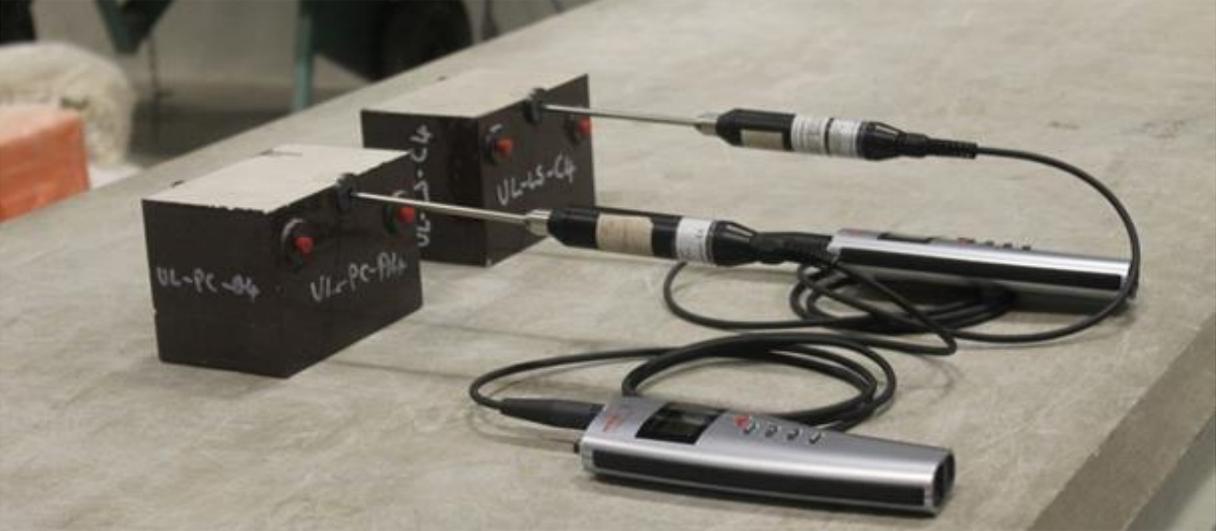
Figure 2: Experimental program for RH measurement

After coating the specimen with epoxy, the initial moisture reading at different depths from the exposed surface was taken. The measurement was done using a 5 mm diameter humidity probe (HC2-P05 from Rotonic Measurement Solutions with measurement range: -40 to 85°C / 0 to 100 % RH) attached to a digital hygrometer (HygroPalm 23-A from Rotonic

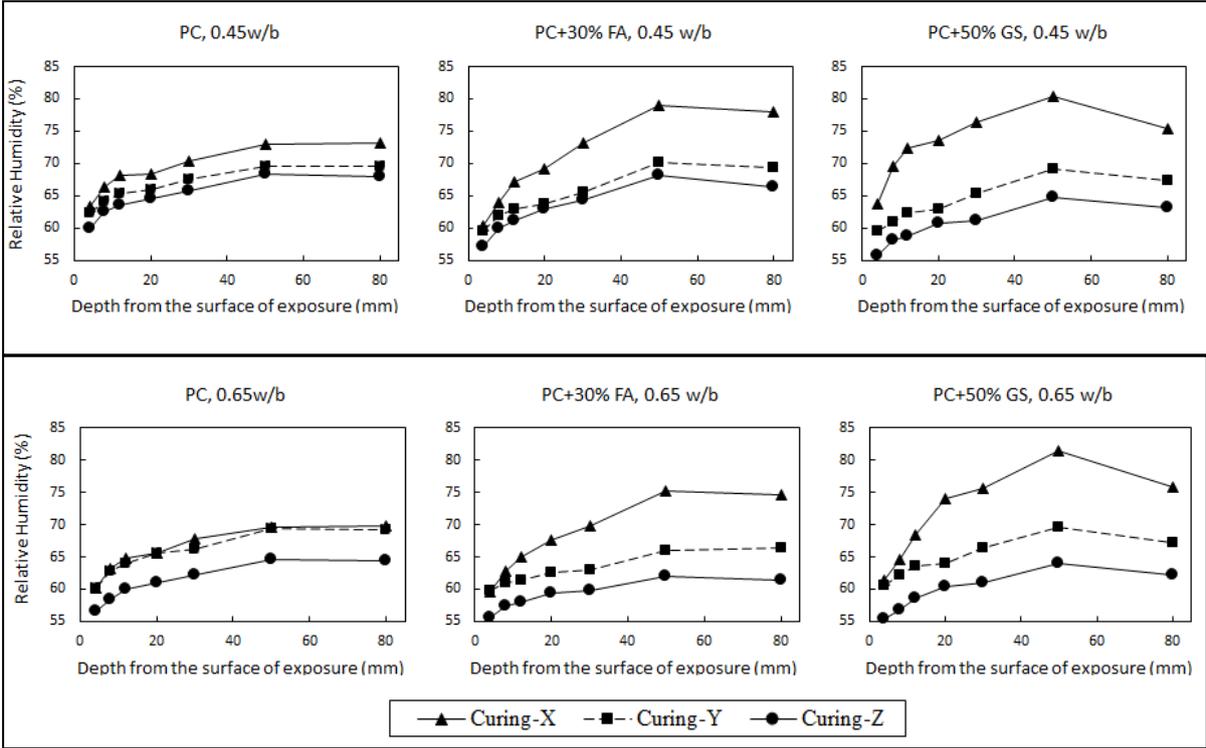
Figure 4: RH profile after 16-17 months of drying (at 20-22°C and 50% ambient RH)

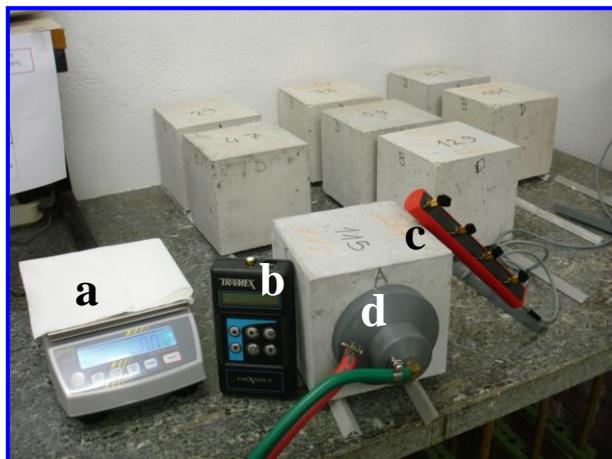
Fig. 1 - Cubes and instruments used

Figs. 1 and 2 show the instruments used and a sketch of the location of the testing points. At intervals, the following NDT and (Instruments) were applied on the cubes (Fig. 1):

- Mass M (10 kg/0.1 g Kern Scale)
- Moisture by impedance method m (*CMExpert*). The instrument's scale goes from 0.0 to 6.9 % [8]
- Wenner Electrical resistivity ρ (*RESI*). These results are not discussed here, as the new results confirm that ρ is not a useful indicator of concrete moisture, as already discussed in [7]
- Air-Permeability kT (*PermeaTORR*). The instrument measures values of $kT \geq 0.001 \cdot 10^{-16} \text{ m}^2$

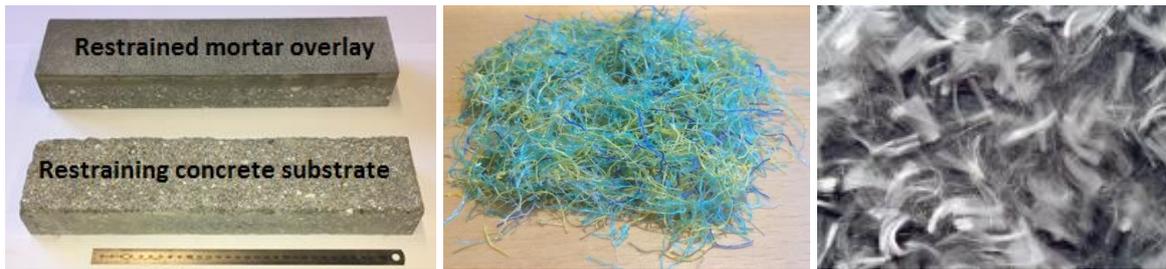
Figure 1: Geometry of substrate bases and mortar overlay; R-PE fibres; and PP fibres

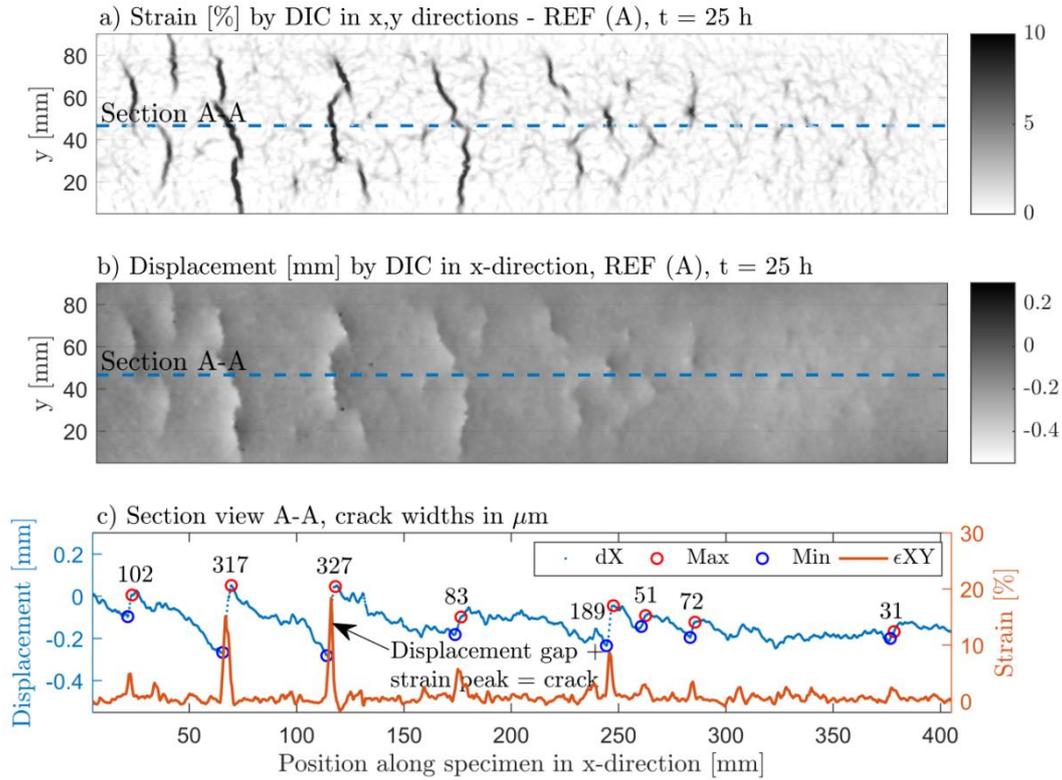
Figure 3: REF (A) specimen at $t = 25$ h. a) Principal surface strain in the (x,y)-direction by DIC; b) Surface displacement in the x-direction by DIC; c) Section A-A going through specimen showing surface displacement in x-direction and principal strain

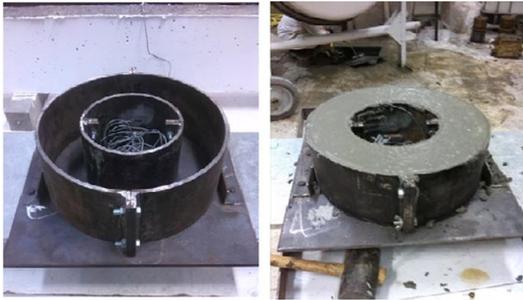
Figure 2: Ring samples

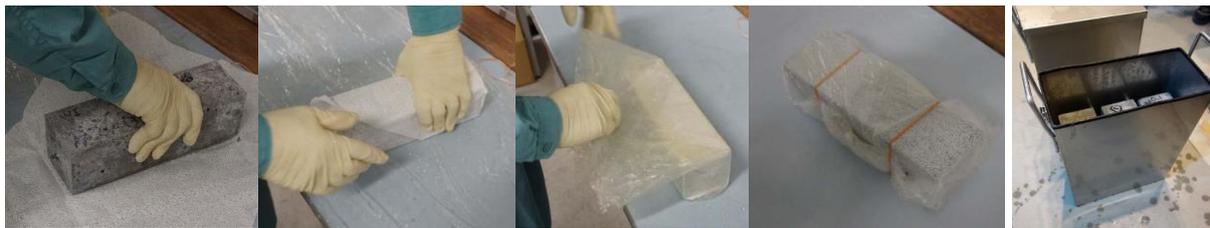
Figure 2: Examples of alkali-wrapping of concrete prisms.

A new test method was introduced to overcome these two problems [10]. The concrete test prism from the traditional CPT is modified by overwrapping a wet cloth, containing an alkaline solution with a pH close to that of the concrete pore solution. This modification results in the alkali-wrapped concrete prism test, AW-CPT, as shown in Figure 2. For samples with boosted alkalis, the pH of the alkaline solution is modified accordingly. In particular, for assessing ASR, controlling the alkali contents of the concrete is critical, as the alkali-silica reaction consumes alkalis to form the alkali silica gel that causes the expansion, and when all alkalis are consumed, the reaction terminates. If there are excess alkalis supplied by the solution, the reaction is prolonged and the expansion may be overestimated. The alkali content in the wrapping cloth is controlled to prevent this. Finally, water is consumed by the alkali-silica reaction, so additional water is supplied periodically. This matches external environmental conditions, where additional water is supplied continuously from the environment and no additional alkalis are supplied.

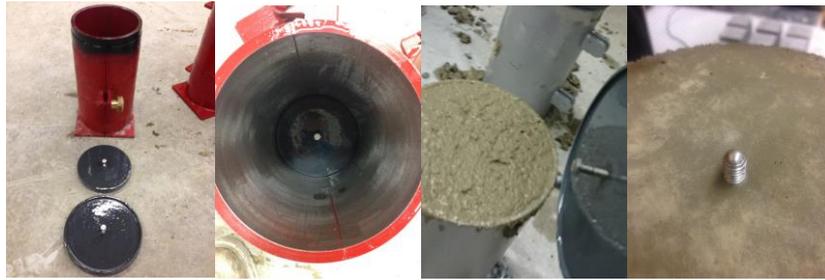
Figure 1: (a) Custom made mold with top and bottom plates holding embedded studs, (b) Concrete mold with bottom plate prior to casting, (c) Installing top plate with gauge pin, (d) embedded gauge pin following curing

The University of New Brunswick Concrete Cylinder Test (UNBCCT) consists of casting concrete “job” mixtures into custom made concrete molds (145 mm diameter x 280 mm) as presented in Figure 1a and 1b. Figure 1a also demonstrates the process employed to cast gauge pins into the top and bottom of the specimens. The casting process begins by placing the bottom plate in the mold with a gauge pin screwed into its centre. Concrete is cast in three layers after which the top plate, also with an embedded screw, is secured to the top of the mold and agitated in order to ensure concrete completely consolidates around the embedded screw (see Figure 1c). Specimens are then covered in wet burlap and plastic for 24 hours at room temperature (22±2°C) after which they are demoulded. Following the removal of the top and bottom plates, the gauge pin is embedded in the concrete as presented in Figure 1d. At this point, initial length change measurements are completed using a standard length comparator. Specimens are then placed in a plastic 150 mm diameter x 300 mm standard laboratory mold where the annulus between the concrete and the mold is filled with a “model pore solution” which is determined based on the composition of the binder in the job mixture (see Figure 2a and 2b). The level of equivalent alkalis in the host solution was determined using the assumption the pore solution is 0.7 mol/L per 1% equivalent alkalis in the cement, as conducted by Diamond and Penko [11]. Three specimens from each mixture were then placed in ovens at both 38 and 60°C in order to study the effect of temperature on rate of expansion.

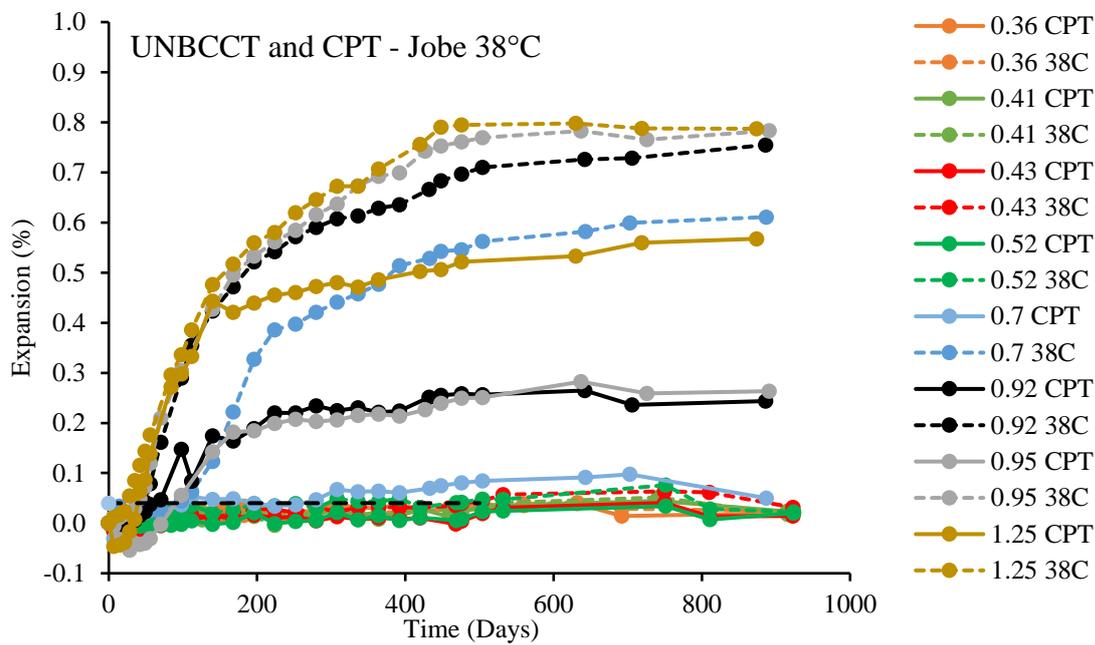
Figure 3: UNBCCT and ASTM C1293 expansion results using Jobe aggregate at 38°C.

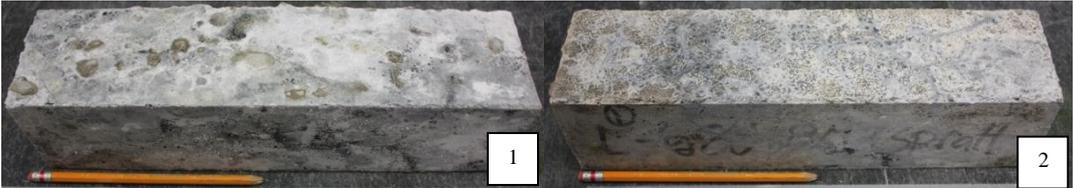
Figure 2. Visual Aspect of Slag-Based Concrete Prisms after 2 Years of Expansion Testing with NM Aggregates (1) and Sp Aggregates (2)

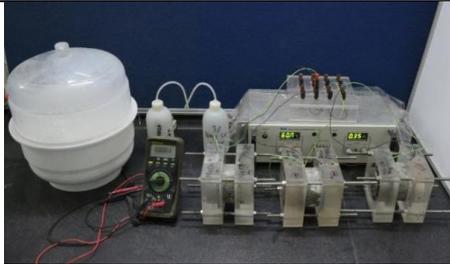
The chloride conductivity test method was proposed by Streicher and Alexander of the University of Cape Town in South Africa in 1995 [16]. This test is developed based on the electrochemical theory and is very rapid as it involves only single current measurement. Chloride conductivity test is standardised in the Durability Index Testing Procedure Manual, South Africa [4] and is a widely used test method in that country. The classification criteria developed by Alexander et al. [17] with respect to chloride conductivity is provided in Figure 1.

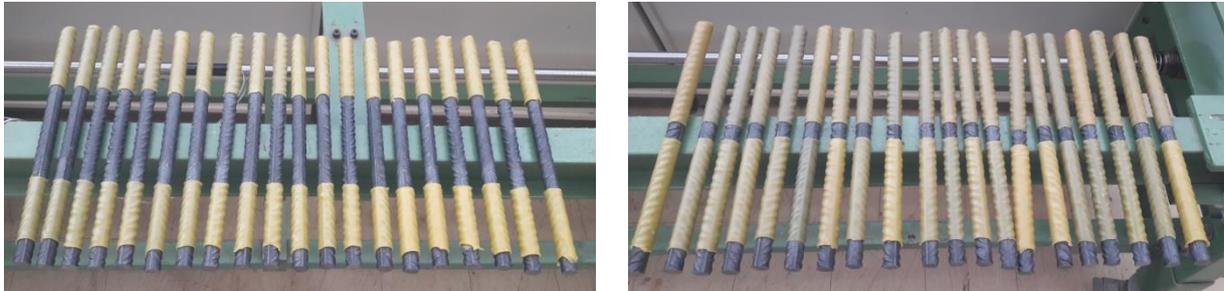
Figure 1: Preparation of the “long” specimens (exposed length 12cm – left) and “short” specimens (exposed length 2cm – right)

In order to probe the corrosion consequences in different exposed lengths, the rebars were subdivided into two groups, these being 2 cm and 12 cm free to be corroded and the rest of rebar's length was protected with a wax layer, as it is shown in Figure 1.

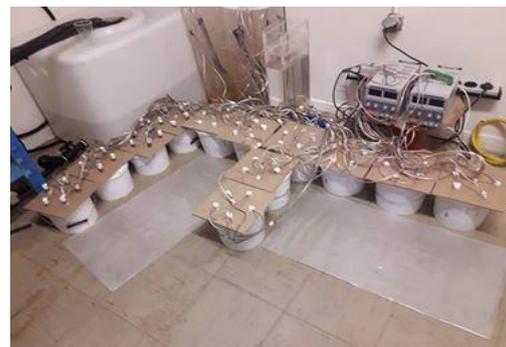
Figure 2: Procedure of accelerated electro-corrosion. (Left) Schematic representation, (Right) Experimental setup

Since corrosion phenomenon is a slow natural process, it would be required a long testing period. In order to have faster results, each group of rebars was subjected to artificial accelerated corrosion. The tests were carried out in polymer (plastic) cells containing 5% NaCl. Four "bare" reinforcing bars and one stainless steel bar were immersed in each cell. In this method, a D.C. power supply is used to accelerate the corrosion process. The reinforcing bars were connected to the positive terminal of the power supply, acting as anode of electrochemical circuit, and stainless steel bar was connected to the negative terminal, respectively, acting as the cathode (Figure 2) Generally, coastal areas are classified into three different zones, according to their susceptibility to corrosion.

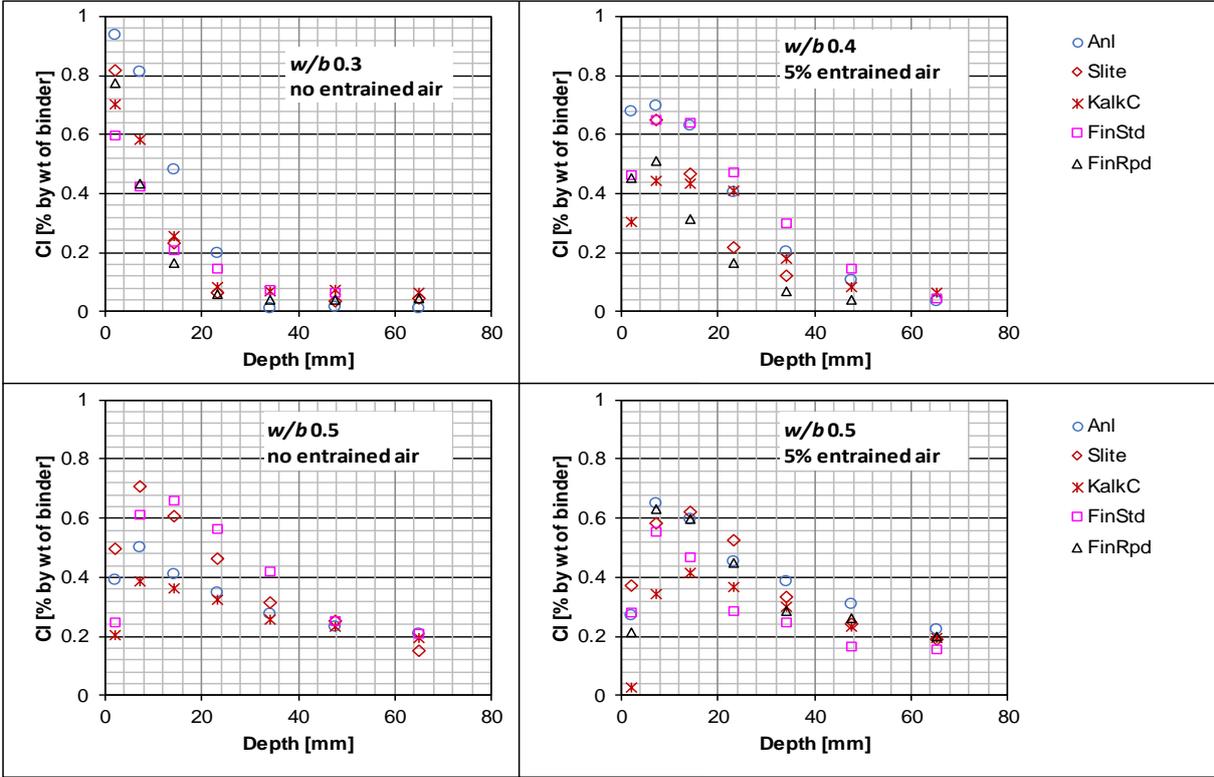
Figure 2: Chloride ingress profiles in concrete with different commercial cement after exposure for 20 years in a de-icing road environment.

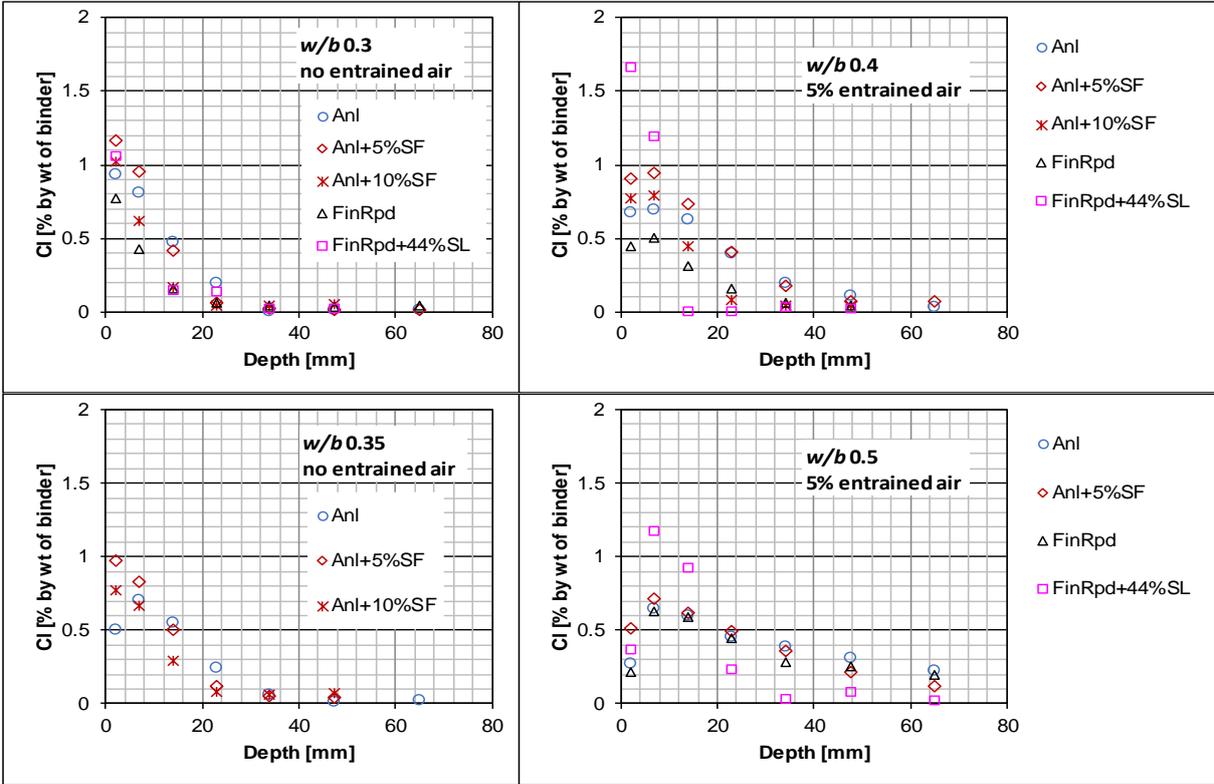
Figure 3: Chloride ingress profiles in concrete with replacement of silica fume and ggbf slag after exposure for 20 years in a de-icing road environment.

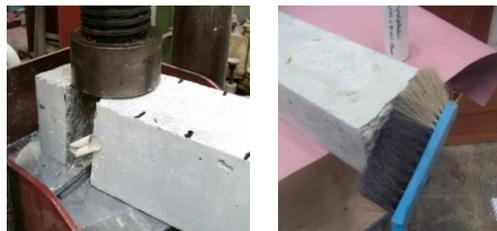
Figure 1: Cutting and Cleaning of concrete prisms

For the measurements, a 5 cm thick piece of a beam was split in a press, freed from loose parts and immediately sprayed with a colour indicator, Fig. 1. Colour indicators are in principle dyes that react as self-corresponding acid-base pairs, so that their color change depends on the pH value of the solution. Due to their practical relevance, the indicators in table 3 were used.

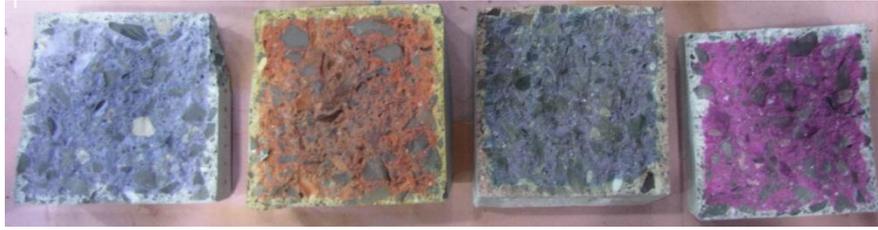
Figure 3: Colour change on a concrete sample determined with different indicators (from left to right: 0.1 % thymolphthalein, 0.5% curcumin, Rainbow Indicator, 1% phenolphthalein)

Fig. 3 shows an example of a sample surface 3-4 hours after spraying with different indicators. The colour change of phenolphthalein and curcumin was very well visible from the reading accuracy even with dark concrete compositions. The colour changes of thymolphthalein and the Rainbow Indicator were not quite so well recognizable.

The colour front increased on average about 8 % from 10 minutes readings to 3-4 hours (maximum 16%). No significant change occurred from 3-4 hours to 24 hours. However, after 24 hours, the colour of 0.1 thymolphthalein completely faded. Fig. 4 shows a good correlation ($R^2 > 0.98$) for all indicators, with the alkali border (\approx depth of carbonation) being indicated as expected: curcumin < phenolphthalein < thymolphthalein < Rainbow Indicator. The presented reading time were 3-4 hours. Fig. 4 d) shows the gradual carbonation front determined with TGA. From this, 0.1% thymolphthalein and the Rainbow indicator are the closest to the area where no further $\text{Ca}(\text{OH})_2$ decrease is measured.

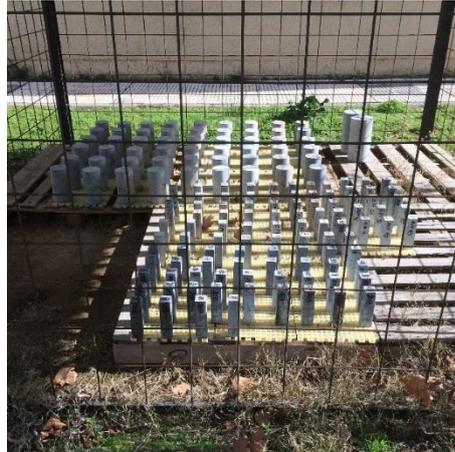
Figure 1. Specimens exposed to outdoor environment

After curing for 28 d, the $4 \times 4 \times 16 \text{ cm}^3$ specimens used for this set of tests were stored in laboratory conditions (20 ± 2 °C and 65 % to 75 % RH) for 7 d and subsequently exposed to the outdoor environment for 90 d or 180 d, albeit under cover from the rain. The mean CO_2 concentration during the test periods was 400 ppm. The exposure conditions are depicted in Figure 1.

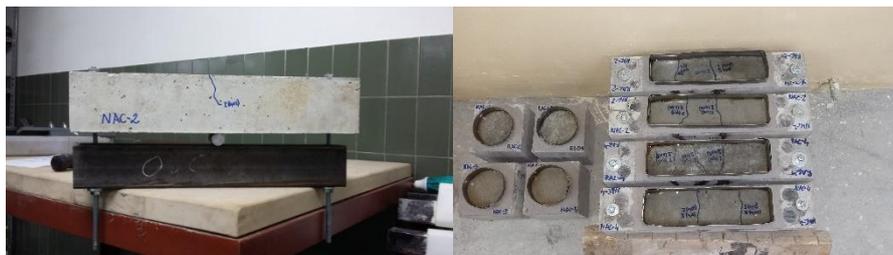
Figure 1: Experiment setup for salt scaling

Salt scaling resistance was tested on reinforced concrete prisms with dimension 10x10x50 cm. After finishing, the specimens were covered with wet fabric and stored in casting room at 20±2°C. They were demoulded after 24 h. After that, concrete cubes (a=15 cm) were kept in a water tank until compressive strength testing and concrete prisms were covered with the wet fabric for additional 7 days after which they are stored in a casting room at 20±2°C. At the age of 28 days, three point bending test was used to induce cracks on the samples, Figure 1. After the crack opening displacement reaches a desired width, applying of force using a torque wrench was stopped.

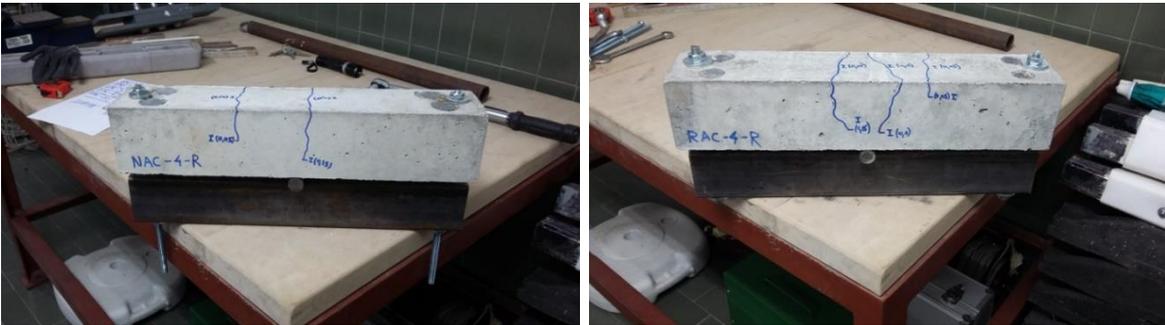
Figure 5: Position and cracks of samples NAC_NC_2 and RAC_NC_2

Concrete samples with a crack width of 0.08 mm (NAC_NC_1 and RAC_NC_1) showed an almost identical amount of scaled material regardless of aggregate type, while sample with a crack width of 0.2 mm with natural aggregate concrete (NAC_NC_2) had a 18% greater amount of scaled material compared to concrete with recycled aggregate (RAC_NC_2). The difference in resistance between these two samples was in the number of cracks which were formed on the surface (Figure 5).

Sample of RAC_NC_2 had three cracks (0.20, 0.15 and 0.05 mm), while the sample of NAC_NC_2 had only 2 cracks (0.20 and 0.05 mm). Therefore, RAC_NC_2 sample had a greater number of "expansion joints" in the process of ice shrinking, which reduced the amount of scaled material. Accordingly, it can be concluded, in this case, that the strength of RAC is not a crucial factor when comparing the salt scaling resistance of these concretes with NAC. More important factor is the number of cracks formed on the exposed surface and their widths.

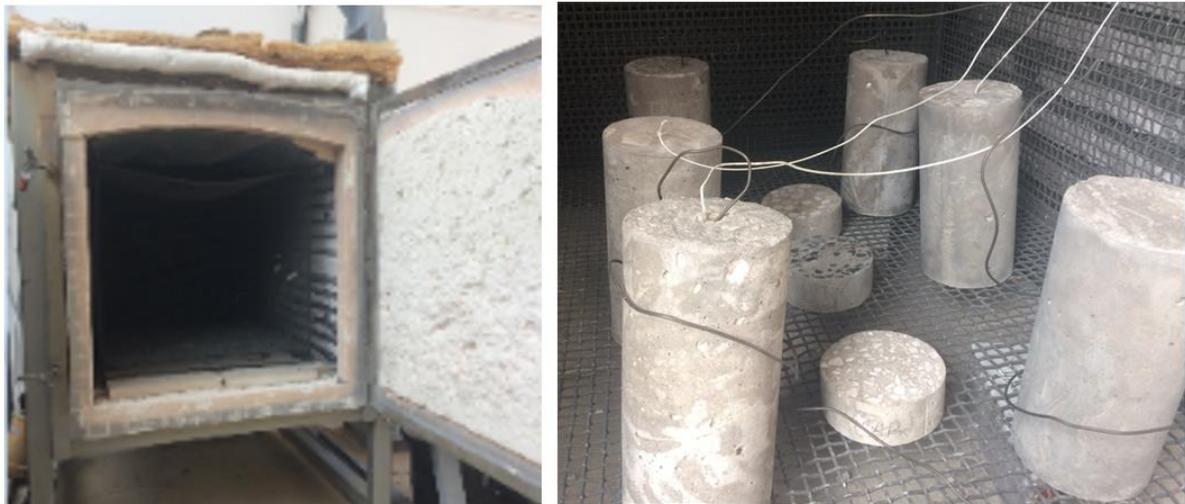
Figure 1: Left: electric arc furnace for specimens heating; right: specimens instrumented with inner thermocouples.

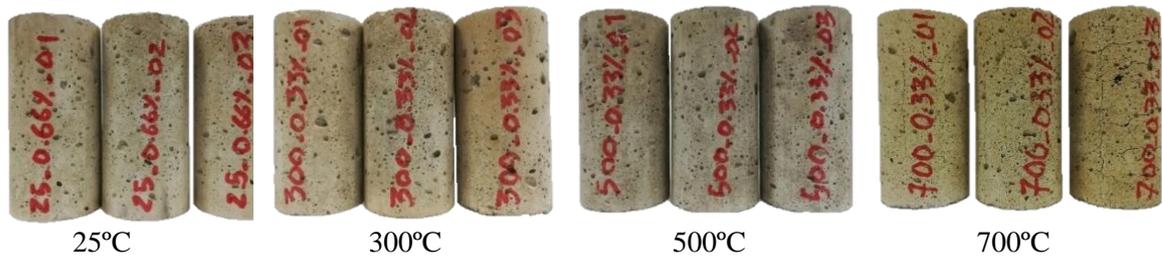
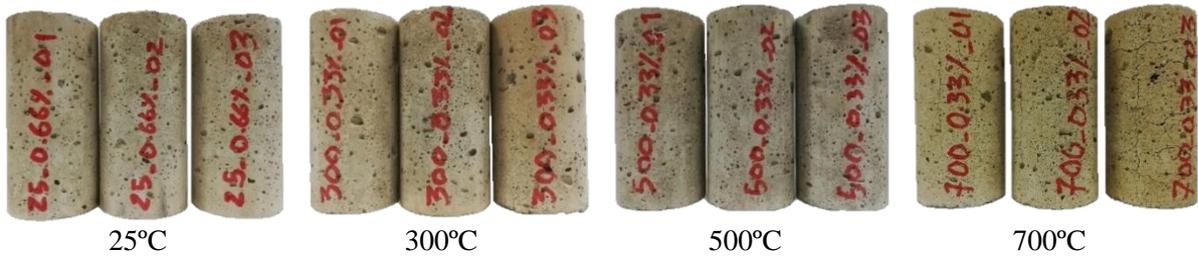
Figure 3. A change in the colour of the specimens is observed with the increase of the temperature exposure. The presence of relatively large cracks is noticed for specimens exposed to 700°C. The specific weight of the specimens was measured before and after the thermal treatment, being 16.80, 15.73, 15.51 and 15.13 kN/m³ for 25, 300, 500 and 700°C, respectively.

Figure 3: Visual appearance of the specimens after high temperature exposure.

The visual appearance of the specimens after the exposure to high temperature, and immediately before carrying out the uniaxial and triaxial tests, is shown in

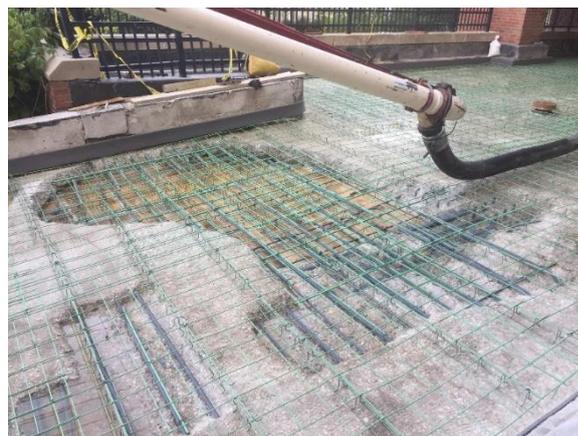
Figure 2: Surface preparation of concrete and coating of reinforcing bars at partial and full depth patches, and installation of new epoxy coated bars for bonded overlay

Following the sandblasting, concrete surfaces should be blown with clean compressed air in order to remove debris and contaminants from the sandblasting and chipping procedures. Example of concrete surface preparation is shown in Figure 2.

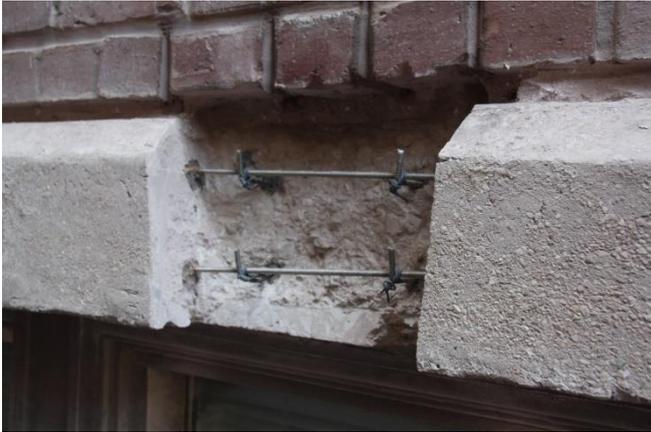
Figure 3: Installed stainless steel rods in edge of slab

For vertical or overhead repairs, depending on the layout of the existing reinforcing bars, there might be a need to install supplemental dowels in order to provide a mechanical anchorage for the new patch to the substrate. Those dowels are usually stainless steel threaded rods set with an epoxy adhesive in drilled holes, as shown in Figure 3. The spacing and number of additional dowels is determined in the field based on the existing conditions. Care should be taken to provide an adequate concrete cover over newly installed additional reinforcing bars.
