**Proceedings of the
International Conference
on Sustainable Materials,
Systems and Structures
(SMSS2019)**

**Durability, Monitoring and
Repair of Structures**

International Conference on Sustainable Materials, Systems and Structures (SMSS 2019)
Durability, Monitoring and Repair of Structures
20-22 March 2019 – Rovinj, Croatia

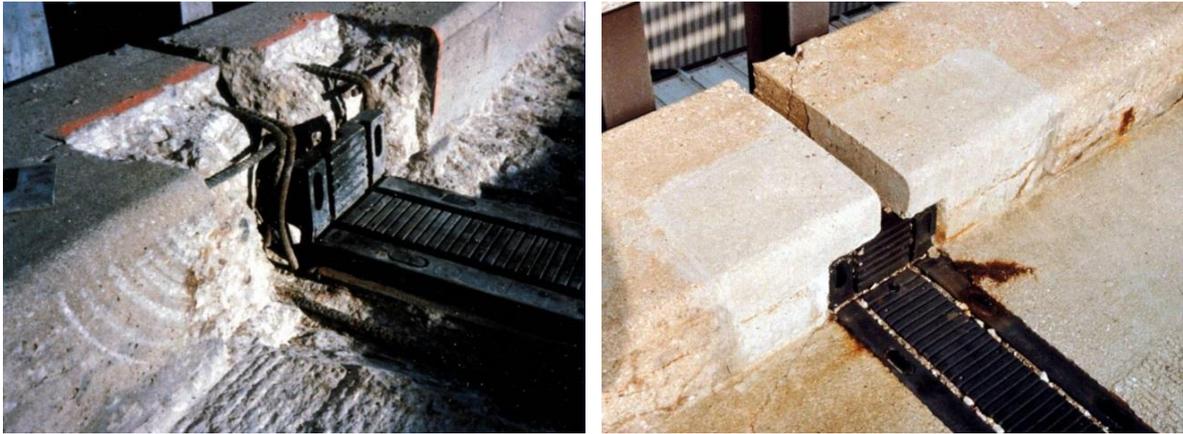
Figure 5: View of patches performed at Argonne bridge. Surface preparation of the concrete to the left, and condition of those repairs 10 years after to the right

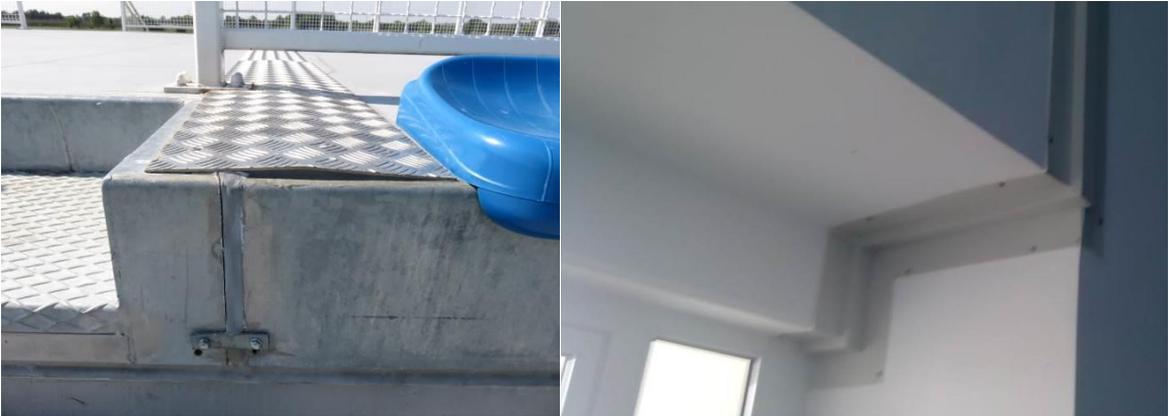
Figure 4: Unsatisfactory crack repair (upper and lower side of the structure)

Although it is common in practice craft that structure length without expansion joints is usually limited to 35 or max. 40 m structure was built in total length of 78,60 m without any which caused structure cracking (self – disjuncting) on places with cross section changes e.g. where stress concentration is maximal. Two cracks approximately 1 cm wide, with depth equal to the cross-section depth and all-over transversal span were detected.

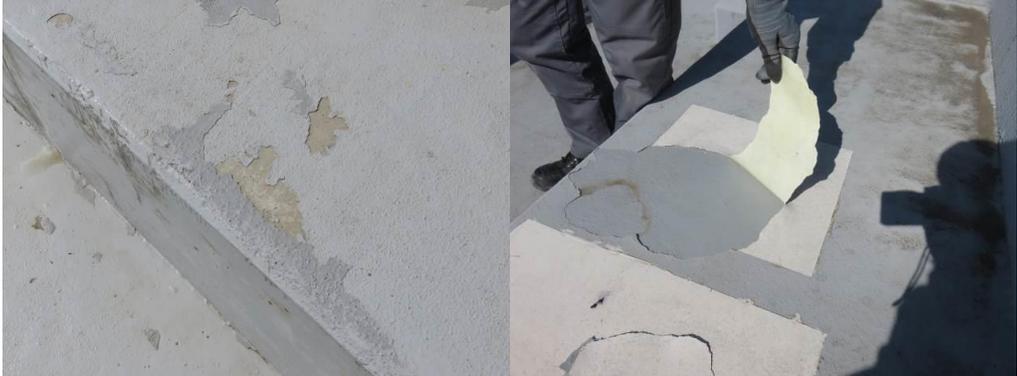
Figure 5: Surface coating deterioration (spalling, peeling...)

Stages of execution process were not properly considered, respectively to the materials applied. Sufficient water permeability of the concrete should be achieved due to afterward canopy installation. Demanded property should be achieved within concrete properties or with adequate surface coating. Existing surface coating is detached and peeled of the concrete surface (probably caused by improper appliance process). Locally, cracks and spallings of the coating are visible, indicating incompatible applied materials and/or improper building process.

Visual inspection showed that multiple damage types are present, mostly caused by water leakage from upper (outside) surface to the interior (lower side) through the cracks formed in

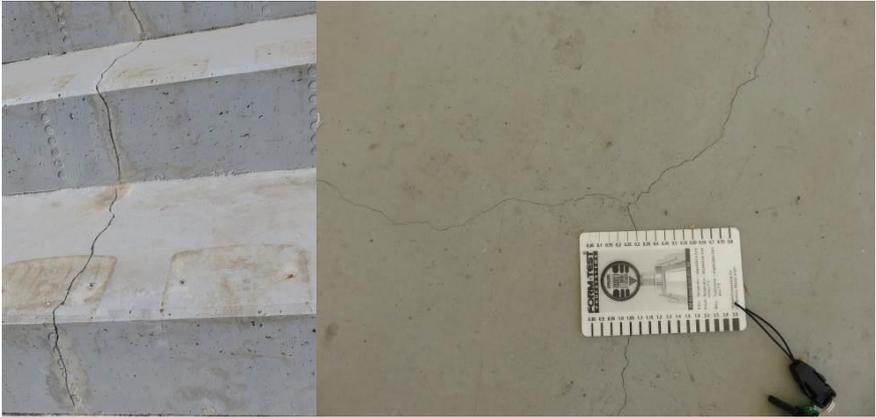
Figure 6: Typical cracks in upper surface

For quality and durable solution for all flaws and damages shown in structural elements of tribunes it is necessary to firstly remove present insufficient repair attempts (e.g. steel plates over cracks, additional concrete slabs without function, insufficient surface coating...). After preparation works all cracks must be repaired with epoxy based sludge or mortar, and new impermeable surface coating must be applied on all upper visible surfaces. Also, water insulation must be placed in all perimeter RC walls. Solutions for large transversal cracks and insulation of the foundation deck are processed in individual project and will not be presented in this article. It is important to notice that newly executed structure is more rigid and heavier than original. These facts probably had major impact on damages because ground settling deformations are bigger and structure is cracking throughout respectively. One of the major cause of cracks is probably the fact that there were no expansion joints for length of 78,60 m what is too long for single concrete element.

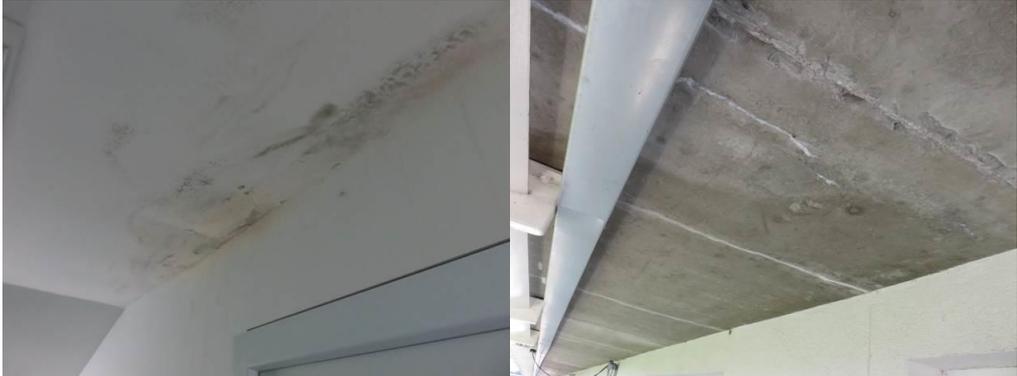
In almost all interior surfaces signs of leakage and leaching are visible as well as lime sediments. Remanent water from the upper surface is placed inside cracks and with cyclic freezing-thawing process is devastatig and degradating impact on surrounding concrete in the moist zone. Leakage and wet spots inside the structure are visible after every heavy rain.

Figure 7: Leakage and lime sediments

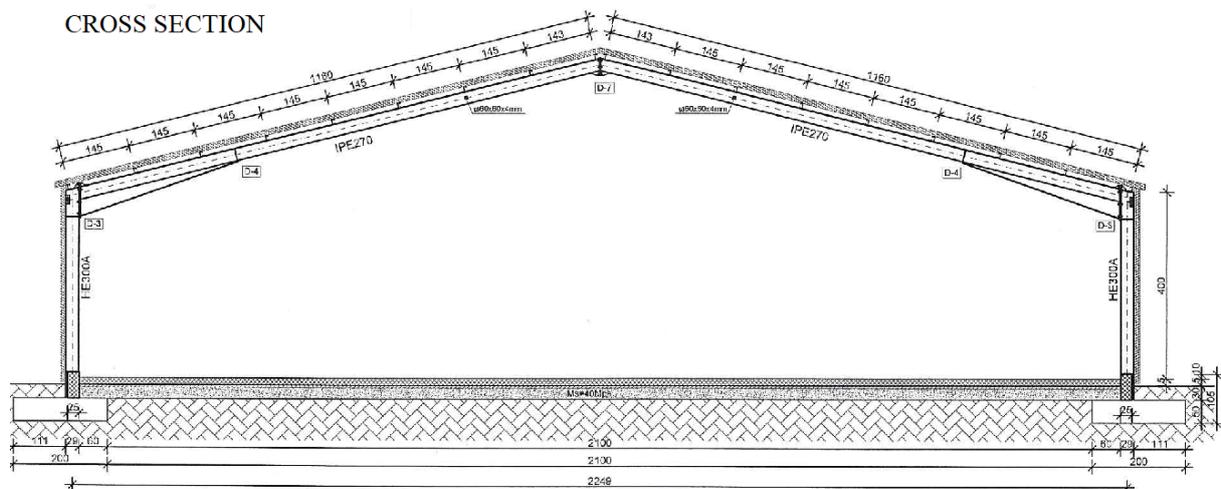
Figure 8: Cross section of the structure

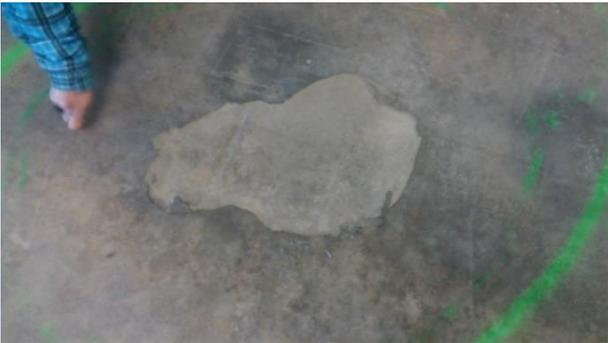
Figure 9: Surface coating spalling

During the visual inspection larger parts of the concrete floor structure show surface “peeling” signs indicating that concrete surface is chemically attacked and fast degradation is soon expected. Local repairs of the surface were made but with no success.

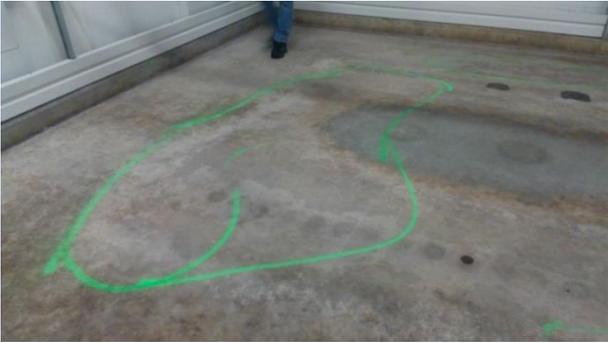
Figure 10: Surface coating spalling

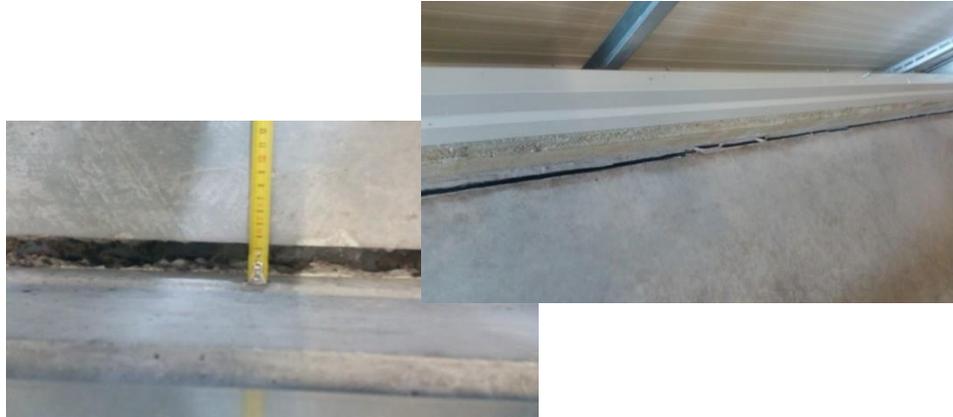
Also, structural deformations of the concrete floor slab caused by shrinkage process were not taken into the account in the proper way. This caused constant increment of the connection joints between concrete floor slab and surrounding beams. In some parts gap width is up to 40 mm resulting in water and poultry excrements penetration and precipitation and rapid deterioration process of the concrete and reinforcement corrosion.

Figure 11: Joint gap at slab-beam connection

Applied permanently elastic sealing has lost its function, because it is not applicable for gaps bigger than 5 mm. This size gaps should be treated as expansion joints e.g. filled with chemically resistant spongy material or gasket rope and then filled with sealing. All contact surfaces have joint gaps larger than 20 mm indicating that repairment is needed all around in hall.

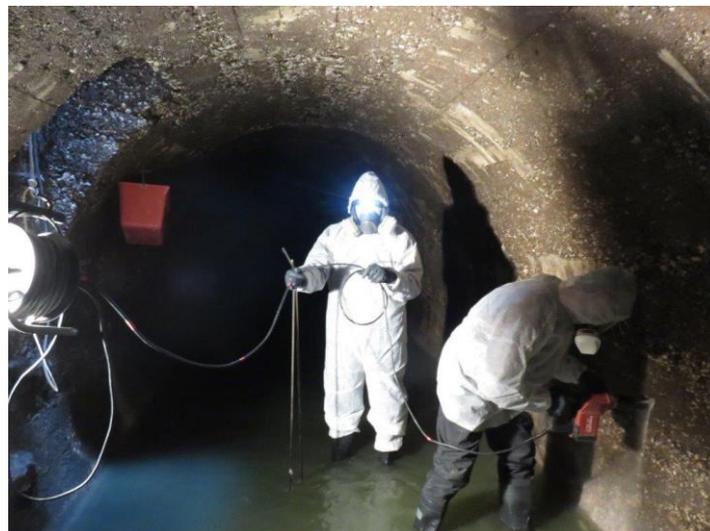
Protection equipment used was consisted of rubber overall suits (first layer protection) and cotton one-time overall suits (second layer protection). Disinfection equipment was placed nearby exit shafts. For respiratory protection respirator masks and gas detectors (for H₂S, CH₄, CO and CO₂) were used.

Figure 3: Work conditions inside the sewerage pipe

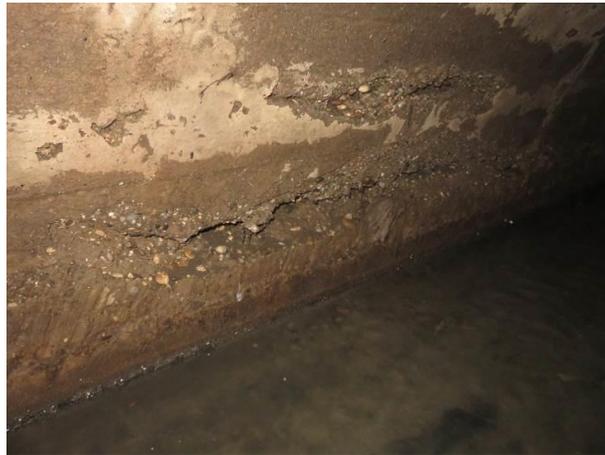
Defects like cracks in the vault crown (longitudinal), local concrete spalling as a result of the abrasive action of water and solid particles, and visible aggregate grains due to washing out of the bonding material (cement stone). Because of the aggressive environment spalling is noticed through all length of both pipes. Cracks are mostly placed at the vault crown and at the connection of the arch and the bottom of the pipe due to the execution process.

Figure 4: Deterioration of the concrete cladding

Geometry imperfections were noticed throughout cladding for both pipes. Bigger holes in the concrete body are result of the washing out of the cement stone speeded up with abrasive influence of waste water and hard particles in it. On the entire length signs of water leakage and leaching are visible all over the cross section on the both pipes.

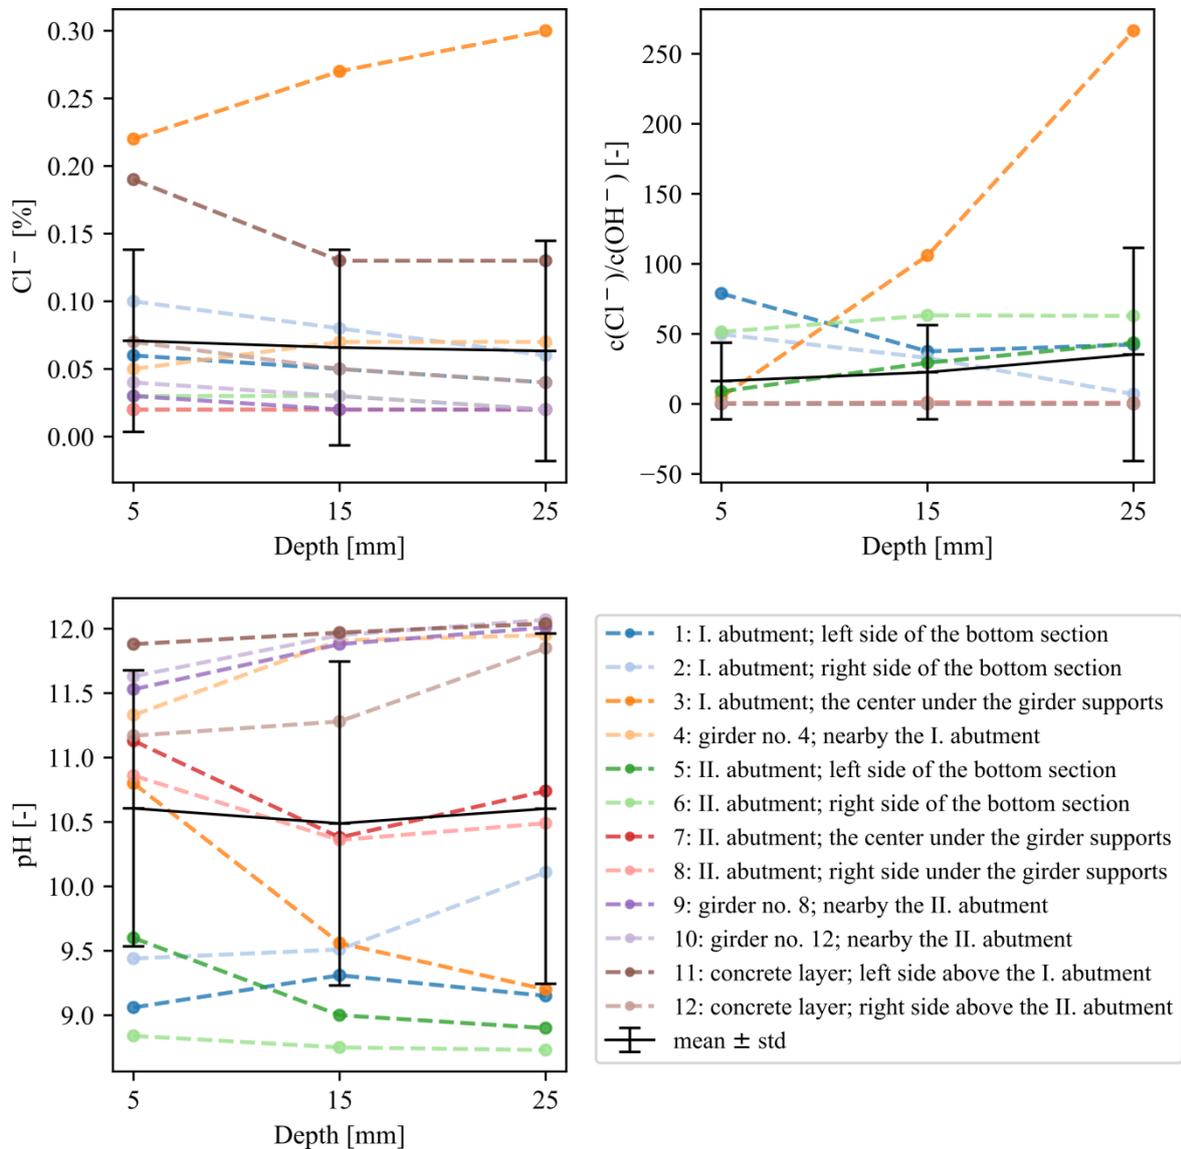
Figure 3: Observed parameters vs. depth of concrete for 12 locations on the bridge.

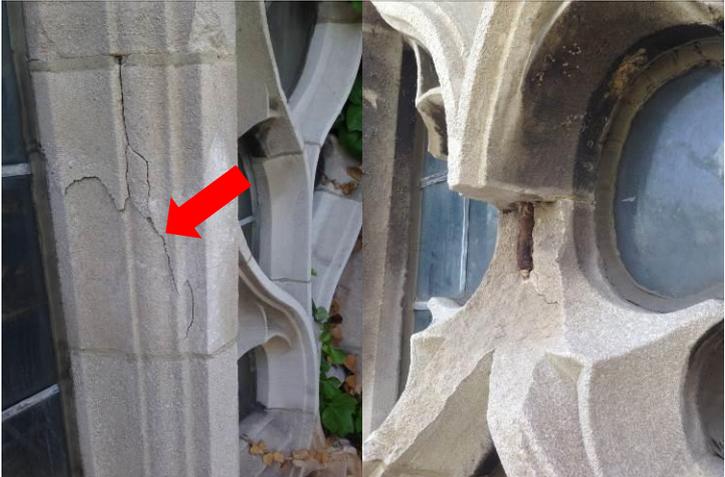
Figure 2 - Cracked and spalled window mullions and rosettes

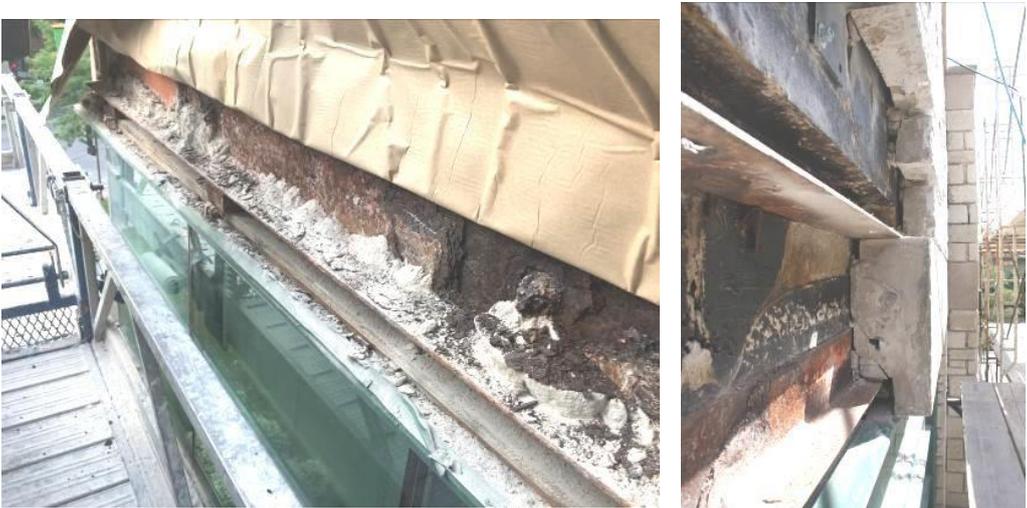
After removal of displaced limestone panels it was discovered that sections of steel lintels behind the limestone panels above the windows were severely corroded. The expansion of corrosion build-up has created large expansion forces causing pressure on adjacent stone, which caused displacement and cracking of the limestone blocks at their back portion. In addition, it was observed that portions of some of the steel shelf angles were never attached to the concrete beam of the building's structural system, had an insufficient bearing width, and at several locations the attachment anchors were severely corroded. Typical observed distress is show in Figures 3 and 4.

Figure 3 - Severely corroded steel shelf angle and cracked and spalled limestone block due to corrosion

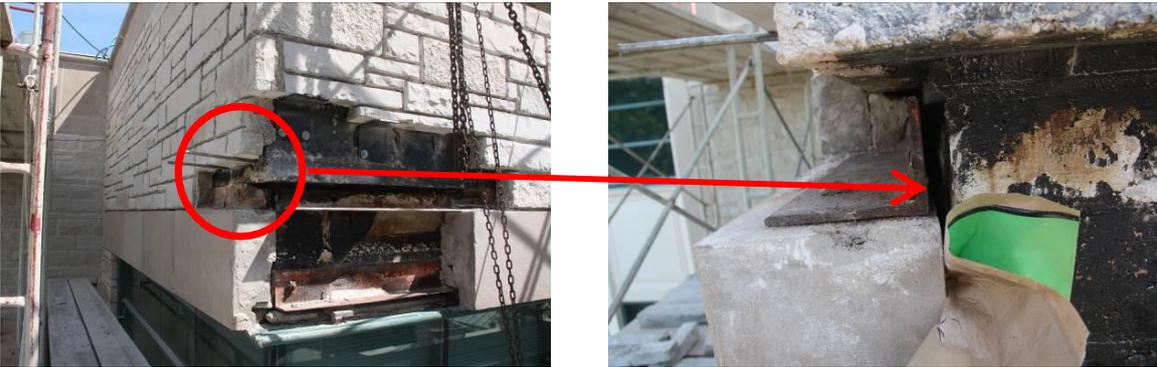
Figure 4 - Overall and close up view of shelf angle detached from structural beam and cracked limestone panel at the back side due to corrosion of shelf angle

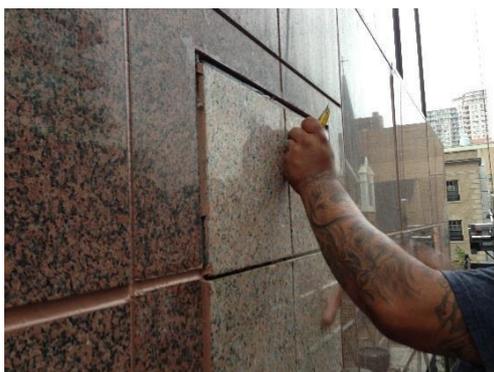
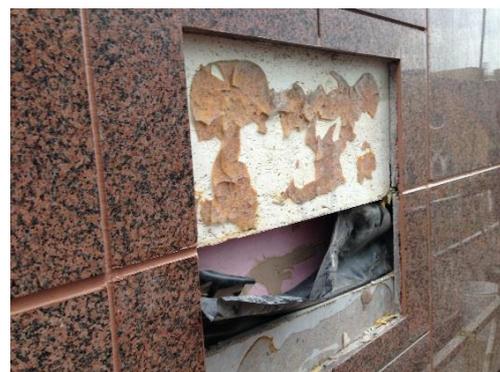
Figure 6 - Granite inserts attached with epoxy adhesive that has failed.
As built conditions are different than designed

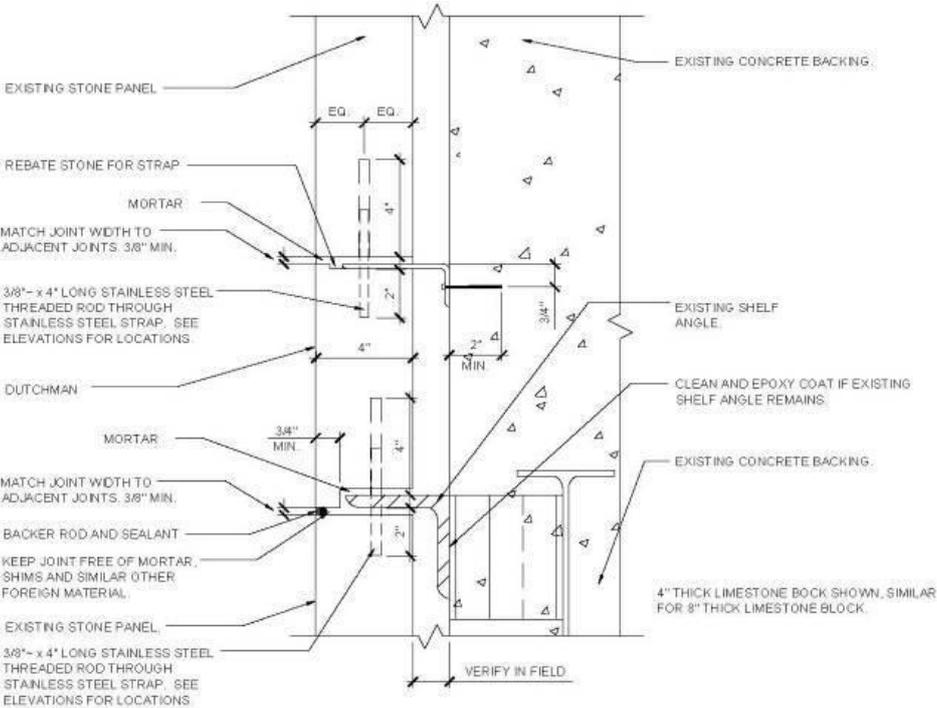
Figure 8 - Dutchman limestone repair

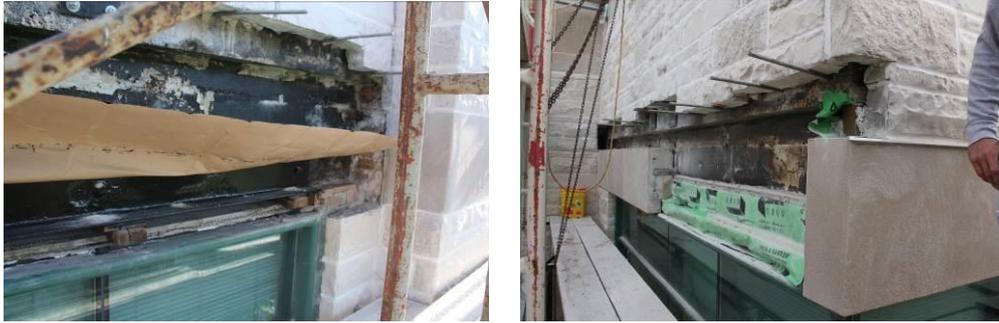
Repair 6 - Repair of shelf angle/lintel: includes removal of stones above the shelf angle/lintel as needed to expose the corroded portion of the embedded steel, as shown in Figure 9. The engineer who reviewed the condition of the existing steel and percentage of section loss, based on its condition, will determine if the shelf angle/steel lintel would be repaired or replaced.

If the level of corrosion was acceptable, the corroded steel was sandblasted clean, its surfaces properly prepared, and two coats of epoxy paint applied. Bytil based flashing with a stainless steel drip edge was installed over it. Weep tubes with ropes were installed in vertical joints between stones, and the entire section of the wall was rebuilt with limestone to restore its original profile. New limestone work was installed flush with the existing limestone. If the level of corrosion was severe, the steel lintel/shelf angle was replaced with new material, and flashing with a drip edge was installed over it prior to rebuilding the section with limestone.

Figure 9 - Repair 6, repairing of steel shelf angles / window lintels at building built in

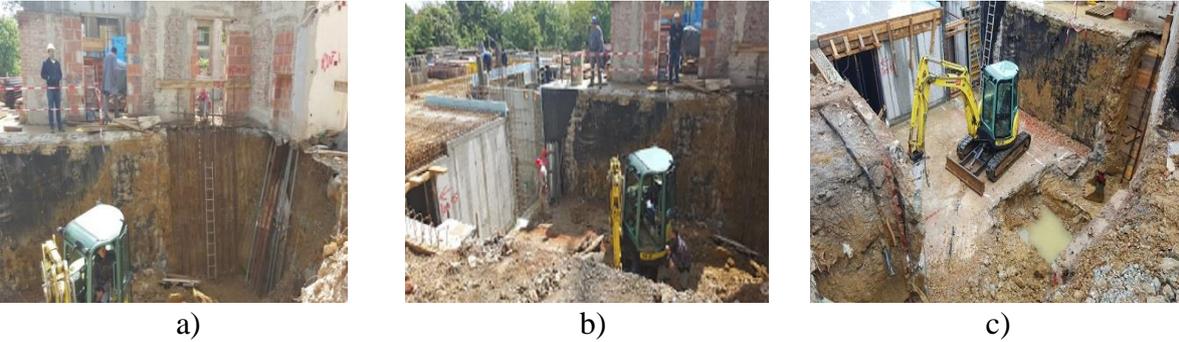
Firstly, the existing building was demolished in accordance with the plan and the upgraded basement section was removed and excavated to assure the connection of the new rebuilt basement with the old, existing house (Figure 1a). Figure 1b presents details of cleaning and preparation of the old wall and joints with the new wall. The foundations were deepened and reinforced, under the basement part with concrete C25/30, in the segments of 1 m. New design included an elevator, to assure an ease transition through future four floors of the villa. As this was not predicted in the original villa’s design, a very demanding digging was performed at the location of future elevator (Figure 1c). Figure 2a it was made so that existing walls and structures were first strengthened and then new walls were built. Part by part, step by step, very carefully. Figure 2b presents a progress on the base plate and elevator foundations.

Figure 1: a) cleaning the old walls for preparation for building of the new walls on joints with the old ones b) a newly built basement and a junction with the old wall of the house, c) excavating of the elevators pit

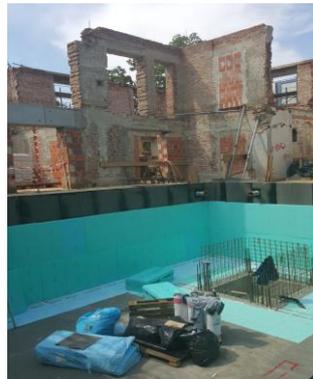
Waterproofing and thermal insulation of newly built basement walls was performed, as presented on Figure 4. After completion of the construction works at foundations of the annex, construction is being processed further on the structure of the existing building. Insulation of the existing walls was performed, in the zone of contact with the ground, by injection of the insulating foam (Figure 5).

Figure 4: waterproofing and thermal insulation of the basement area, walls and floor

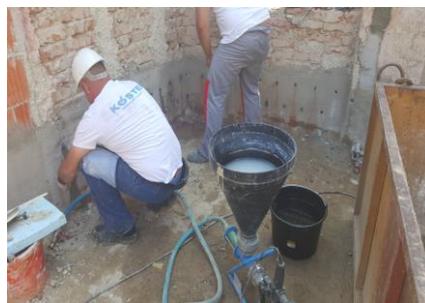
Figure 5: injection into the zone of contact with the ground (STABILCEM, MAPESTOP, LAMPOCEM, MAPE-ANTIQUE INTONACO NHL)

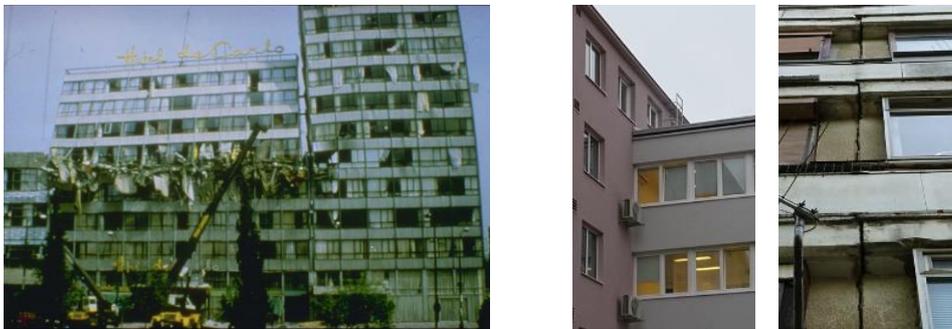
Figure 1: a) Examples of pounding effect during an earthquake [2]; b) photographs of separation gaps in analysed examples

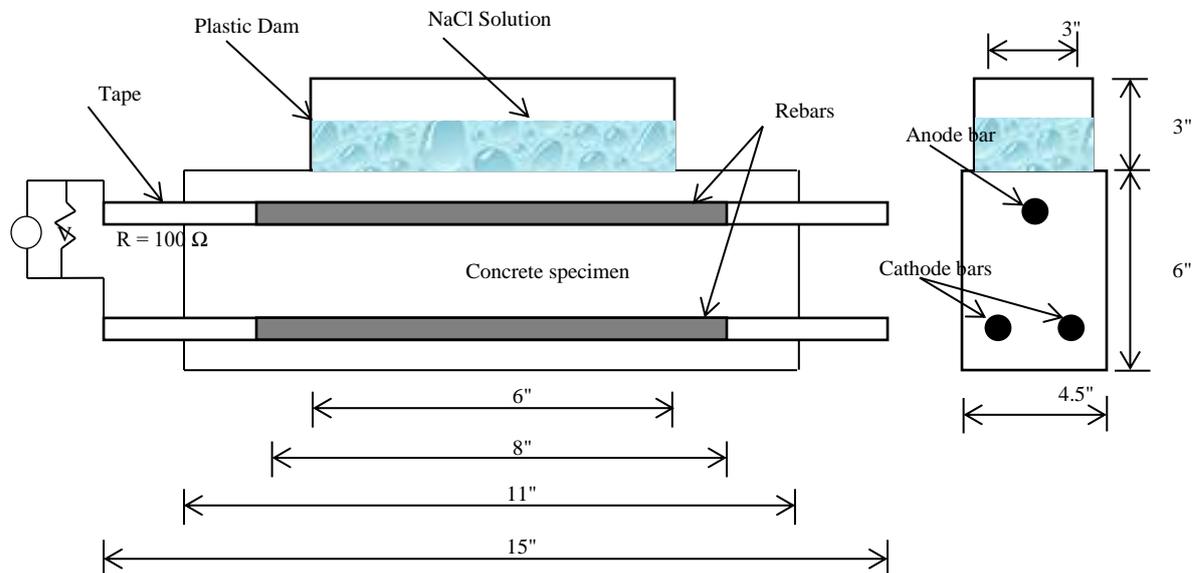
Figure 1. Corrosion test setup

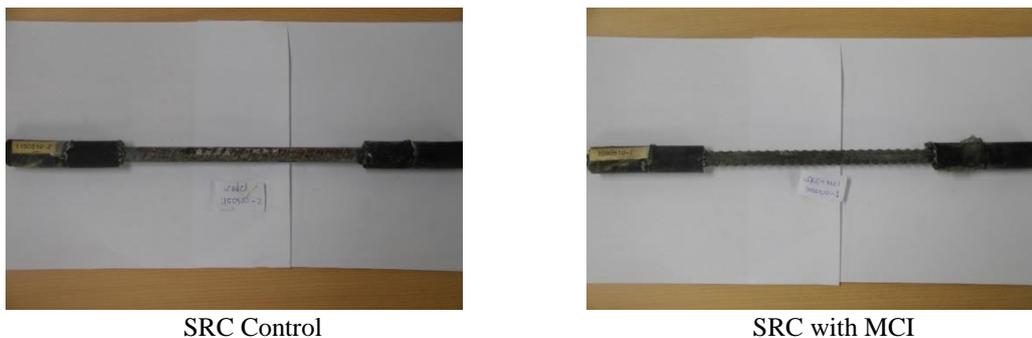
When the integrated current reached 150 Coulombs or higher, specimens should be broken and reinforcing steel bars examined in accordance with ASTM G 33 and ASTM G 46. SRC and OPC (control) and SRC and OPC with MCI mixes specimens were broken and reinforcing steel specimens. Typical Photos of the reinforcing steel bars of SRC and OPC specimens are shown in Figures 5 and 6. As shown in the figures, steel bars of control specimens were subjected to uniform corrosion and pitting as well, while the bars of SRC and OPC with MCI specimens were in a good shape with no pitting or uniform corrosion observed. The mass loss of control bar was close to 1% and the pitting is rated 3 in accordance of ASTM G 46. Average soluble chloride contents measured in the vicinity of the bars were 0.16% by weight of concrete of MCI specimens and 0.11 % for the control specimens.

Figure 5 Reinforced steel removed from of SRC and SRC with MCI

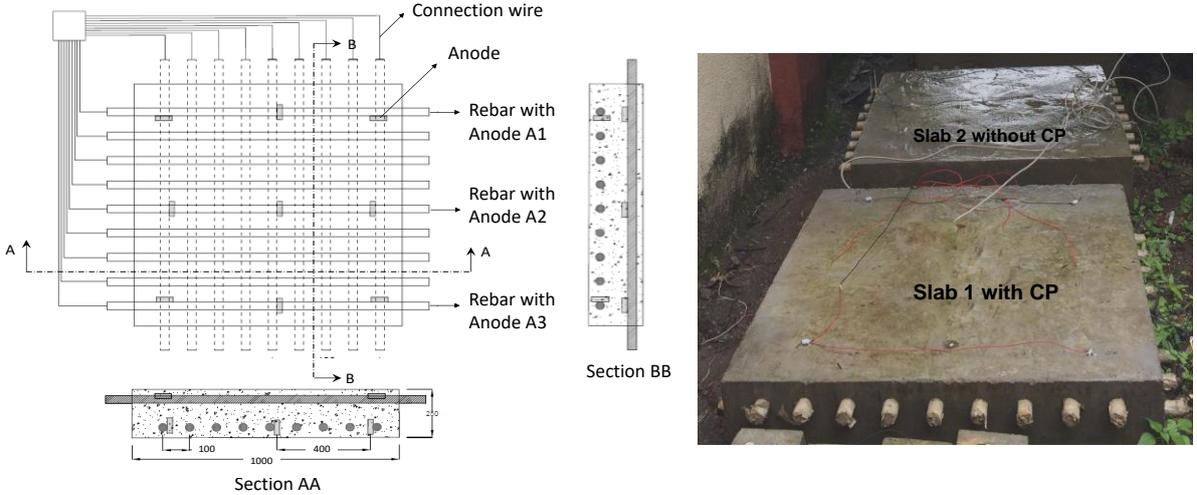
a) Schematic of anode locations in Slab 1 b) Photograph of Slab1 and Slab 2

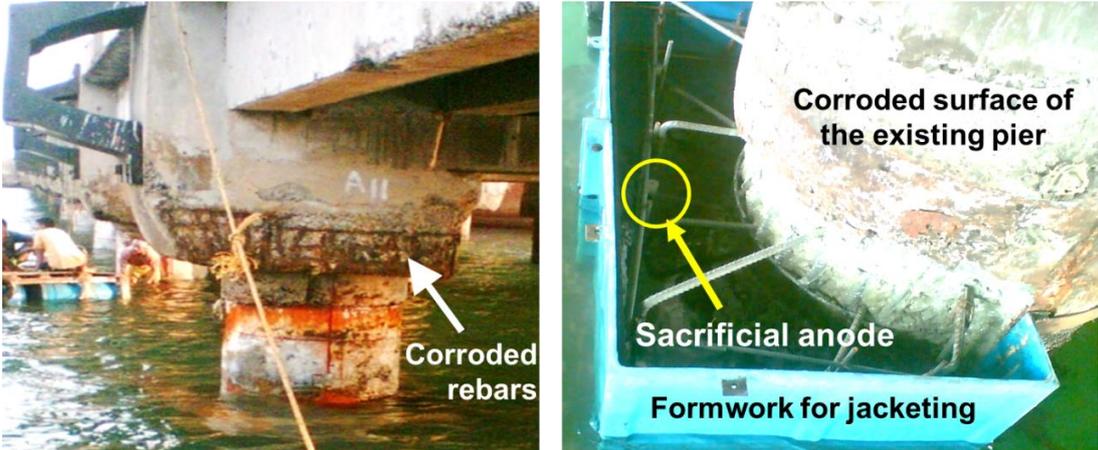
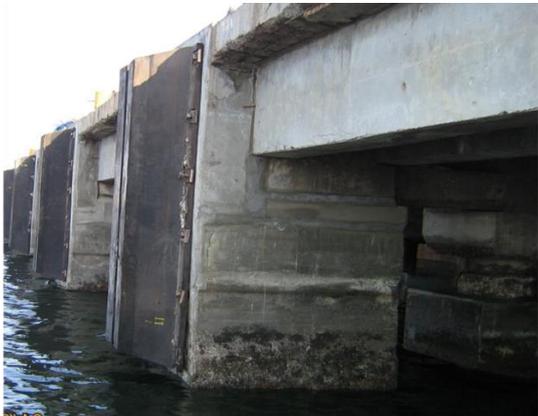
Figure 2 shows the photographs from a 20-year old finger jetty located in the East coast of South India, was considered for this study. The finger jetty is expected to have the service life of 100+ years. These piers experience cyclic wetting and drying condition in the splash zone – leading to accelerated chloride ingress. After about 20 years of service, significant corrosion was observed on the splash zone of the piers (see Figure 2(a)). It was also found that the chloride concentration at rebar level was significantly higher than the chloride threshold of the

steel rebars. Concrete jacketing with additional rebars was done to enhance the strength of the piers. For this, a total of 9200 kg of additional reinforcing steel and 10 m³ micro concrete were used. Considering the high chloride concentration at the rebar level, a total of 1390 sacrificial anodes were installed in various structural elements (pier, pier cap, longitudinal beams, and slabs). Figure 2(b) shows the additional reinforcement and sacrificial anodes installed on a typical pier. A monitoring box was installed so that the sacrificial anodes can be disconnected to measure the depolarized potentials. Figure 2(c) shows the piers after repair using CP technique. Later, the depolarized steel potentials were monitored for about 4.5 years.

(a) Corroded rebars in a pier (circular cross-section) and pier cap

(b) Setup for concrete jacketing with additional rebars and sacrificial anodes

(c) Piers after repair (with rectangular cross-section)

Figure 2 Finger jetty in the coastal region

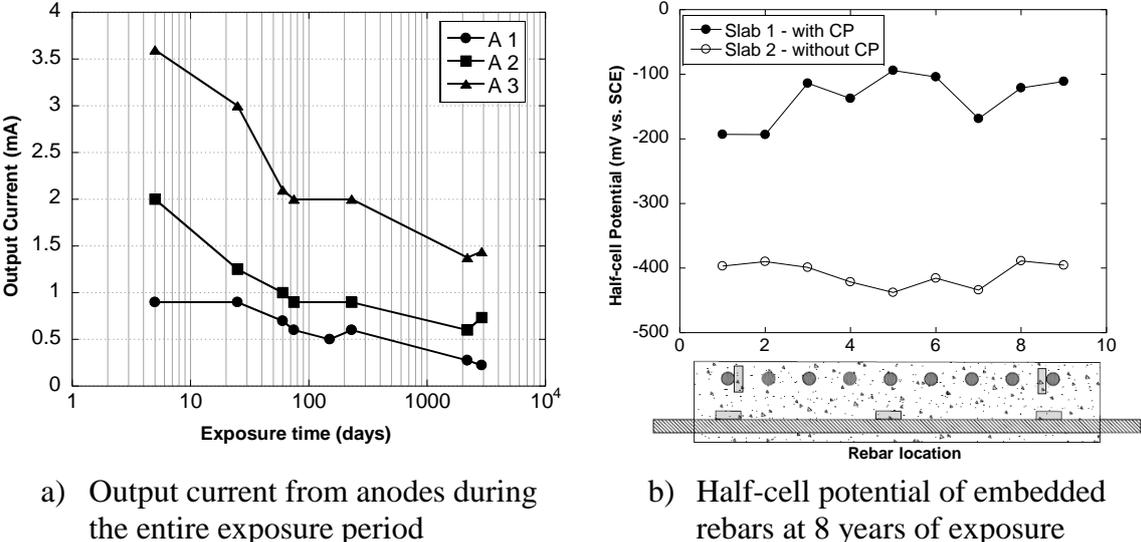
a) Output current from anodes during the entire exposure period
 b) Half-cell potential of embedded rebars at 8 years of exposure
 Figure 3 Long-term performance of anodes in protecting the embedded steel reinforcement

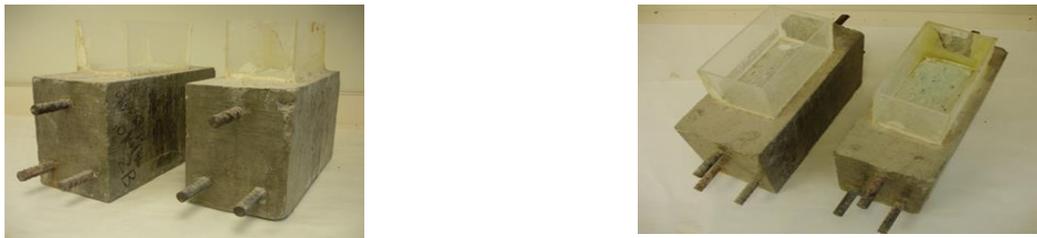
ASTM G109 test samples can be seen in Figure 3 below. The test consists of casting concrete blocks containing a triangular arrangement of rebar embedded within them – one bar on top and two on the bottom. These samples are then exposed to cyclic wetting and drying cycles with salt water, and the macrocell current between the top bar and bottom two bars is monitored and recorded every 4 weeks (4 weeks = one cycle). The testing stops once the total integrated macrocell current reaches 150 Coulombs.

Figure 3. Example of ASTM G109 Test Blocks

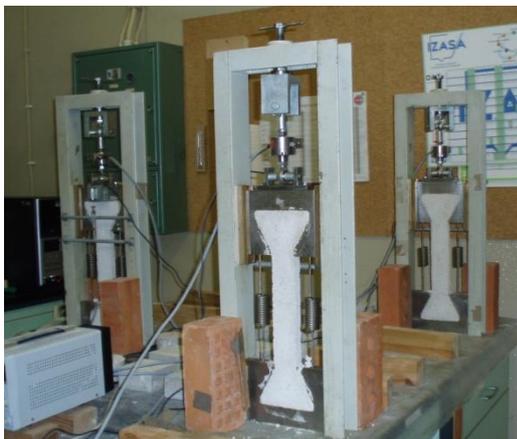
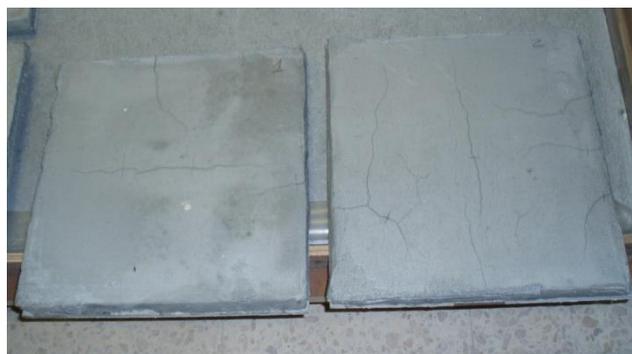
Figure 1 – Restrained shrinkage tests: a) Uniaxial test; b) Slab test

These tests are based on moulding a uniaxial specimen inside a device that allows blocking the deformation, and measurement of the force induced by restrained shrinkage [11,21,22,10,2] (Figure 1 a). Free shrinkage can be measured simultaneously in similar specimens. Some advantages of this type of method are: curves force-displacement and force-time can be drawn; restrained shrinkage can be compared with free shrinkage; parameters such as energy of fracture and maximum elongation at rupture load may be determined; due to the simple geometry of the device, the values obtained can be simply related to stress and strain to be obtained in-service. A drawback is that a very specific equipment is needed.

These methods [23,24,25] are based on the application of a mortar on a stiff substrate, such as a concrete slab, which simulates the wall that restrains shrinkage (Figure 1 b); the cracks formed are observed and several parameters are measured: time of opening of the first crack; pattern and area of cracking; number of cracks; maximum crack width, etc. These are the tests that better simulate the in-service conditions and they are easy to perform and do not need

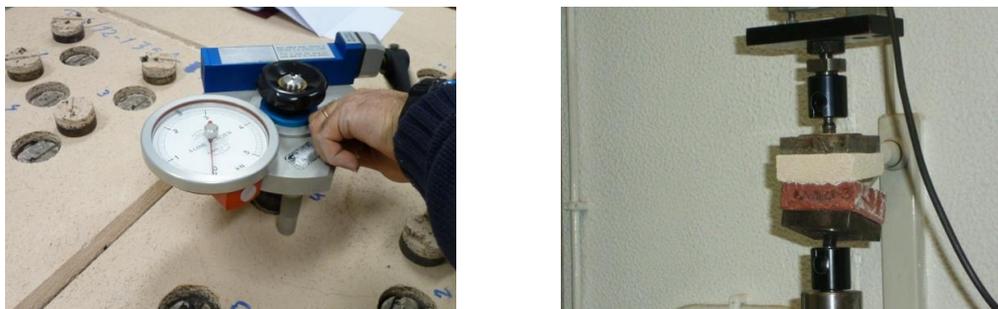
Figure 2 Adhesion with a) pull-off apparatus and b) tensile machine

A method for determining the adhesion strength between mortar and substrate is described in EN1015-12 and is defined as the maximum tensile strength applied by a direct load perpendicular to the surface of the mortar on a substrate. The adhesive strength obtained is the quotient between the failure load and the test area. It is commonly known as pull-off method and is performed with a pull-off dynamometer specified also in several standards and Guides [28,29,30]. Pull-off is a widespread method (Figure 2 a), easy to perform. However, it has some drawbacks concerning air lime mortars: their tensile strength is very low, and as the test is based on the application of a tensile load, the obtained adhesion values are in the range 0.01-0.10 MPa [31,32], corresponding to applied forces of 20-100 N, which significantly reduce the precision of the method. In fact, pull-off devices commonly available with the best accuracy have capacity until 5000-6000 N, and low sensitivity to small variations of load. Additionally, the load application control is limited. Hence, the accuracy of results for low strength mortars is insufficient. A method based on a tensile load applied on a composite specimen substrate-mortar by a mechanical machine of higher precision and allowing adequate control of load application has been tested and results obtained proved to be more sensitive [31,32] (Figure 2 b). However, this method is not applicable on site.

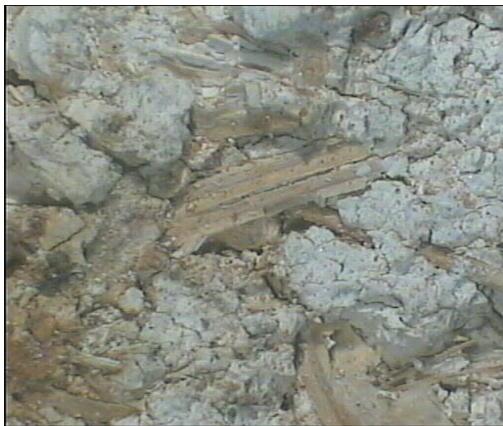
Figure 4a: Straw in the structure of old lime mortar

The microscopic study of ancient mortars, reveals, that apart from the main ingredients, binders and aggregates, there are other materials as well, in small percentages in the mass, such as shells, charcoal particles, lime lumps, chips of wood or straw. These enclosures are met in structural mortars as well as in renders and they are observed in different historical periods (from the mud mortars of archaic period to strong pozzolanic mortars of Roman and Byzantine era and even in the mortars of 19th century or pre-cement period) [13]. Their role in the behavior of ancient mortars, as well as their origin, is not always clear, but their morphologic characteristics (shape, size and distribution), their percentage (not more than 2wt %) and their cohesion with the binder (usually strong) gives useful information about the older technology of building construction. Additives such as fibres, act as reinforcement and they have been widely used either knitted into the matrix or added as a net between mortar layers (Fig4).

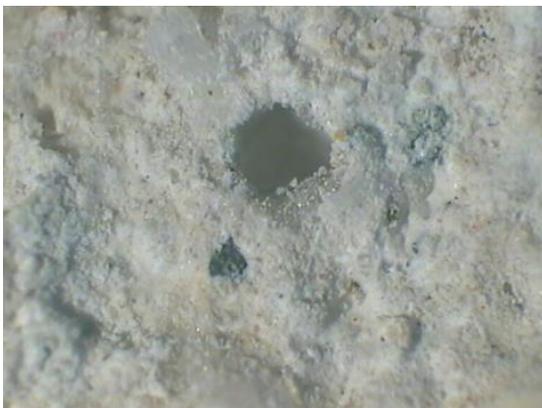
Figure 6a: Secondary crystallization in pores

Secondary re-crystallization phases are often observed in the structure of ancient lime-based mortars (Fig6). They are mainly situated in previously formed cracks, in spherical pores and in the loose transition zone. The composition of these phases depends mainly on the type of binders used and the hydro thermal conditions to which the mortar was subjected during its service life. The secondary crystals reduce the porosity, as they fully or partly cover pores and cracks [12].

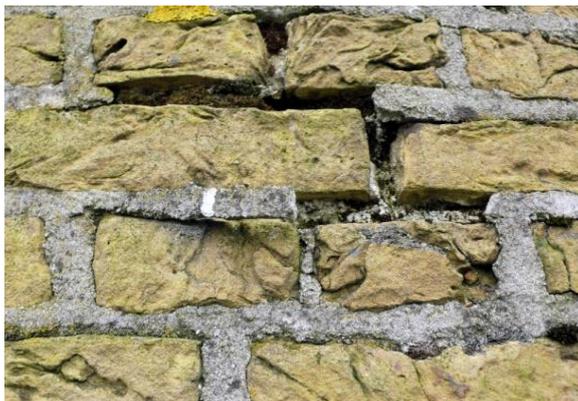
Figure 2: Left: Push out of joints by thermal deformation cycling; Right: graph with E-modulus development of various mortar compositions (NHL mortars, 1:2,5 (vol. parts NHL3,5:sand); cement lime mortars e.g.1:1:6 (vol. parts cement:lime:sand)); (curing conditions 20°C and RH 90%: favourable hydration conditions!)

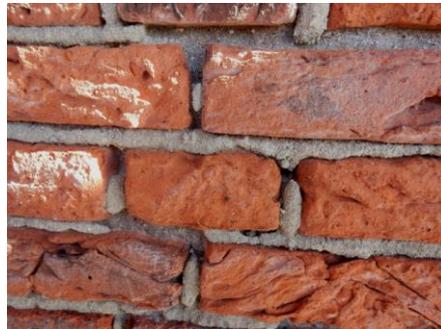
Figure 4: Damage in a trass-lime repointing caused by incomplete hydration of the binding system.

Figure 4 shows an example of incomplete hydration of a lime-pozzolan mortar. The composition in volume parts is: 1 trass-lime : $\frac{1}{4}$ blast furnace cement : $3\frac{1}{2}$ river sand. The object is a 35 m high tower of fired clay brick masonry. The site is close to the sea. Incomplete hydration of the mortar resulted into a low strength so that rain and wind erosion could cause damage.

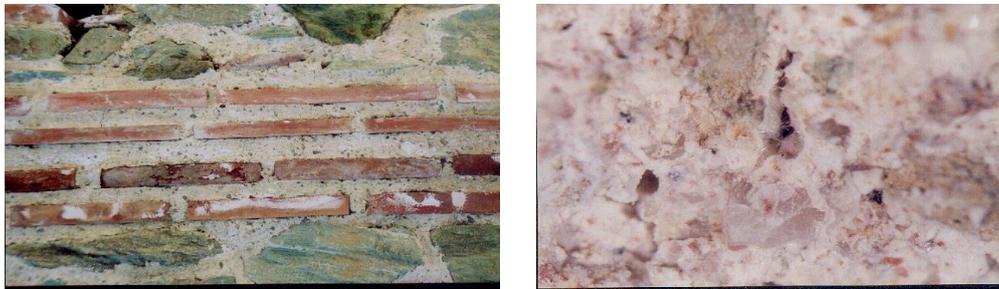
Figure 5: Left: Galerius palace (4th century BC). Detail of the repaired masonry. Right: Repair mortar from salt damage area of masonry of Galerius Palace. Content in soluble salts which are mostly accumulated into the pores (Cl= 0.28%, NO₃= 0.83%, SO₄= 1.14%)

In the pictures taken from repaired masonry (figure 5) of the Galerius Palace (4th century BC) after the earthquake of 1978, the salt damages are obvious.

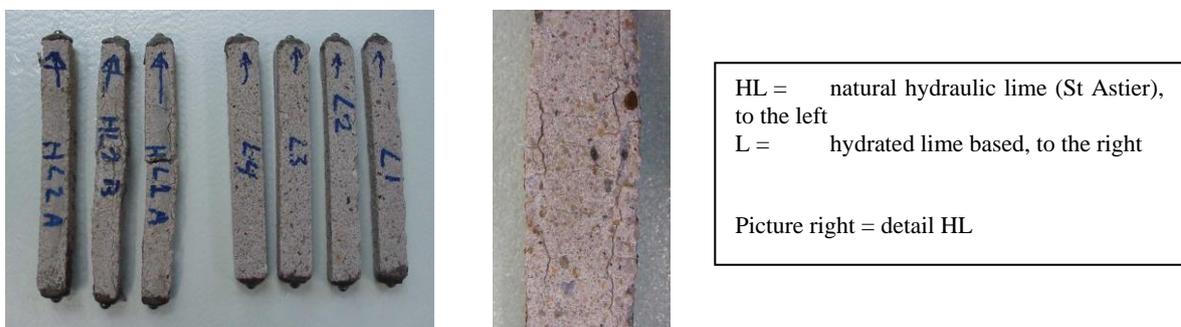
Figure 6: Mortar prisms after 15 weeks in sulfate solution. Natural Hydraulic Lime based (HL) specimens with clear expansion and deformation. Hydrated lime based (L) not any expansion, [10]

A situation which is even worse than the above occurs when a reaction can take place between the salt and components of the mortar. For example, in case of hydraulic lime or trass lime mortars in the presence of sulfate, mainly thaumasite may be formed [8], [9]. The sulfate may derive from the atmosphere (SO₂) or from the brick (due to low firing of sulfate containing clays).

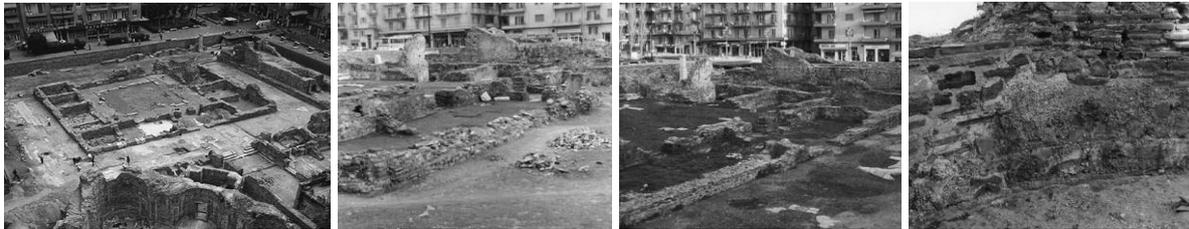
Fig. 1-4 Preservation state of the Galerius Palace after the intervention of the 70's [1]

The pathology symptoms of the monumental Complex of Galerius were severe, since after the excavation of 1971, the ruins remained without any protection and were exposed to weathering. Previous (fortunately at limited extend) interventions of the 70's, based on cement had worsened the pathology of the masonry units [1]. The following photos (Fig. 1-4) are representative of the state of the monumental complex of Galerius before restoration.

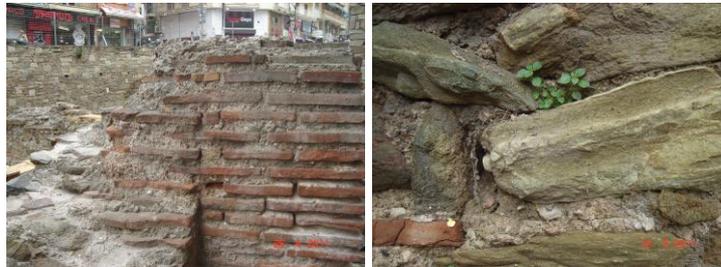
Figures 5-6 Deterioration problems of the masonries before the intervention works.

discolorations, due to pollutants and biological attack. Destruction and demolition the masonry parts made the morphological unity of the building 'complexes' no recognizable. Plasters in many places were detached, while mortar joints were eroded (Fig.5). Uncontrolled natural growth of plants created additional problems (Fig.6).

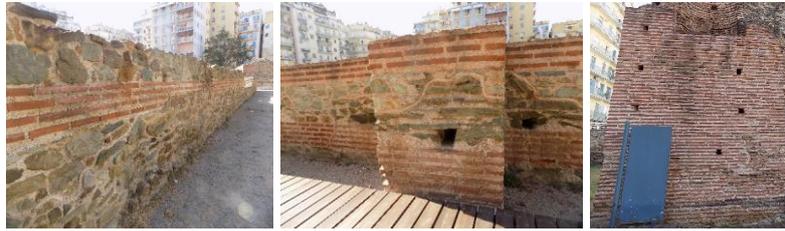
Figure 8 Preservation state of the complex's masonries 20 years after repair

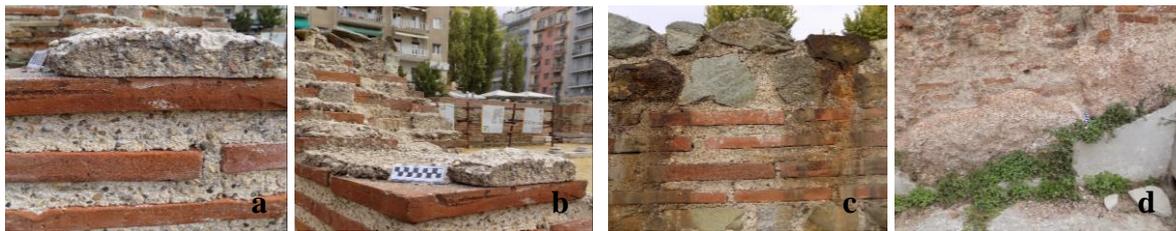
Figure 9 Deterioration phenomena of the repaired structures. a. microcracking, b. black crust, c. oxidation products, d. biological growth

- Micro-cracking in the mortar joints, especially near the vertical joints (Fig.9a)
- Black crust on protective mortar layer, on the top of the masonries (Fig.9b)
- Loosening of material due to alveolization
- Discoloration of the masonry elements due to oxidation products from the gneiss (Fig.9c)

- Biological growth (Fig.9d)

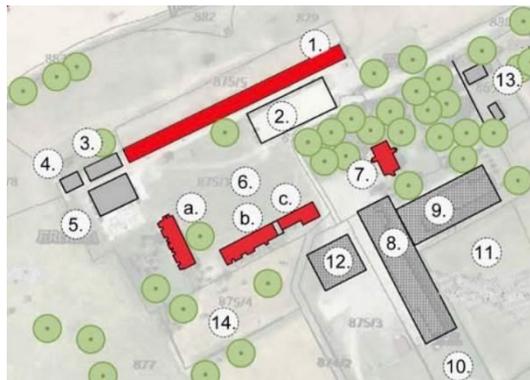
Figure 1: Ground plan of the Stud Farm complex in Lipik

The Stud Farm Lipik was established by count Izidor Janković who built this complex in 1843. The subject of this research are the following buildings (figure 1): horse stable (1), workers' houses (6a, 6b and 6c) and manager's building (7). All the buildings are predominantly made of clay brick with a small part of natural stone masonry units using lime mortar. The horse stable is quite impressive: 170 m long and 10.5 m wide without dilatation. It has been partially reconstructed in 2007 and is still in use for its original purpose: breeding Lipizzaner horses. Other buildings are in ruins, without roof and partially inaccessible.

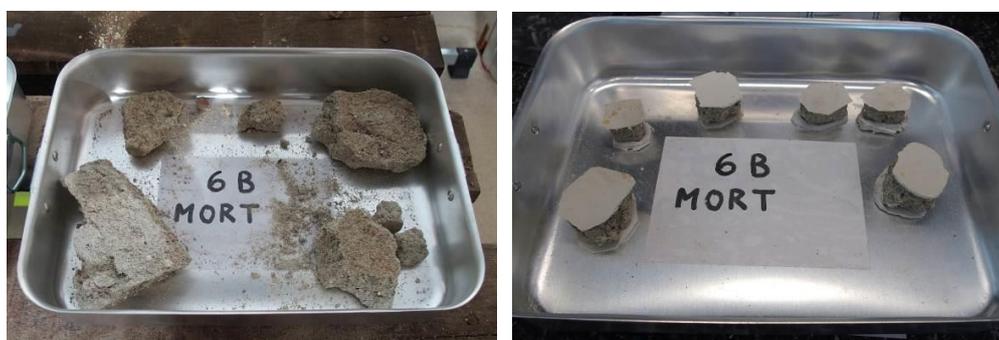
Figure 2: Mortar samples (left) and specimens prepared for testing (right)

Mortar testing has been conducted on samples taken from bed joints, which were then formed in specimens by hand cutting in order not to disturb the specimen strength. Specimens had the shape of a prism with approximately rectangular base and height equal to the bed joint thickness which was about 18.9-29.6 mm. Mortar specimen dimensions are given in table 1: samples 6A, 6B and Z1 are taken from buildings 6a, 6b and 1, respectively. Based on a visual inspection of the masonry quality it was estimated that samples taken from buildings 6a and 6b are also representative for buildings 7 and 6c, respectively. Before testing upper and lower base have been levelled with a thin layer of gypsum (figure 2). Testing (figure 3) has been conducted according to EN 1015-11 [3].
