**Proceedings of the
International Conference
on Sustainable Materials,
Systems and Structures
(SMSS2019)**

**Durability, Monitoring and
Repair of Structures**

International Conference on Sustainable Materials, Systems and Structures (SMSS 2019)
Durability, Monitoring and Repair of Structures
20-22 March 2019 – Rovinj, Croatia

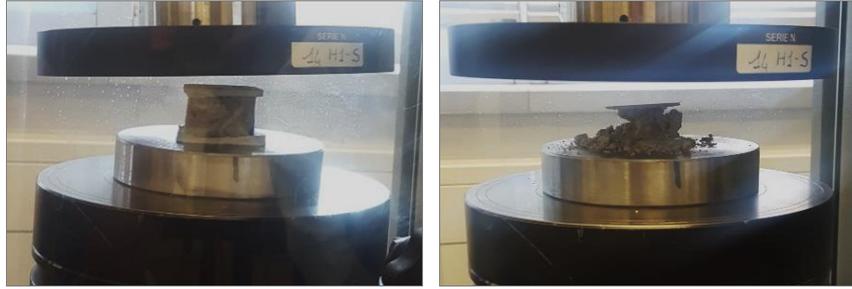
Figure 3: Compressive test of mortar specimens: before (left) and after testing (right)

Mortar testing has been conducted on samples taken from bed joints, which were then formed in specimens by hand cutting in order not to disturb the specimen strength. Specimens had the shape of a prism with approximately rectangular base and height equal to the bed joint thickness which was about 18.9-29.6 mm. Mortar specimen dimensions are given in table 1: samples 6A, 6B and Z1 are taken from buildings 6a, 6b and 1, respectively. Based on a visual inspection of the masonry quality it was estimated that samples taken from buildings 6a and 6b are also representative for buildings 7 and 6c, respectively. Before testing upper and lower base have been levelled with a thin layer of gypsum (figure 2). Testing (figure 3) has been conducted according to EN 1015-11 [3].

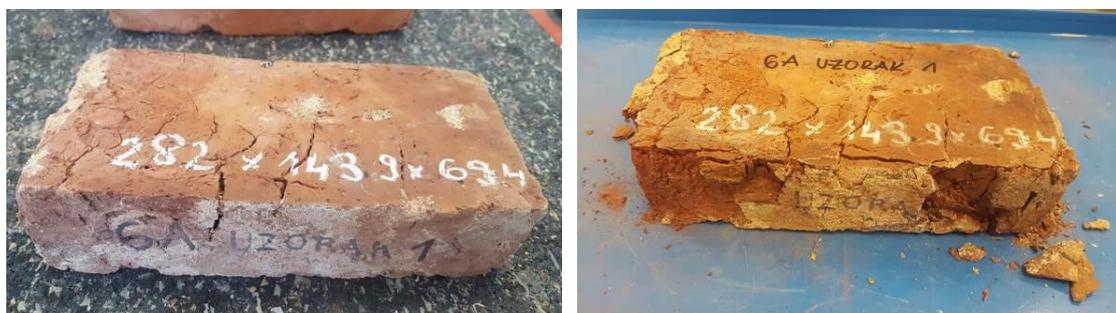
Figure 4: Clay brick specimen before (left) and after testing (right)

grinding in order to satisfy the planeness and parallelism requirements and the specimens have been dried according to [5]. In figure 4 a specimen is shown before and after testing.

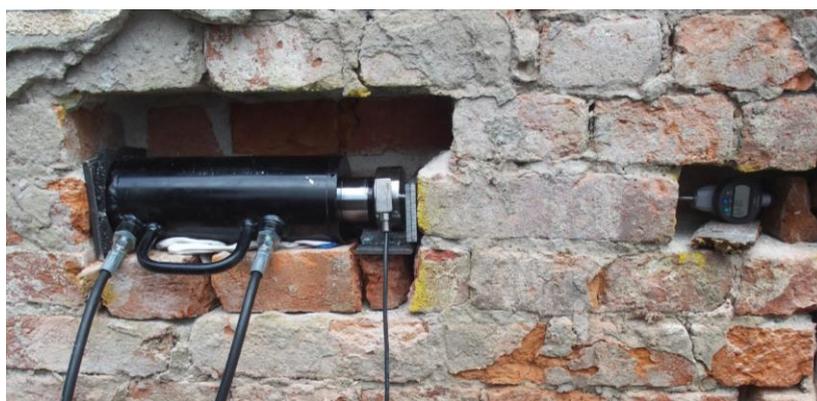
Figure 5: Shear test, building 7 – outside wall

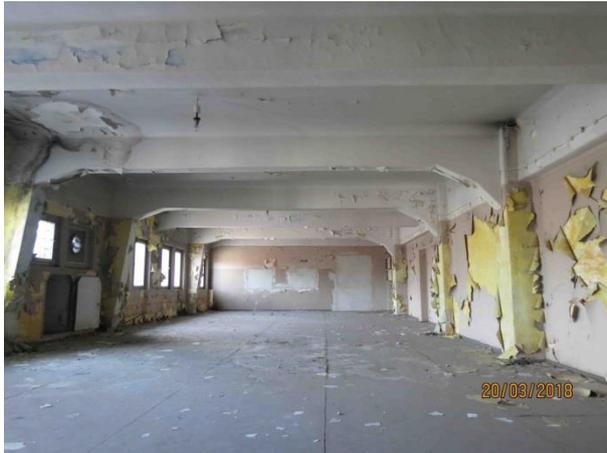
Figure 3: RC structure of the flour warehouse

The bearing structure of the flour warehouse (Fig. 1) is made of reinforced concrete, its load-bearing longitudinal walls are made of brick and it has two rows of reinforced concrete pillars that define a central communication passage (Fig. 2). The floors are massive, made of reinforced concrete, slab-ribbed, and based on the central pillars and external walls (Fig. 3). The structure of the two floors of the attic is also reinforced concrete, with an oblique frame determining the slanted roof in the form of a thin reinforced concrete slab. The floors are based on longitudinal beams and transverse frames, which transfer loads to the external walls and central pillars. All the load-bearing structural elements, due to the complex geotechnical conditions, are placed on wells.

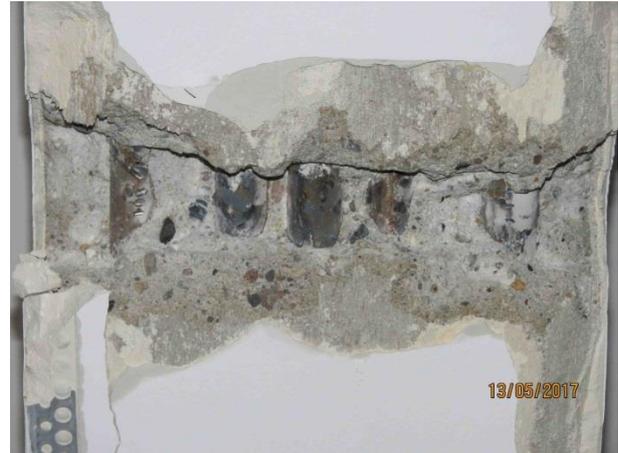
Figure 4: Reinforcement identification

In the case of this object, due to its intended use for lofts and apartments, the main problem concerned the proper detection and assessment of steel rebars in the RC elements (Fig. 4).

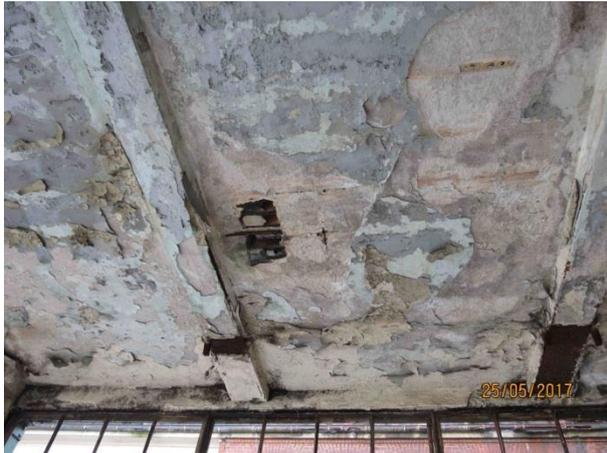
Figure 7: Destruction on Ackerman floors

In the case of this building - its degraded Ackerman (Fig. 7) and Klein floors were the main structural problem, the bad condition of which meant that they could not be used as bearing elements. Additionally, the vast majority of the steel beams of the floors over the ground on the 1st and 2nd levels showed deep corrosion. It was decided to replace them all with new RC floors. However, all floors with very decorative ceramic claddings on parts of the ceilings (as well as on walls) were preserved and restored (Fig. 8).

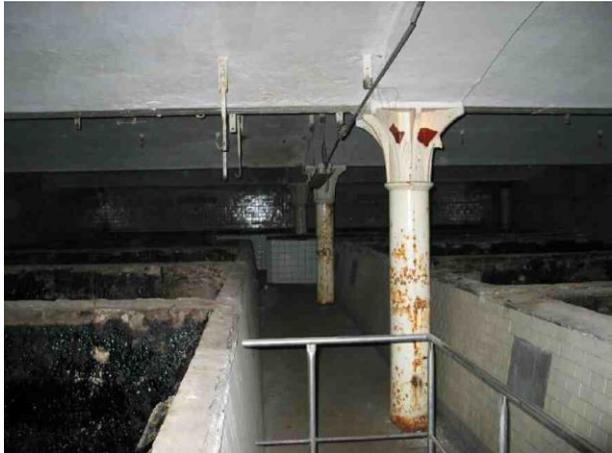
Figure 11: RC reservoirs with cast iron columns

The structure of the building (Fig. 9) is very diverse, depending on the period of construction and technological purpose of its individual parts: from a typical brick masonry construction to skeletal cast iron and steel, as well as reinforced concrete elements. The most spectacular structure is the roof steel truss over one of the main production rooms, which has a span of about 24 m (Fig. 10). The majority of floors were made as arch brick masonry ones and based on steel beams. However, in one of the halls there was a slab carrying RC reservoir, based on cast iron columns, with a masonry floor over it (Fig. 11).

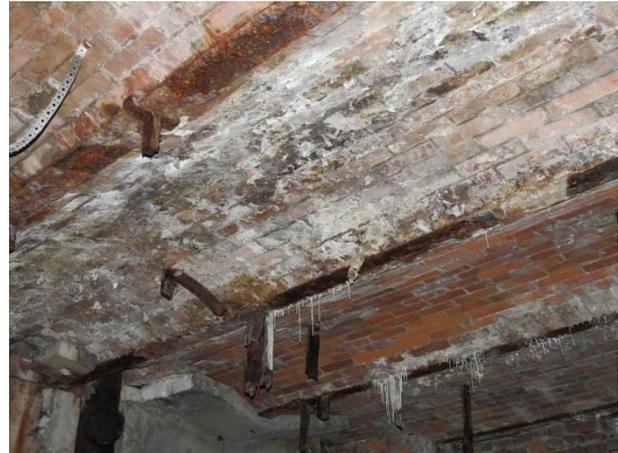
Figure 12: Destruction of brick masonry floors

Most of the masonry floor slabs were strongly damped and there was also locally strong corrosion degradation of steel beams, binders and columns (Fig. 12). Some of the floors are designed to be replaced with new, composite ones.

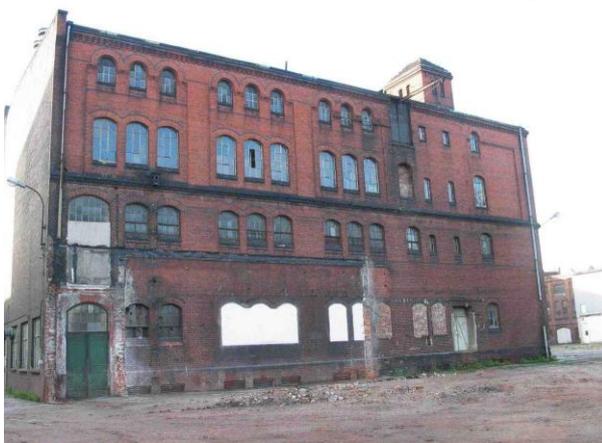
The main bearing structure of the stables building (Fig. 13) constitutes a system of steel columns (part of them covered with concrete or brick and mortar), situated in two internal longitudinal axis, as well as on the bearing external and internal walls. Transversal steel binders are located on columns and longitudinal walls, while steel slab beams are arranged on both them and the external walls. The floors are brick masonry arch ones on steel beams over a cellar, and its Klein type floors are on steel beams over the remaining stories. The thickness of the floors is diverse - 30 cm, 40÷45 cm and 50 cm; full brick was used in the masonry arc slabs, and hollow bricks in the Klein ones. In the central part of the building there is an inclined ramp (Fig. 14) that was used for the transportation of horses to stables on the ground and 1st floors (Fig. 15). The building is designed to be an apartment house.

Figure 13: Stables building current view

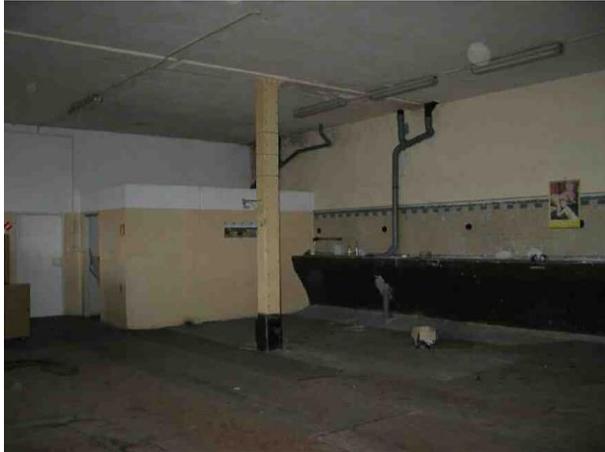
Figure 15: View of stables room

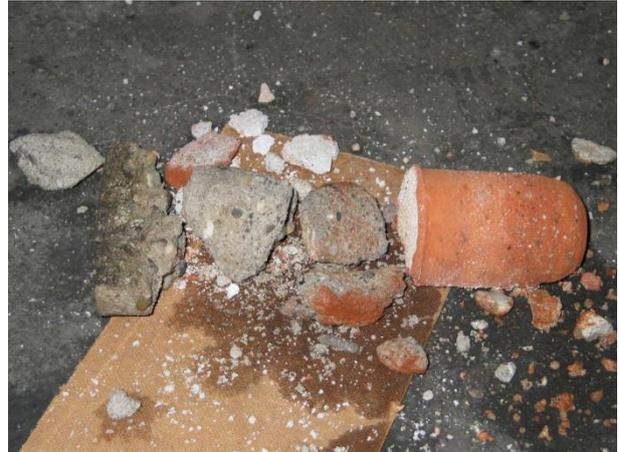
Figure 16: Drilling core of stables floor

The main constructional problem to be solved involved the object's very thick slabs – the bearing capacity of the slabs and steel beams was almost at the limit state. Moreover, the bricks and pavement layers were extremely chemically polluted (Fig. 16). There was a necessity to remove a 10 cm layer of concrete by milling or hand-made demolition, and also a need to construct new floor layers with acoustic insulation and to decontaminate all the floors.

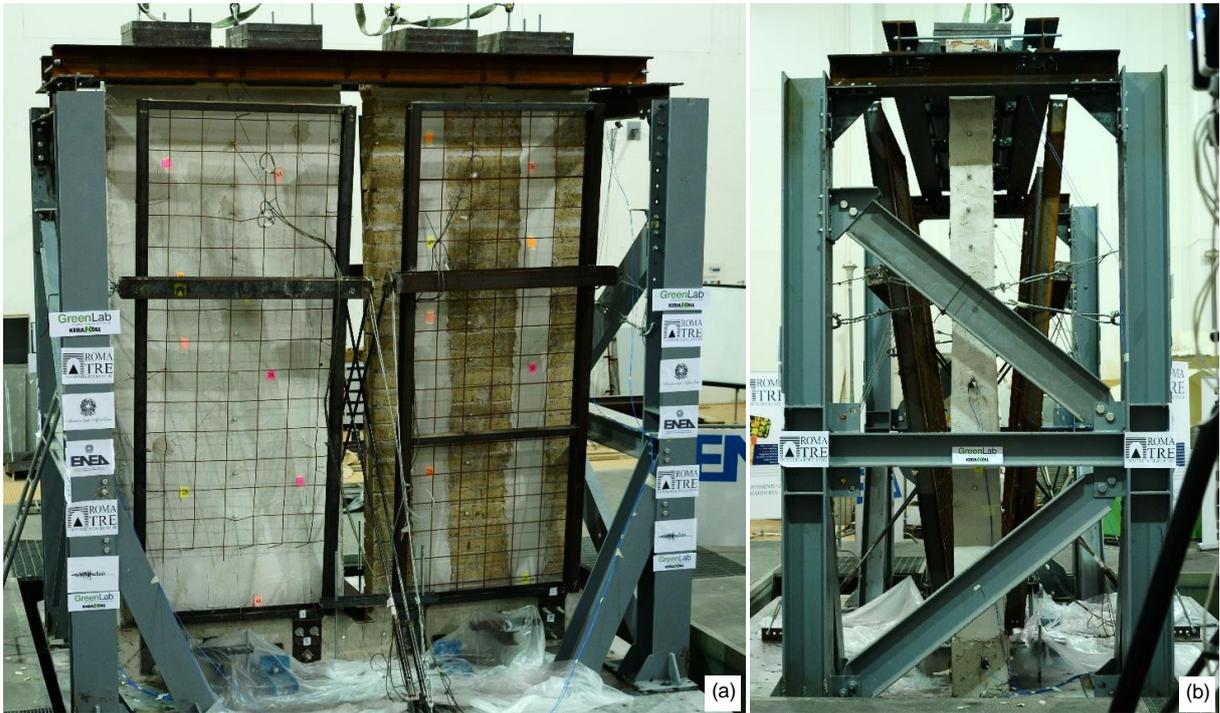
Figure 1: Front (a) and side (b) views of the experimental setup

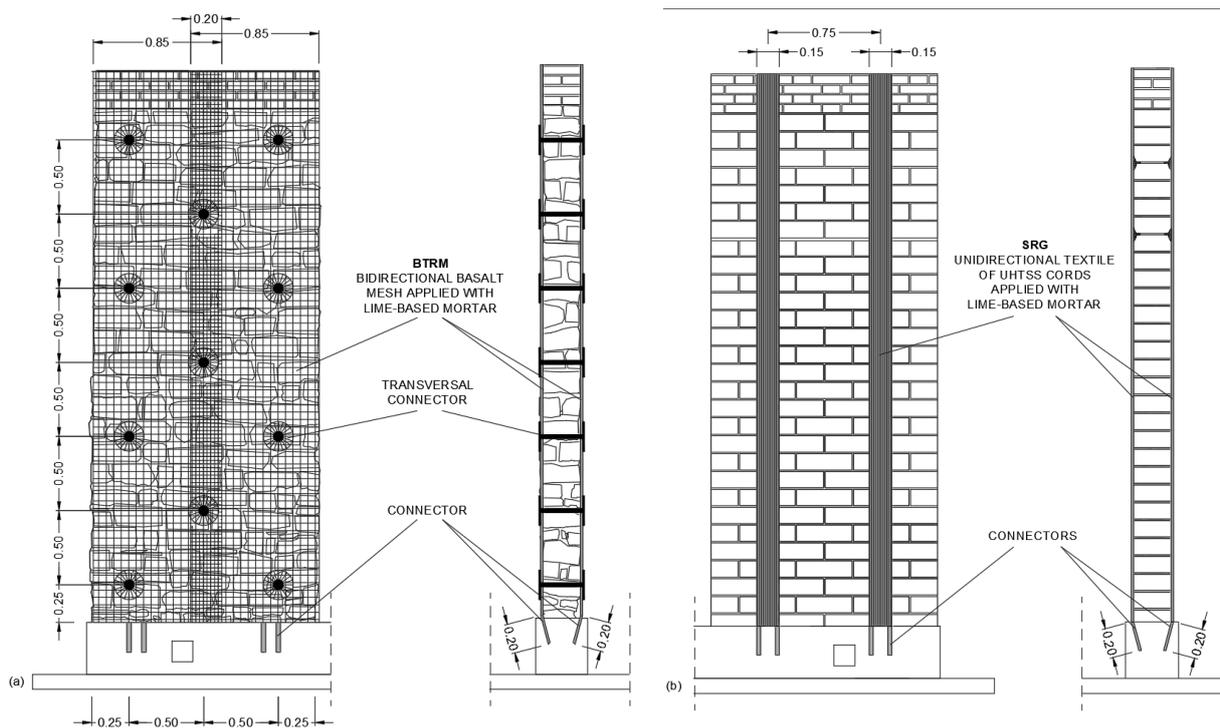
Figure 2: Retrofitting design for the stone (a) and tuff (b) walls

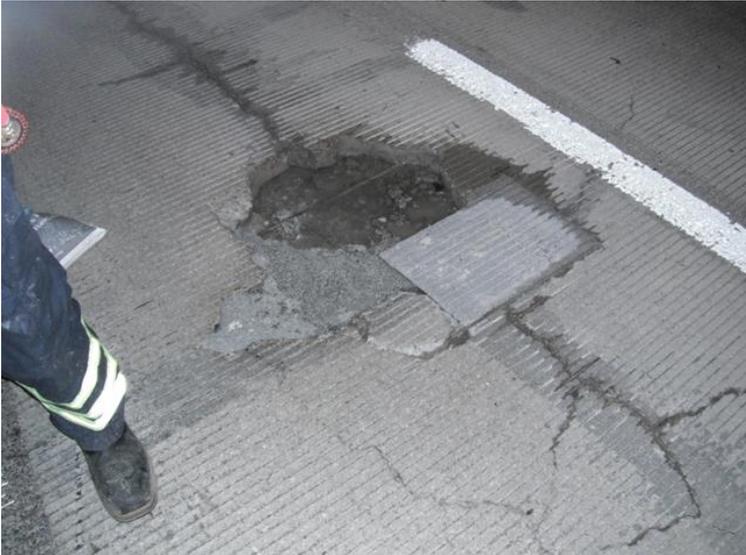
In 2016, it came to the attention of the infrastructure managers that large cracks were occurring in the overlay. The cracking and ensuing deterioration of the overlay was so severe that it led to the need to execute local emergency repairs (see Figure 1). These emergency repairs were however, very ineffective and were themselves heavily damaged within a short period of time.

Figure 1: – Observed cracking and deterioration of the overlay requiring emergency repair procedures

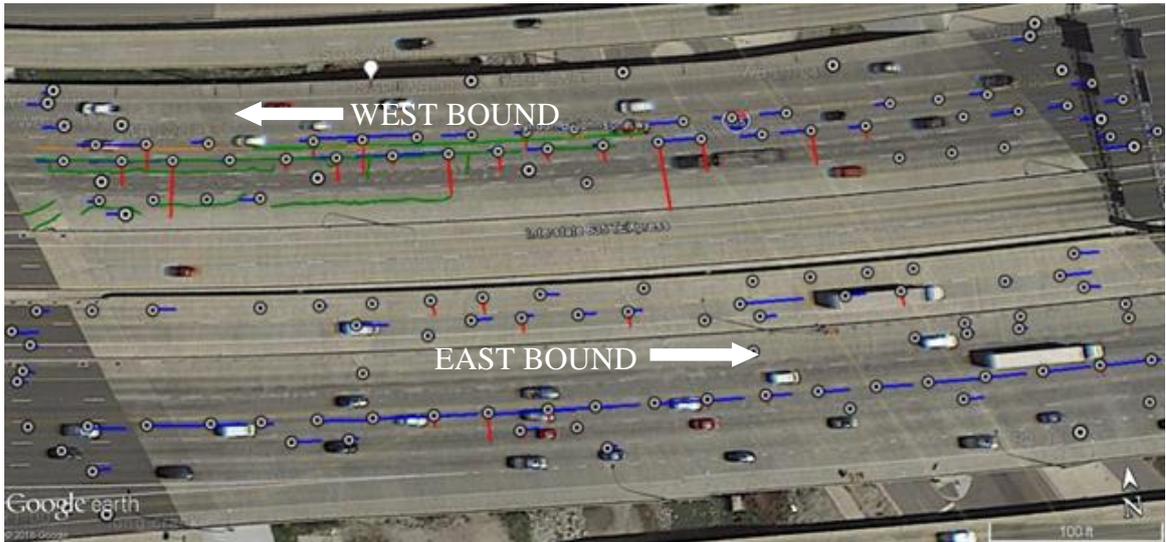
Figure 2: Comparison of cracks detected in February, in blue, and cracks mapped in the following months (in green and red).

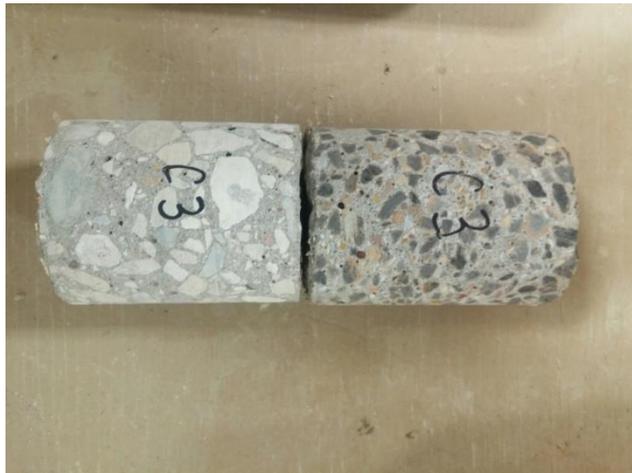
The lack of bonding was confirmed by cores extracted from the slab, where the two concretes, the original one from the 1960's (whiter) and the light weight concrete overlay (much darker) could clearly be distinguished and were easily separated by the interface. This feature was also observed during repair works. Because of the lack of bonding between the overlay and the original slab, instead of a thicker monolithic element the deck was performing as two separate slabs, one on top of the other. Furthermore, since the reinforcement of the overlay is placed near the bottom, this slab has virtually no resistance to negative bending, which explains why large uncontrolled longitudinal cracks appear on either side of the girders.

Figure 3: Core extraction

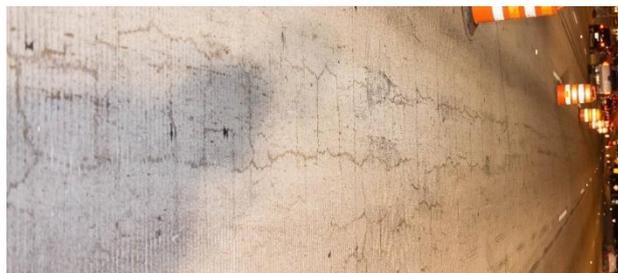
- The formation of the longitudinal cracks leaves a transversally unsupported concrete strip, on which truck wheel loads will generate longitudinal bending whose value will be increased by the possible gaps between the original slab and the overlay. It is likely that this strip will try to support itself on the transversal reinforcement bars which are placed over longitudinal bars placed directly on the original slab, forming, again, stiff points. Since the overlay lacks longitudinal reinforcement near its top fibre, uncontrolled cracks will form transversally where negative bending occurs. Most likely, this would be over the points where there is transversal reinforcement. This seemed to be what was currently occurring on the East-Bound lanes, where cracks seem to mirror the reinforcement spacing, as can be seen in the photograph of Figure 4.

Figure 4: Cracking pattern in one of the East-bound lanes

- As a result, the concrete overlay is divided into rectangular chunks, essentially broken at their edges. The fact that the crack widths are very large due to the lack of reinforcement makes them vulnerable to deterioration from passing traffic. Their width increases due to repeated loading and impact, forming even more cracks and eventually destroying the concrete.

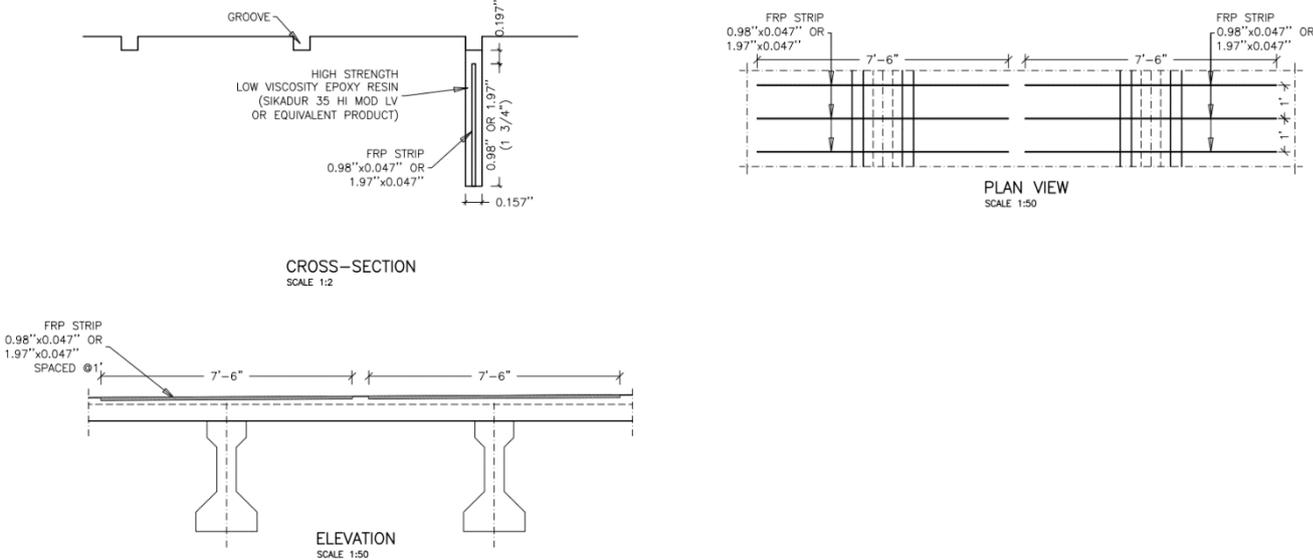
Figure 5: Reinforcement using NSM FRP strips

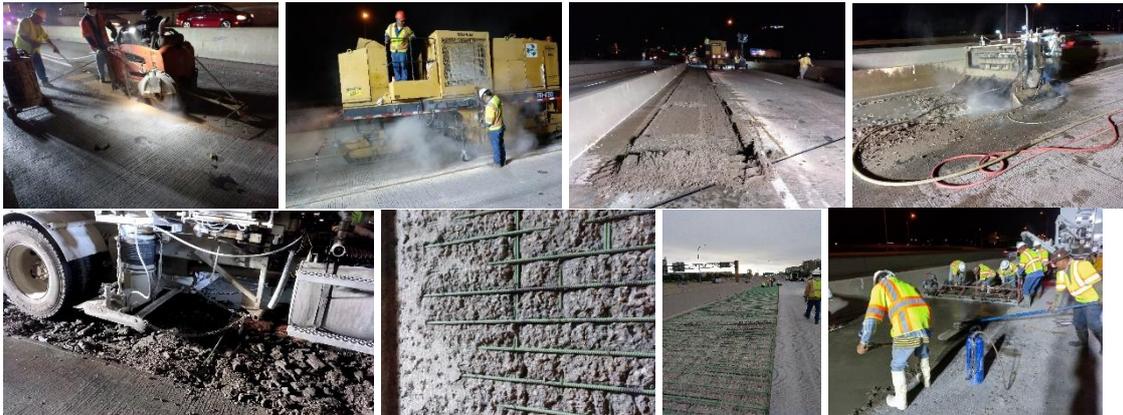
- Marking of the area to be demolished.
- Saw cutting of the perimeter.
- Milling of the concrete to a depth of about 3".
- Hydrodemolition of the rest of the overlay, until full removal of the defective bonding agent. The remaining interface surface was roughened using pneumatic hammers where the roughness obtained from hydrodemolition was insufficient.
- Replacement of the overlay reinforcement.
- Concreting and curing.

Figure 6: Demolition and reconstruction of overlay – from left to right, top to bottom: Saw cutting of demolition perimeter, milling machine, result of milling, hydrodemolition machine, aspirator truck helping clear debris, left-over rough surface showing original slab, new reinforcement mat in place, and concreting.

For each operation, the reconstruction process began at 21:00 hours on Friday morning and had to be completed, achieving a minimum concrete resistance of 19.3 MPa, by 6:00 on Monday morning, with 24-hour shifts, and involved the following phases (see Figure 6):

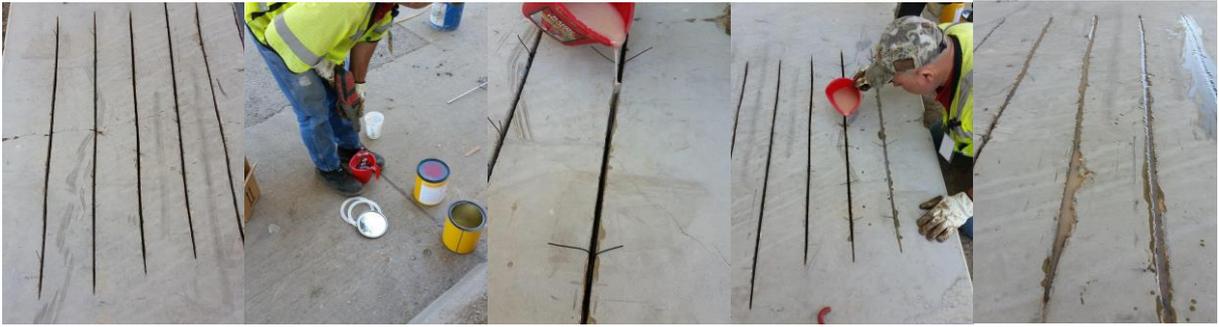
Figure 7: Test installation – from left to right: saw cuts, mixing of epoxy resin, FRP strip introduced and maintained in place using wires, filling of the slot with epoxy resin and result

Figure 7 shows the tests that were carried out to demonstrate the procedure before implementation on the bridge, and Figure 8 shows a saw cut of the test slab, where the FRP strip is well placed and fully monolithic with the slab.

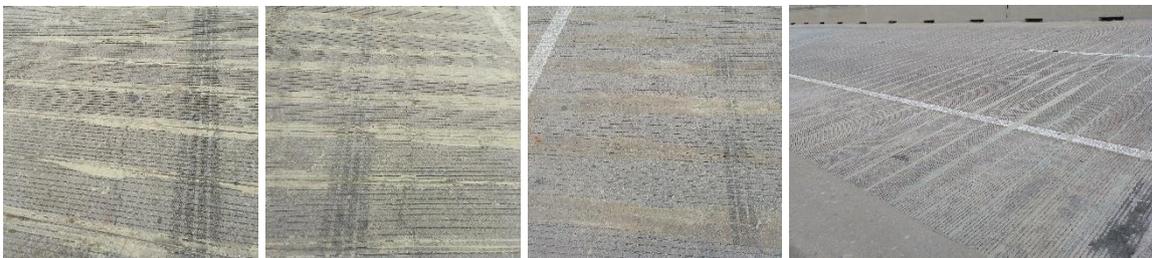
Figure 9: Area repaired after 6 months or traffic. On the two pictures on the left one of the large longitudinal cracks along the beam can be observed being crossed by the FRP strips. No further deterioration was observed since the installation of the NSM FRP strips.

Due to the innovative character of the repair proposed, the area reinforced with NSM FRP strips will be monitored every 6 months. The outlook is good as the engineering team had a chance to supervise the behaviour of an area that was reinforced 6 months previously when supervising one of the overlay reconstruction operations and there was no observable deterioration since the installation of the FRP strips (see Figure 9).

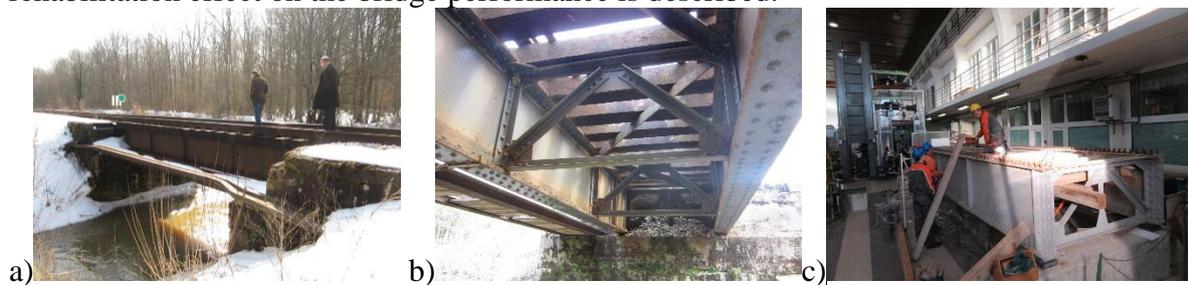
Figure 1: Original bridge on site (a, b) and in the lab (right)

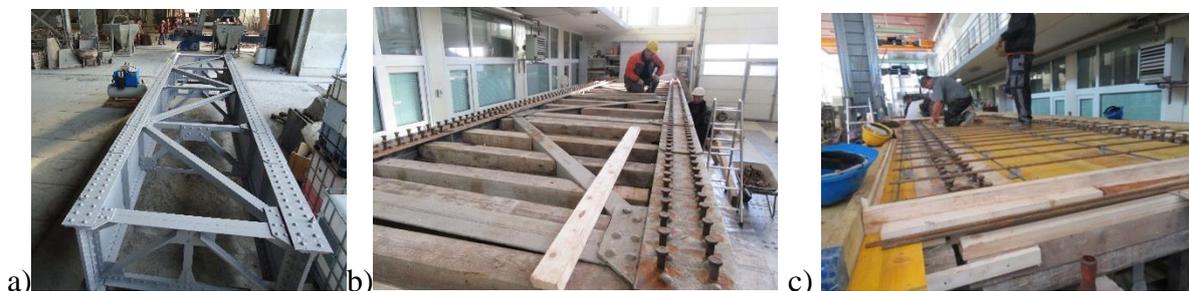
The concrete slab was in the transverse direction reinforced with re-bars of $\phi 12$ mm at a spacing of 250 mm. The reinforcement was placed 2 cm under the designed upper surface of the slab.

Figure 2: a) Bridge cleaned and painted, b) Welded studs, c) Secondary reinforcement and the formwork

The formwork for the slab was set-up as it would be done on-site, i.e. the formwork was supported by the steel girders only (Figure 2c).

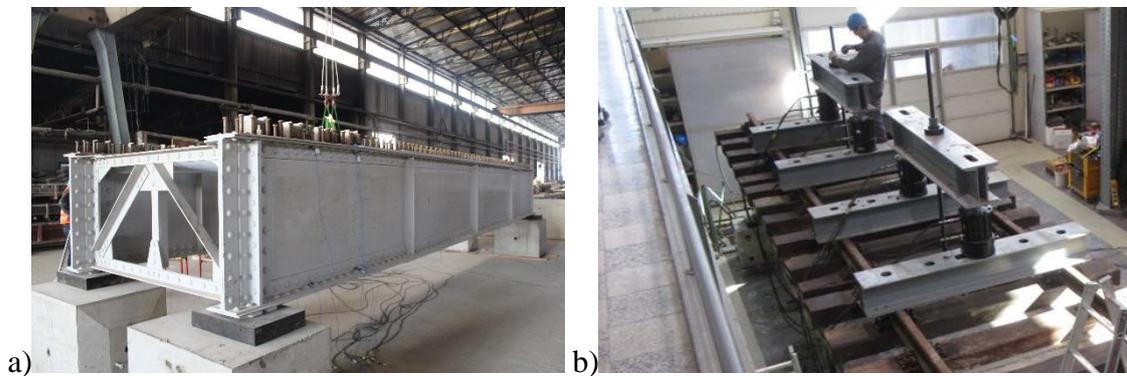
Figure 1: Bridge before deck casting with welded studs on the upper girder flange (a) and bridge with UHPFRC deck, sleepers and tracks mounted with sensors and testing equipment in the lab (b)

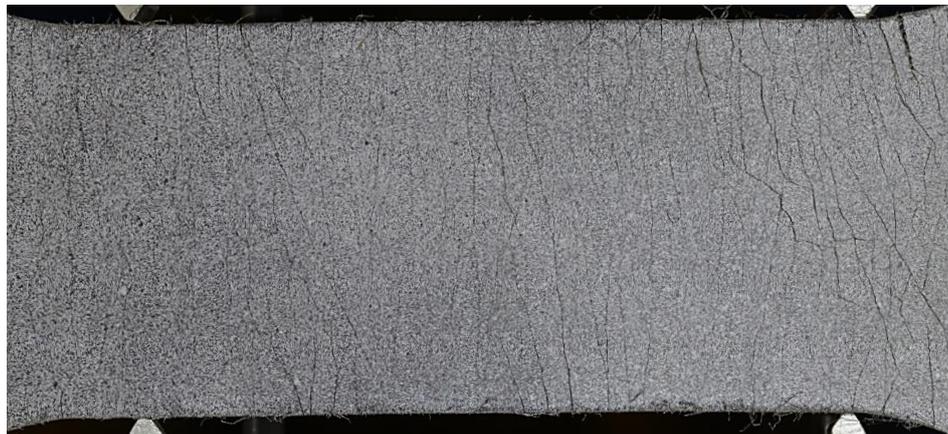
Figure 2: Close-up of the cracked surface of the ECC dogbone specimen after tensile testing. The longitudinal distance between pins is 110 mm and the transverse is 50 mm.

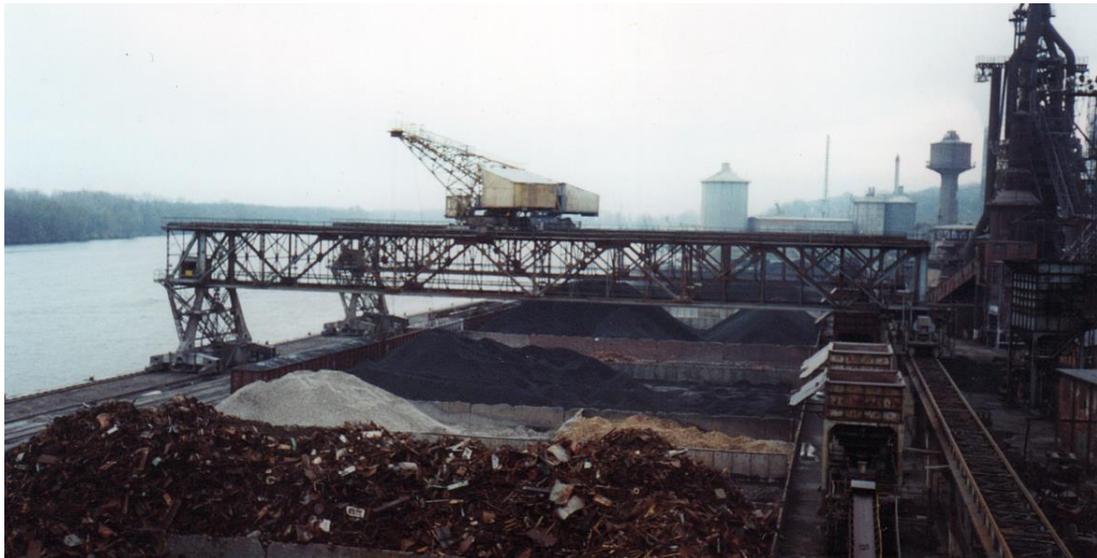
Figure 1: Semi-gantry cranes on the port wharf: a) general view, b) structure scheme

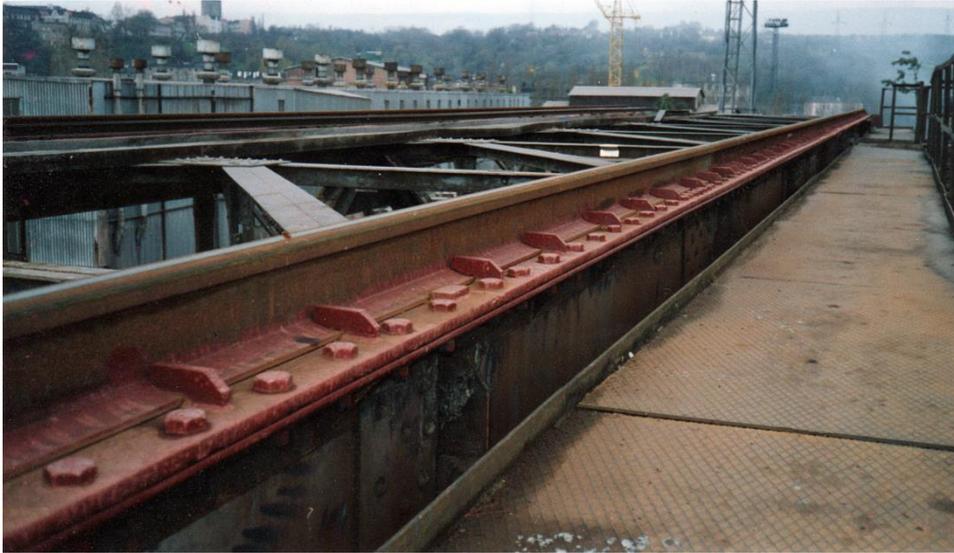
Figure 4: Top chord of semi-gantry crane girder after repair

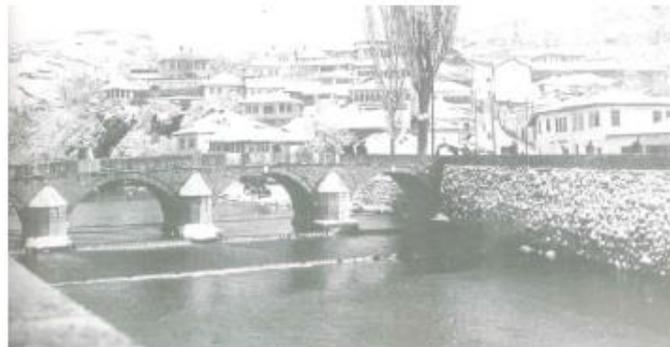
Figure 2: Bridge before removal of the stone railing (korkaluk¹) [10]

The bridge Šeher Ćehajina Ćuprija in Sarajevo was built at the end of the 16th century, in 1585. Very scarce information about this bridge exists. The original bridge had spans of different lengths from 7,20 m to 7,85 m and two access roads. During the construction of the river banks the fifth arch and the two access ramps have been covered. The current total span of the bridge is 39,55 m. It can be assumed, with a high degree of correctness, that the foundations were constructed of timber cross beams as is the case in Emperor's [8], and bridge in Konjic and Mehmed-paša Sokolović bridge in [9]. Figure 2 shows the bridge before the removal of the stone railing.

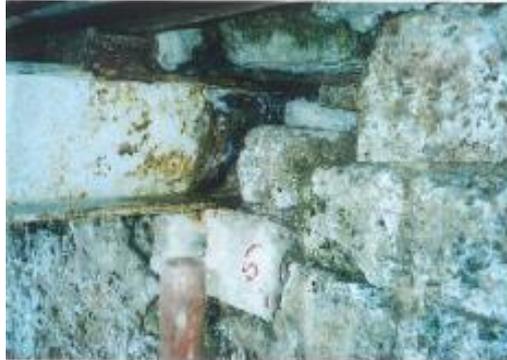
Figure 3: Corrosion of the steel and carbonization of stone [13]

After numerous on-site investigations, testing of materials on the bridge rehabilitation processes started taking into account the ICOMOS regulations and respecting the principles if the Venice Charter [12]. During the investigation process degradation of stone material was noted. Carbonization and corrosion of the stone was depicted caused by the corrosion of the steel girders which were located on the arch for the widening of the pedestrian path on the bridge deck (see Figure 3). Additionally, vertical cracks on the abutment and diagonal cracks on the arch of the bridge were noted which can be connected to the over loading of the bridge, as the bridge was used for vehicle traffic as well, for which it has not been constructed in the

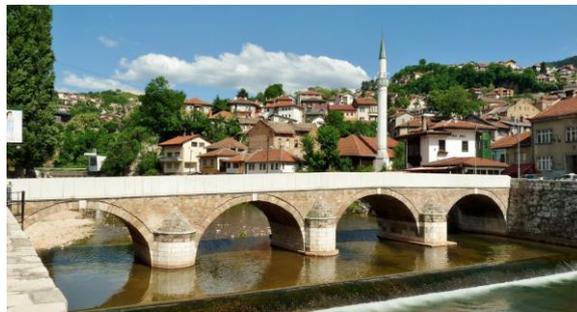
Figure 4: Šeher Ćehajina ćuprija today

first instance. The reconstruction of the bridge took place from 1999 to 2001 and the bridge gained its original view as shown in Figure 4.

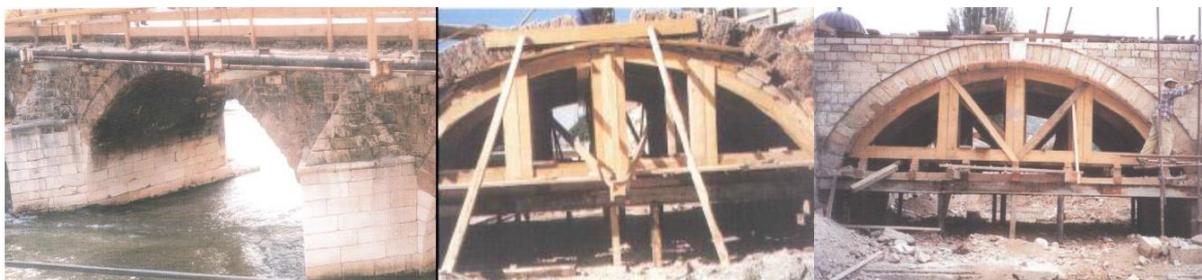
Figure 5: System of the study-background and foreground [10]

The Management series EN ISO 14040 [24] were used as the guidelines to complete the LCA. In undertaking the LCA study the model was formulated around the real Šeher Ćehaja bridge which has been rehabilitated so this data has been taken in the account during the investigation, as the structure is a cultural heritage and only rehabilitation measures are foreseen. Life cycle inventory data that regarding materials important for arch bridges: stone, hydrated lime, fill material was taken into account in respect to their environmental impact and processes. In order to determine the environmental impact a LCA was conducted taking into account only the 1999 reconstruction scheme. In order to conduct this analysis all available data was considered, from consultation of the available structure drawings that were obtained through from the conservation bodies, visit to the site, investigation of all the reports that were conducted during the rehabilitation process. During the rehabilitation process it was noted that the bridge was constructed of different types of stone (tufa, lime stone). Most of the work was concentrated on the replacement of stone, fill material, filling of the joints with mortar, placement of the new stone on the carriage way and new railings now made of stone (Figure 5). On the basis of all the available data from the reports that were conducted during the rehabilitation process the accurate amount of each material that was used during the rehabilitation process was noted. Requirements in the energy usage were taken into account needed for different process in the rehabilitation procedure. In that respect the data was available regarding the construction of the mortar that was done on the site enabling the calculation of the request for energy for a mixer on the site. The next step was filling in the material on the arch and its compaction by the use of a small roller not educing too much vibrations in order not to cause any potential damage to the structure. As well the transport of the debris to the deposit site and transport of the material to the site was taken into account. The entire area of the bridge was checked regarding the quality of the stone masonry. In the reports a clear data was available regarding the amount of stone elements that had to be replaced and the amount of repointing that has been done.
