Demonstration Laboratory Testing of CLT Timber Frame Joint with Glued-in Steel rod

Construction Testing Laboratory

Faculty of Civil Engineering

1st WORKSHOP
of the VETROLIGNUM project

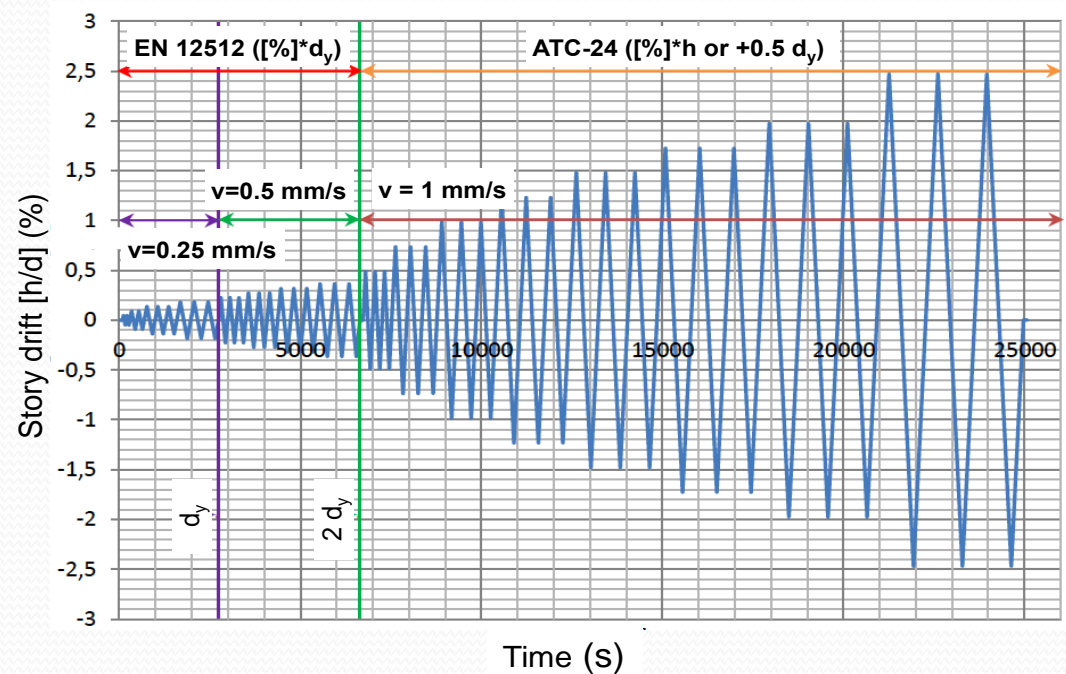
- The cyclic horizontal load protocol is composed of three sets of rules:
 - Definition of a yielding point (the Yasumura and Kawai (1997) procedure for timber shear wall)
 - Cyclic protocol EN 12512:2001 in the range of low displacement amplitudes (up to $2d_y$)
 - Cyclic protocol ATC-24 in the range of high displacement amplitudes (over $2d_y$)

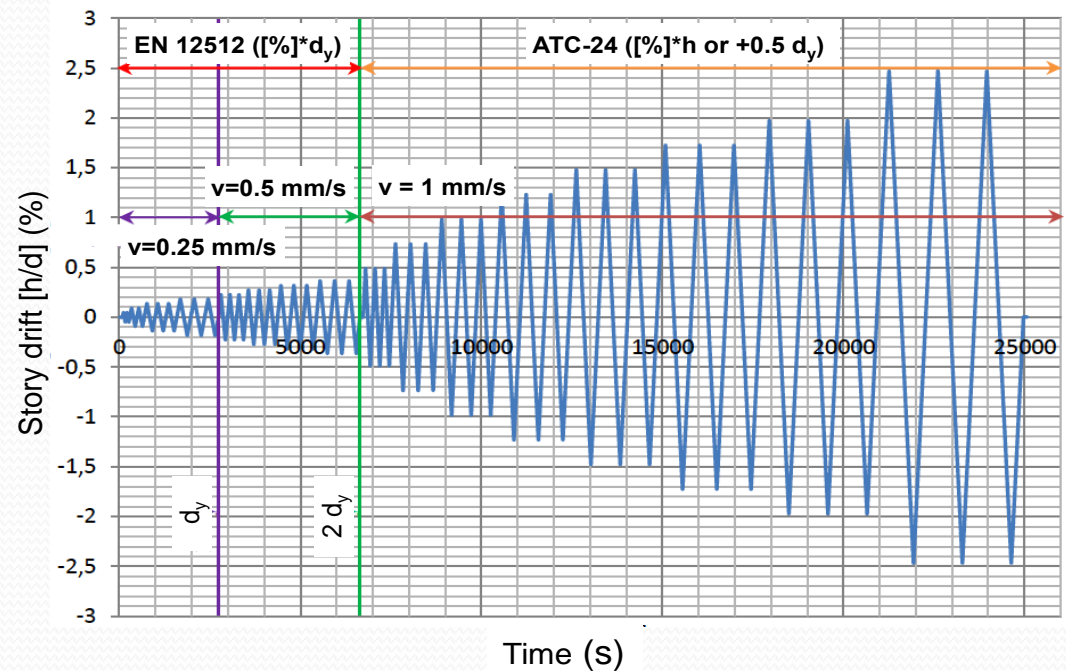
- After reaching the limit of $2d_y$ the speed of actuator increased to 1,00 mm/s
- Three cycles of loading were performed for each selected amplitude
- Testing ended when the complete failure of joints was achieved

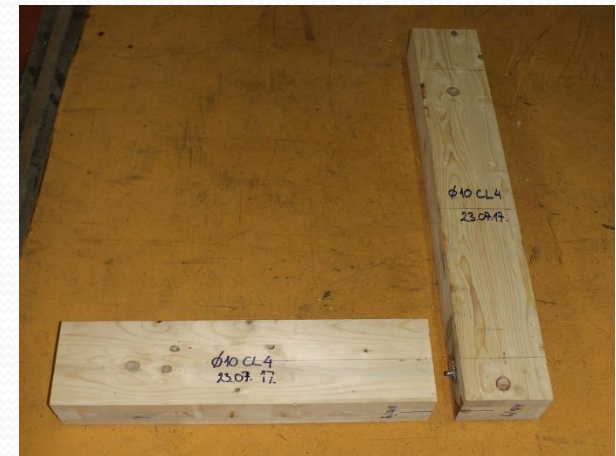
- for $\Phi 10$ mm threaded glued-in steel bar and *Setup B*

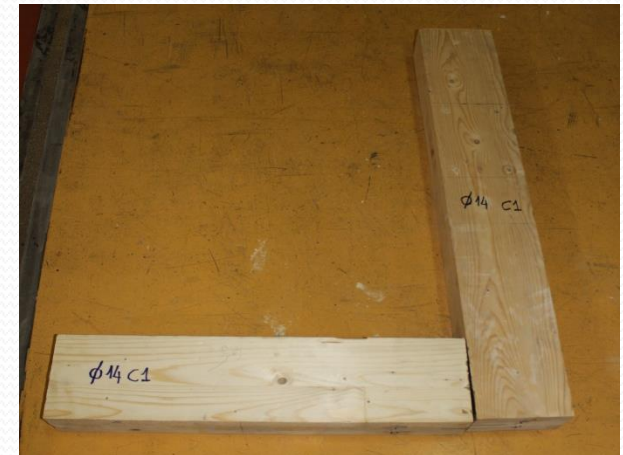
- for $\Phi 14$ mm threaded glued-in steel bar and *Setup B*
