Project title: **Innovative lightweight cold-formed steel-concrete composite floor system**

Acronym: **LWT-FLOOR** Project ID: **UIP-2020-02-2964**

5<sup>th</sup> LWT-FLOOR Project Workshop, Zagreb, 18<sup>th</sup>-19<sup>th</sup> December 2025

# Performance of LWT-FLOOR Steel-concrete Composite Floor Beams: Full-Scale Experimental Study

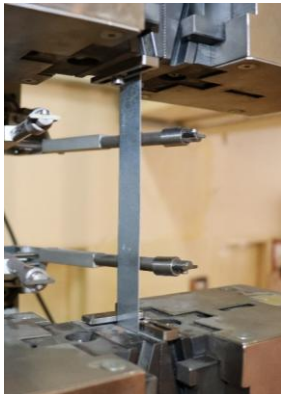
**Steel sheets:** 0,8 mm, 1,0 mm, 1,25 mm, 1,5 mm, 2,0 mm, 2,5 mm and 3,0 mm, steel grades DX51 and GD 350 for 3,0 mm only, **135 specimens**

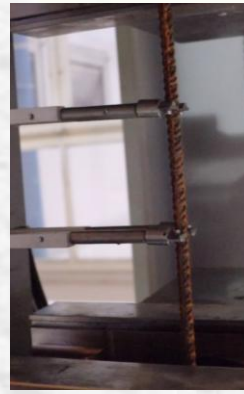
**Reinforcement:** bars 8 mm and mesh 10 mm, B500, **10 specimens**

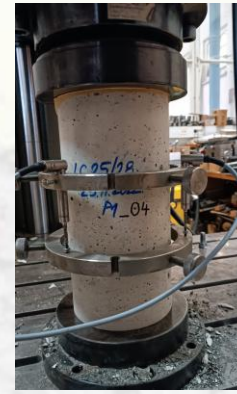
**Concrete:** LC 20/22 and NC 20/25, **43 specimens**

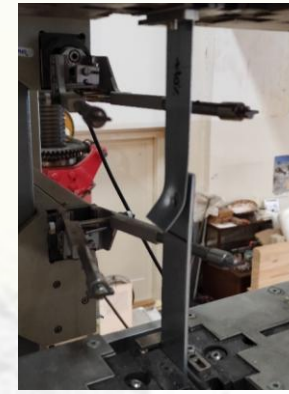
**Spot welds:** different combinations of steel sheet thicknesses, **558 specimens**

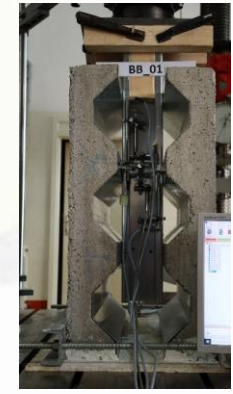
**Shear connections:** different types (with concrete dowels (LC and NC) and demountable types with and without additional corrugated web (NC only)), **30 specimens**

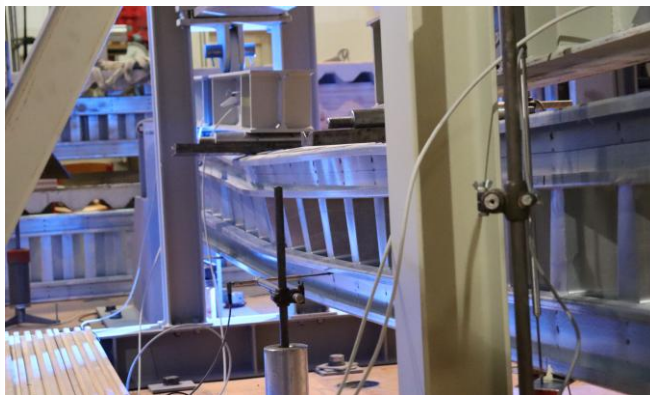
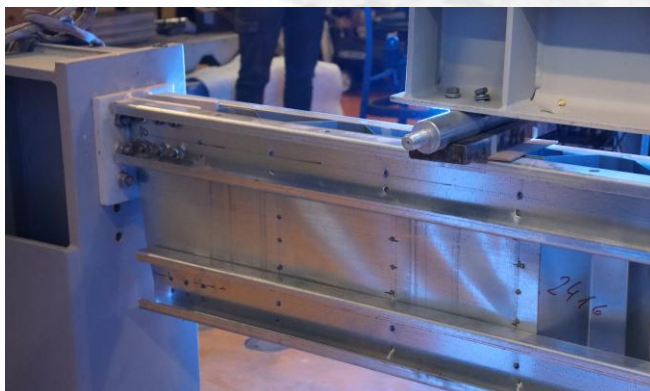
- SB1 and SB2 failed due to local/distortional buckling of the channel section, lateral deflection due to buckling of the channel sections and shear plate buckling.

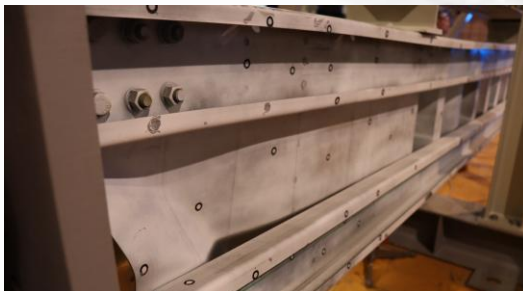
- SB3 failed due to non-ductile interfacial fracture of the spot welds in the area connecting the thicker channel sections (3.0 mm) to the shear plate and corrugated web (1.5 mm) which interrupted the formation of shear fields in the shear plate and corrugated web.

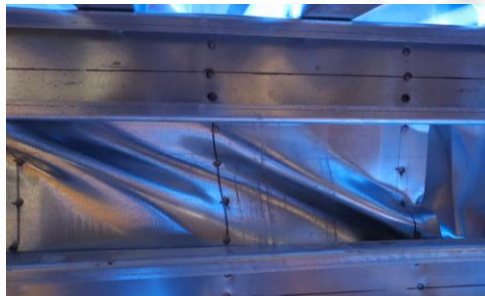
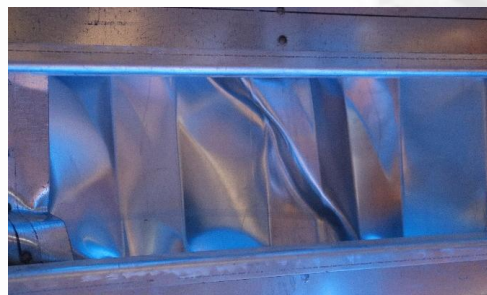
- CB1 and CB2 failed due to shear plate buckling and corrugated web buckling with large midspan deflection.
- No surface cracks were observed in the concrete slabs for any of the composite beams, although the separation between the concrete slab and the profiled steel sheeting was observed.
