The July 10 2000 Payatas Landfill Slope Failure

ABSTRACT: *This paper presents an investigation of the slope failure in the Payatas landfill in Quezon City, Philippines. This failure, which killed at least 330 persons, occurred July 10th 2000 after two weeks of heavy rain from two typhoons. Slope stability analyses indicate that the raised leachate level, existence of landfill gas created by natural aerobic and anaerobic degradation, and a significantly over-steepened slope contributed to the slope failure. The Hydrologic Evaluation of Landfill Performance (HELP) model was used to predict the location of the leachate level in the waste at the time of the slope failure for analysis purposes. This paper presents a description of the geological and environmental conditions, identification of the critical failure surface, and slope stability analyses to better understand the failure and present recommendations for other landfills in tropical areas. In addition, this case history is used to evaluate uncertainty in parameters used in back-analysis of a landfill slope failure.*

Reference: Jafari, N. H., Stark, T. D., and Merry, S. (2013). *The July 10 2000 Payatas Landfill Slope Failure

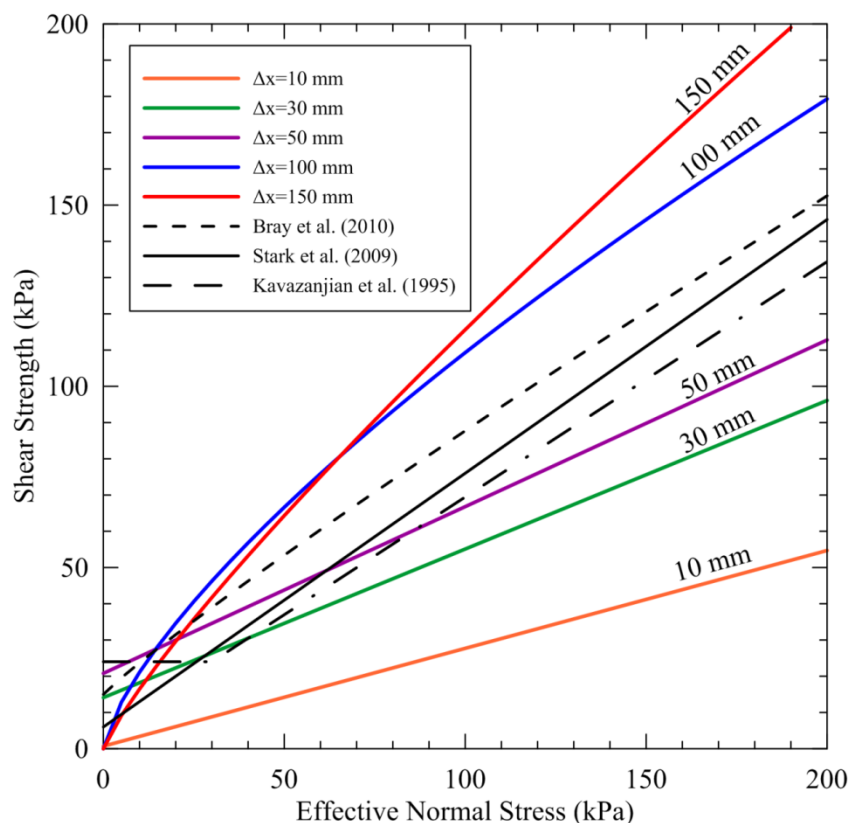
In addition to being dependent on the effective normal stress on the failure plane, the shear strength of MSW is also shear displacement or axial strain dependent and tends to increase with increasing deformation (Eid et al., 2000). Review of existing laboratory data show that most of the laboratory shear tests investigated are not continued to sufficient displacement or strain to mobilize the peak shear strength of the MSW. As a result, Stark et al. (2009) provide MSW shear strength envelopes mobilized at horizontal displacements of 10, 30, 50, 100, and 150 mm. Table 3 shows equations for each strength envelope estimated from direct shear tests, where R^2 values are all above 0.90. Figure 10 compares the shear strength envelopes in Table 2 to envelopes recommended by others (e.g., Stark et al., 2009; Bray et al., 2009; Kavazanjian et al., 1995). As highlighted in Figure 10, all of the recommended envelopes fall between the 50 and 100 mm of shear displacement strength envelopes.

Figure 10. MSW shear strength envelopes.

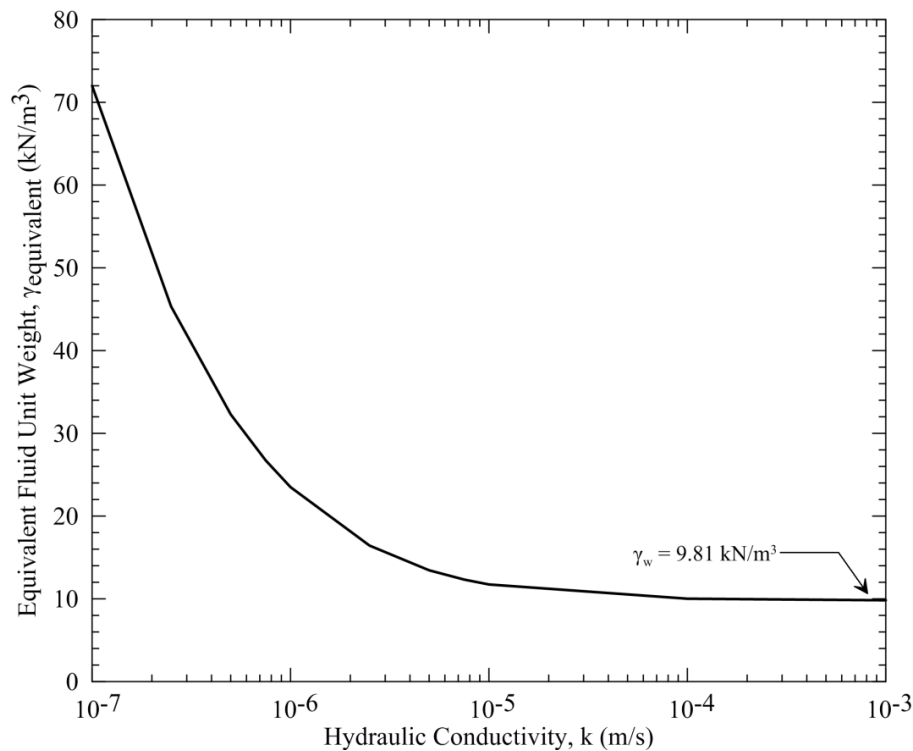
It is hypothesized that landfill gas and leachate pressure reduced the effective stress along the failure surface. Landfill gas, which is dominated by methane and carbon dioxide, is formed as a natural part of anaerobic degradation. In landfills that are sufficiently dry, landfill gas migrates readily through the pore space and is released into the atmosphere with little build-up of pressure in the waste. However, as saturation levels in the waste rise, the permeability of the waste to landfill gas migration decreases. Merry et al. (2006) use a one-dimensional (1-D) column of saturated media where degradable waste exists only in the lowest portion of the column to model this situation. This model shows that below the level of saturation, the steady-state excess gas pressure increases linearly similar to a hydrostatic condition. The combination of hydrostatic leachate pressure and gas-induced pore pressure may be accounted for using an equivalent fluid unit weight for the pore fluid that is artificially higher than water. A subsequent parametric study of the input parameters shows that the equivalent fluid unit weight of the pore fluid is dependent on waste hydraulic conductivity (Merry et al., 2006). The corresponding MSW hydraulic conductivity for this case is assumed to be greater than 1×10^{-5} m/s. Figure 12 shows the relationship between waste hydraulic conductivity and equivalent fluid unit weight of the pore fluid and is used to estimate an equivalent fluid unit weight. The input parameters for Figure 12 are provided in Table 5. The gas generation rate (Q_i) is estimated by Eq. (1):

Figure 12. Dependence of equivalent fluid unit weight, $\gamma_{\text{equivalent}}$, on MSW saturated hydraulic conductivity, $K_{\text{waste,sat}}$

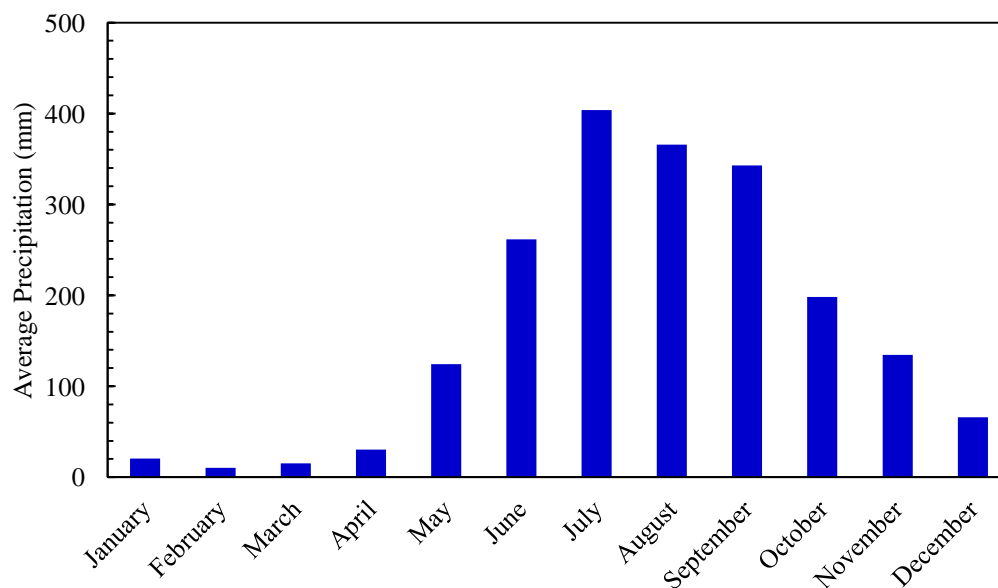
The precipitation database in the HELP model does not provide historical precipitation data for Quezon City, so recorded rainfall data from 1 May through 31 July 2000, was obtained from the Quezon City weather station and imported into HELP. This provides a reasonable simulation of the two months of precipitation immediately preceding the slope failure. Replicating approximate initial moisture conditions before May 1st 2000 involved executing the HELP model for several years prior to the failure. As a result, weather and climate conditions similar to Quezon City were required because this data is not available from the Quezon City weather station. Quezon City, located at 14° latitude, is closer to the equator than the United States and hence, has different climate conditions. Quezon City weather is dominated by high humidity, precipitation, and warm conditions year round. Table 7 presents a summary of the key weather conditions for Quezon City. The HELP program can also generate daily precipitation data using a synthetic weather generator. By entering the normal mean monthly precipitation values of Manila, Philippines shown in Figure 13, HELP generated synthetic precipitation records for 10 years preceding the failure. This synthetic record was used until May 1st of the 10th year, so that the water content and saturation levels reached a reasonable steady state value before applying the recorded data from the Quezon City weather station. From May 1st to July 31st, recorded precipitation values from the Quezon City station (Canty and Associates LLC, 2004) were input to HELP.

Figure 13. Average monthly precipitation for Manila, Philippines from Quezon City weather station (data from www.weather.com).

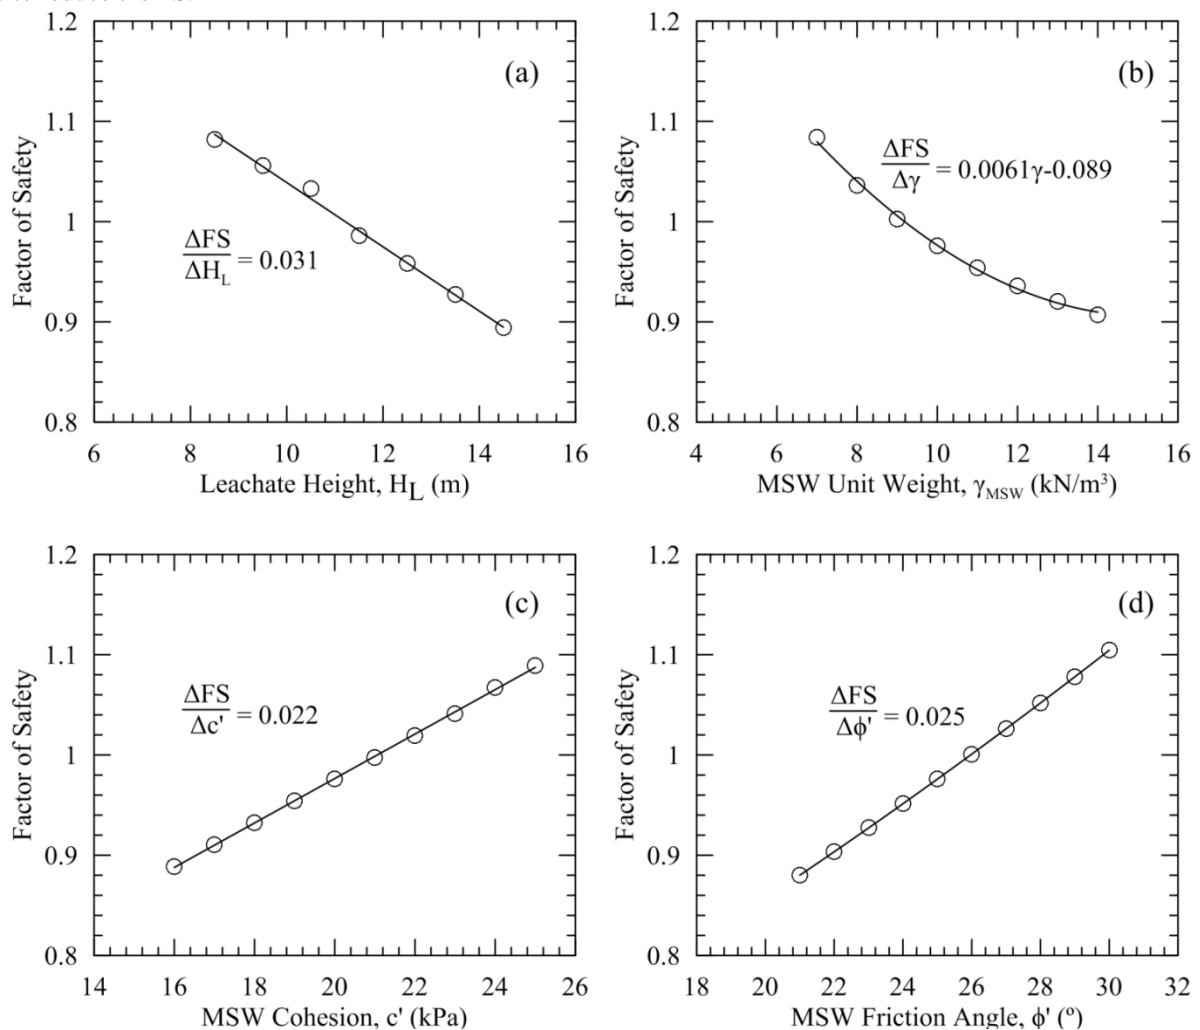
Using site reconnaissance information, pictures, and reports of the wasteslide, an inverse analysis was conducted to estimate the piezometric level at the time of failure. Figures 14(a), 14(b), 14(c), and 14(d) show the sensitivity of the factor of safety for a range of MSW shear strength parameters, MSW unit weight, and leachate level. For each sensitivity parameter, the factor of safety was computed using the circular failure surface in Figure 11(a). In Figure 14, the trend line slope is used to capture the sensitivity of FS to each parameter. For example, Figure 14(a) shows that FS decreases by 0.031 for a 1 m increase in leachate level. Using the trend line slopes for each parameter, the contributing factors leading to failure can be compared. MSW unit weight can increase when rain infiltrates into the waste mass and increases moisture content. The sensitivity of MSW unit weight is a nonlinear relationship shown in Figure 14(b). Figures 14(c) and 14(d) indicate that reducing MSW cohesion and friction, i.e., slopes equal to 0.022 and 0.025, respectively, contributes less to failure than increasing the leachate height (slope=0.031). Thus, Figure 14 suggests that leachate height has the greatest influence to reduce the FS.

Figure 14. Sensitivity of Inverse analysis to MSW input parameters for FS of unity.
