# PART III

## CASE STUDIES AND INCIDENTS

### SELECTION 15 Fire Investigation Report: World Trade Center Explosion and Fire, New York, New York, February 26, 1993

MICHAEL S. ISNER AND THOMAS J. KLEM

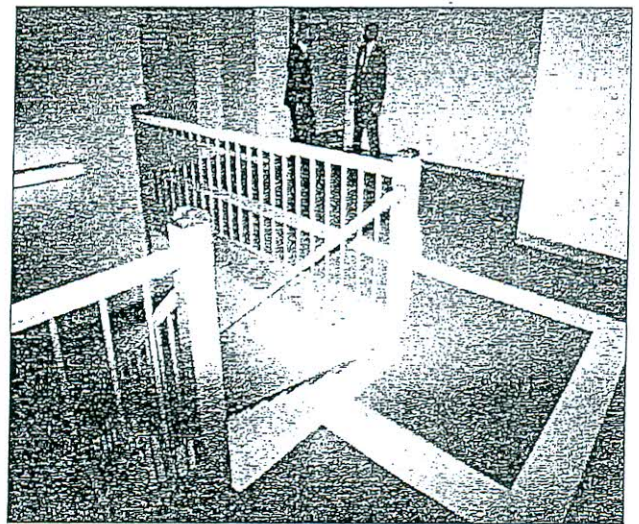
Since the 1993 incident, exit paths in the stairwells have been marked for safety with phosphorescent paint.

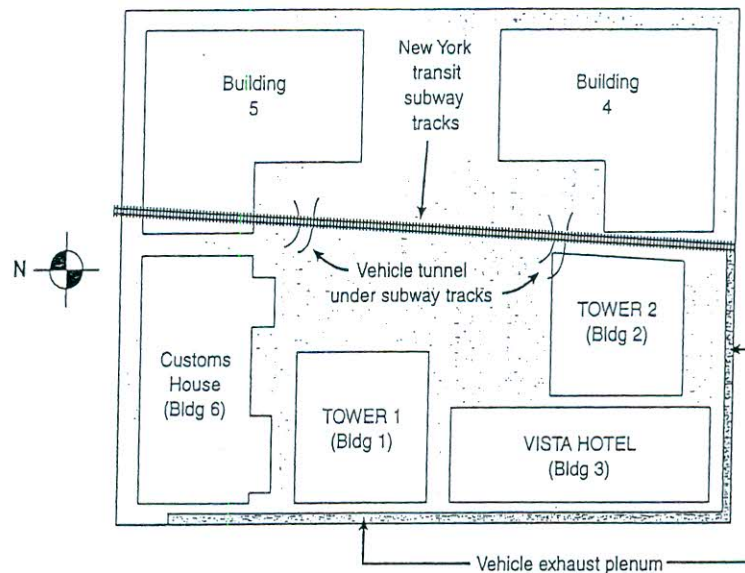
FIGURE 2 *World Trade Center Complex  
B-1 Level Simplified Plan*

Below the Concourse, there are six basement levels, i.e., B1–B6. The B1 and B2 levels exist below Buildings 1–6. Truck loading docks for these six buildings are located on the B1 level. The police and fire command center for most of the complex, maintenance shops and offices, several mechanical rooms, and other rooms associated with the high-rise buildings above are also located on the B1 level. An enclosure for the Broadway–7th Avenue (#1/9) lines of the New York City Transit Authority passes through the B1 level<sup>1</sup> and as a result, the B1 level below Buildings 4 and 5 is separated from the B1 level below the rest of the complex. (See Figure 2.) Two vehicular tunnels run below the subway enclosure and allow trucks to drive between the B1 levels on each side of the subway tracks. The B2 levels under Towers 1 and 2, the Vista Hotel, and the Customs House contain public parking and utility areas; the B2 level under Buildings 4 and 5 contain only utility spaces.

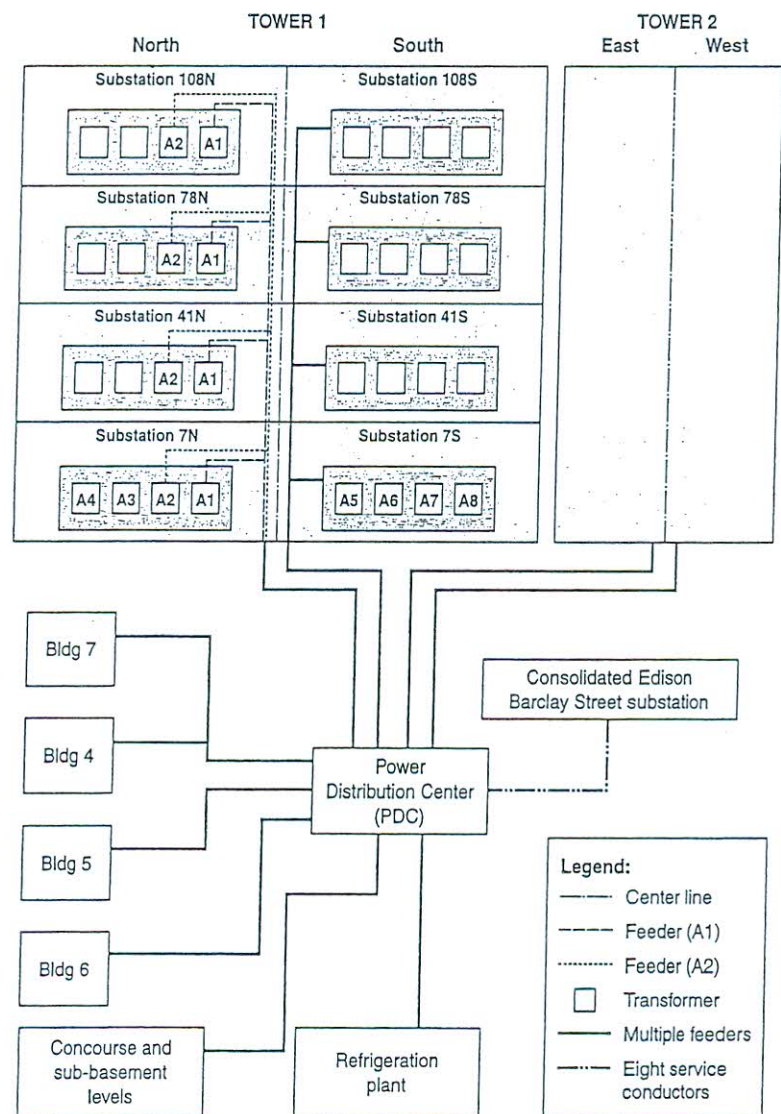
FIGURE 5 *Simplified Electrical Schematic*

Shortly after starting, however, the emergency generator engines overheated and shut down because components of their cooling system were damaged by the explosion. Approximately 1 hour and 15 minutes into the incident, all remaining electrical power to the affected buildings within the complex was shut down.

Service conductors entering the complex are routed through a concrete encased duct bank which is located below an entrance/exit ramp for the B1 level. Once inside the complex, the duct bank makes a vertical transition from below the entrance/exit ramp to the B1 level ceiling. Still enclosed in concrete, the ceiling-level duct bank enters the service equipment vault, called the primary distribution center (PDC). Once inside the PDC, the service conductors drop into eight switchboards which are grouped into pairs and are separated by gypsum wallboard partitions. Electrical power from the PDC is provided to Towers 1 and 2, Buildings 4 and 5, the Customs House, the Concourse level, and to all basement levels (see Figure 5) by several electrical feeders. These feeders are protected by 1200-ampere circuit breakers with protective relays to disconnect the power when a fault occurs. The feeders for Building 7 are tapped off of the Building 4 feeders; therefore, the substation relays protecting Building 4 also protect the feeders for Building 7.

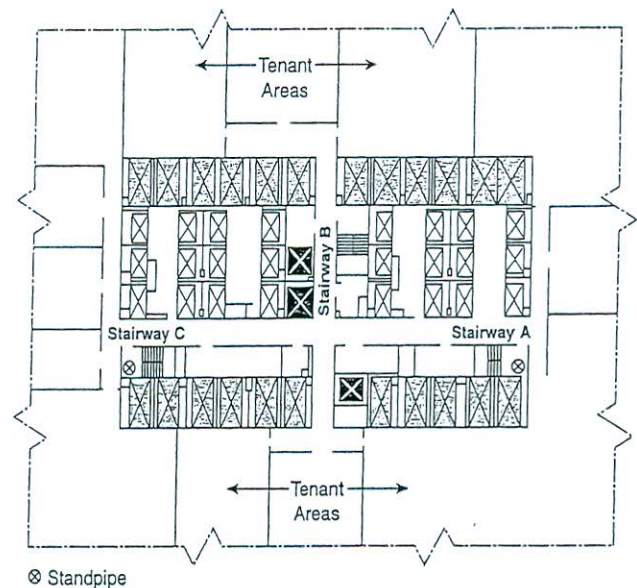
FIGURE 7 Exit Stairway Locations in Tower Core Area

Each of the towers has three enclosed stairways which are located in the core area of the tenant floors. (See Figure 7.) Two stairways (Stairways A and C) discharge onto the mezzanine level in the atrium/lobby area of the respective tower. Several doors provide direct access to the exterior of the building from the mezzanine. The third stairway (Stairway B) in each tower discharges into the atrium/lobby on the Concourse level.
