SHM on Cultural Heritage Structures

University of Zagreb, Faculty of Civil Engineering
Department of Engineering Mechanics

03.02.2016.

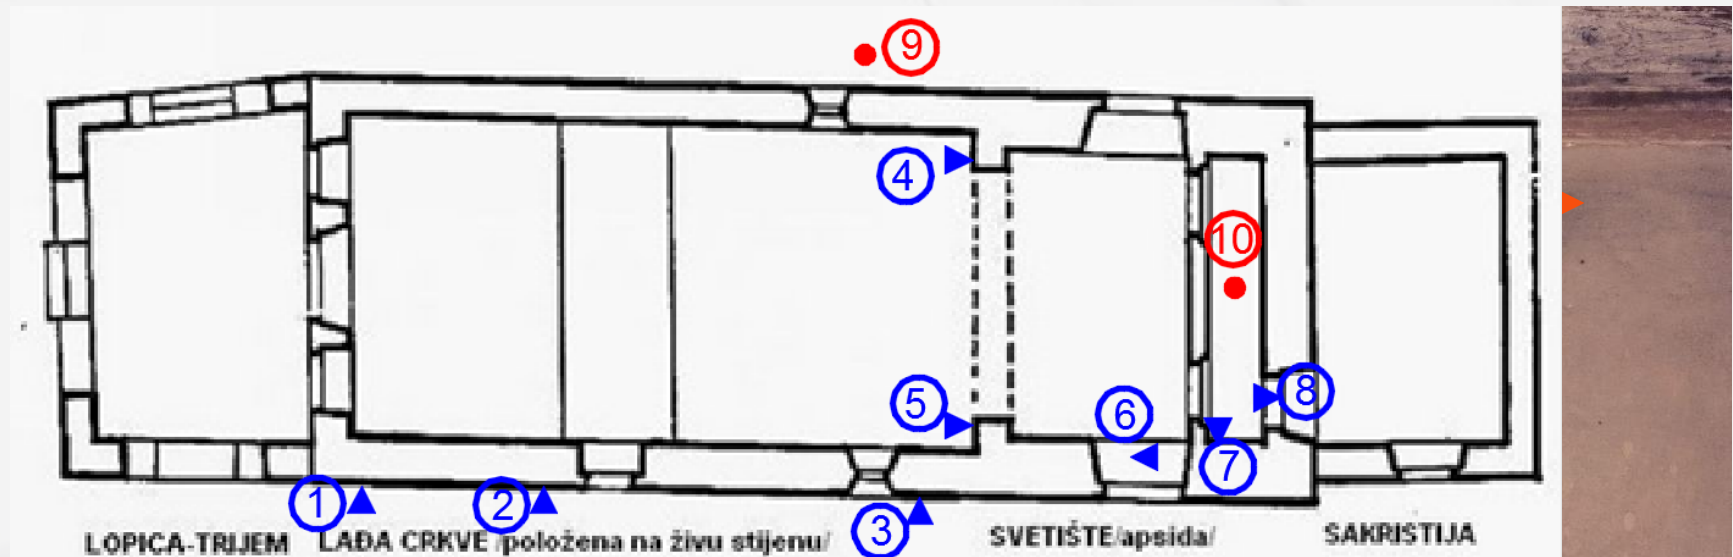
Eight inductive transducers were installed which measured expansion and contraction of cracks on load bearing elements.

In addition, inner and outer temperature was recorded during measurements.

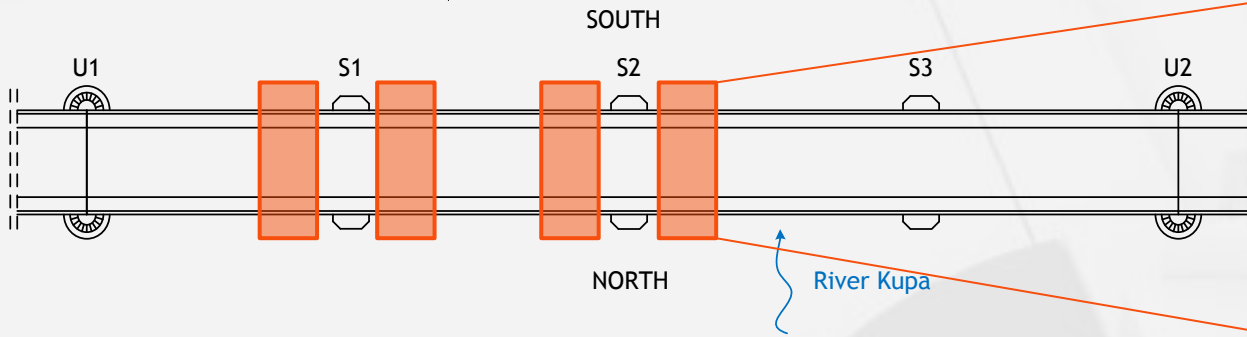
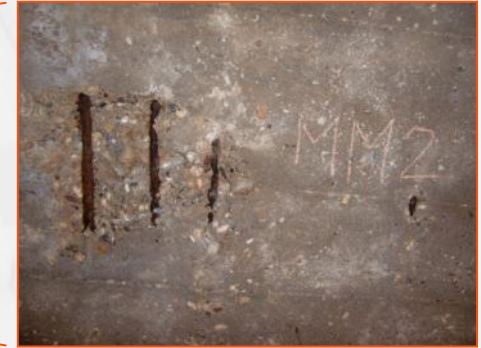
3] Corrosion parameters of structural elements of the bridge were measured.

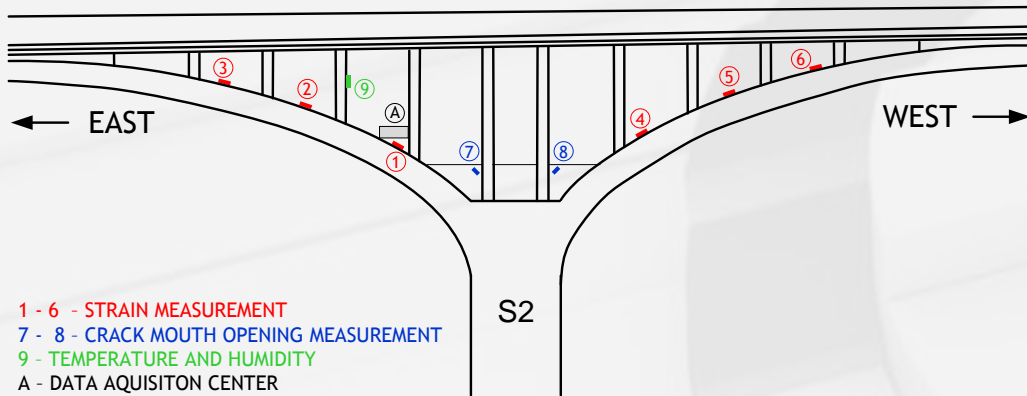
4] Structural health monitoring was installed.

Measured parameters:
displacements
strains
cracks opening
temperature
and relative humidity

1 - 6 - STRAIN MEASUREMENT
7 - 8 - CRACK MOUTH OPENING MEASUREMENT
9 - TEMPERATURE AND HUMIDITY
A - DATA ACQUISITION CENTER

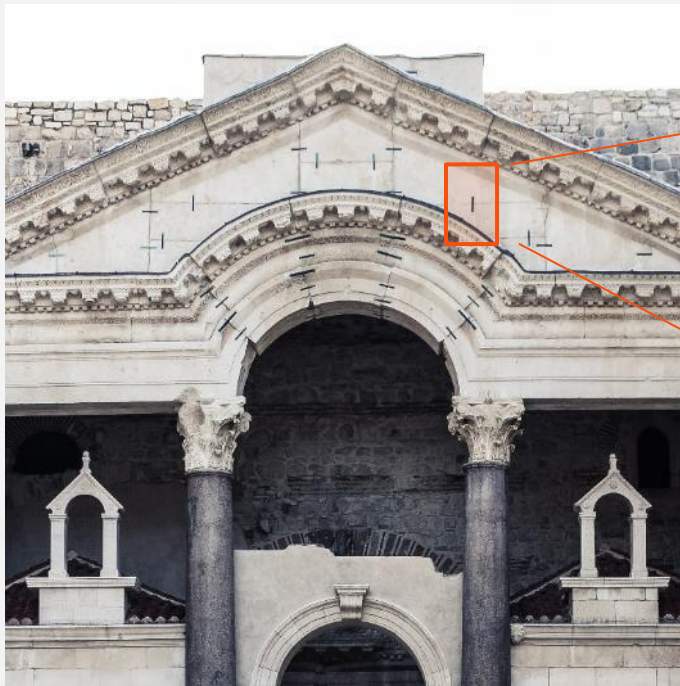
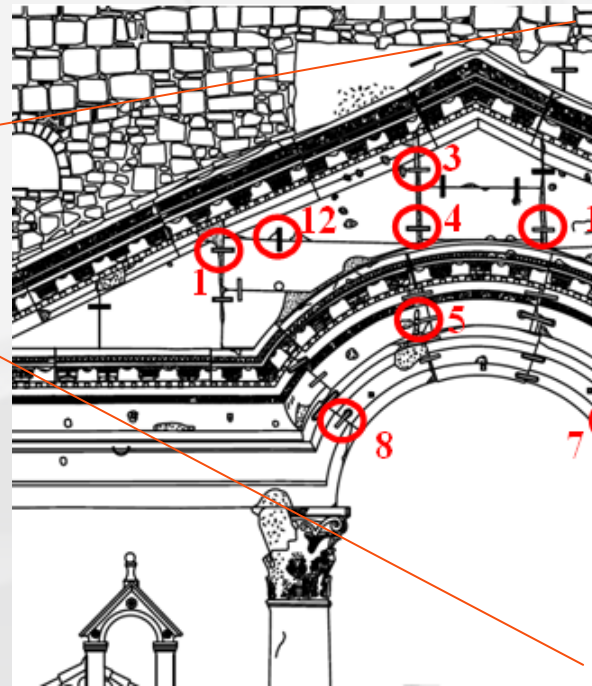
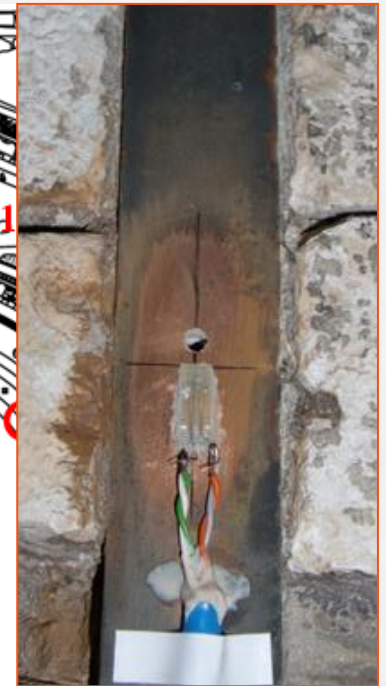
1] The hole drilling method was used to measure the magnitudes of residual stresses. The residual strain measurement was performed in order to determine the actual force in the copper clamp (12 measuring points).

In addition, mechanical properties of the copper clamp were determined using tensile test.

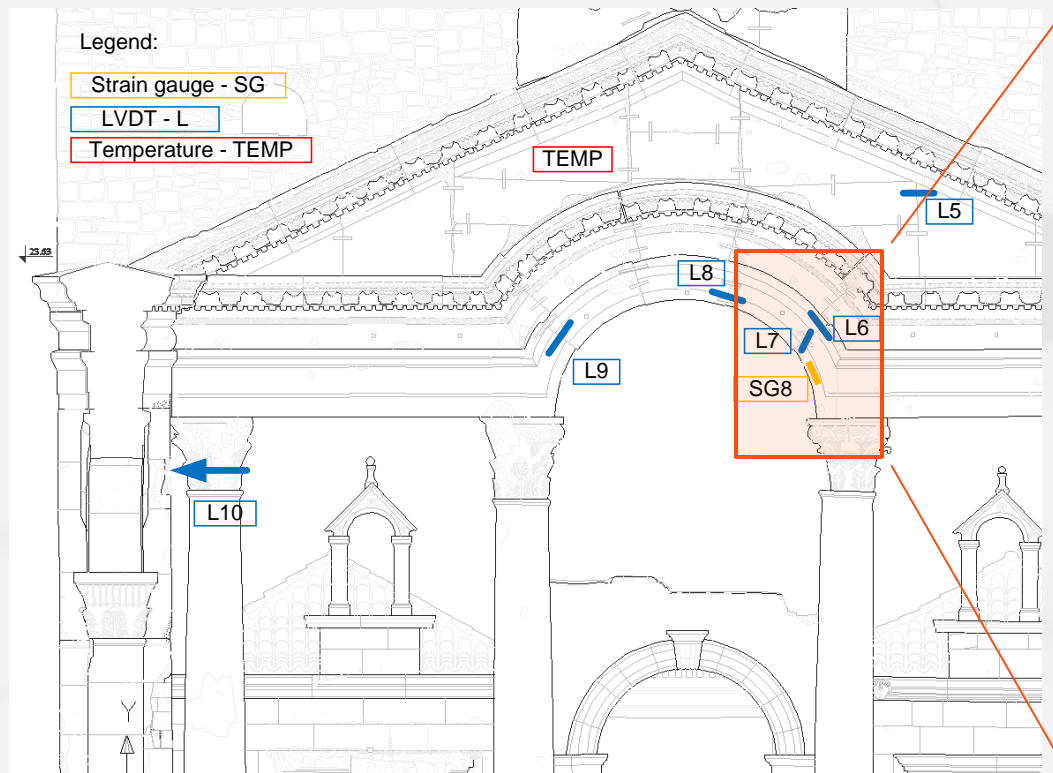
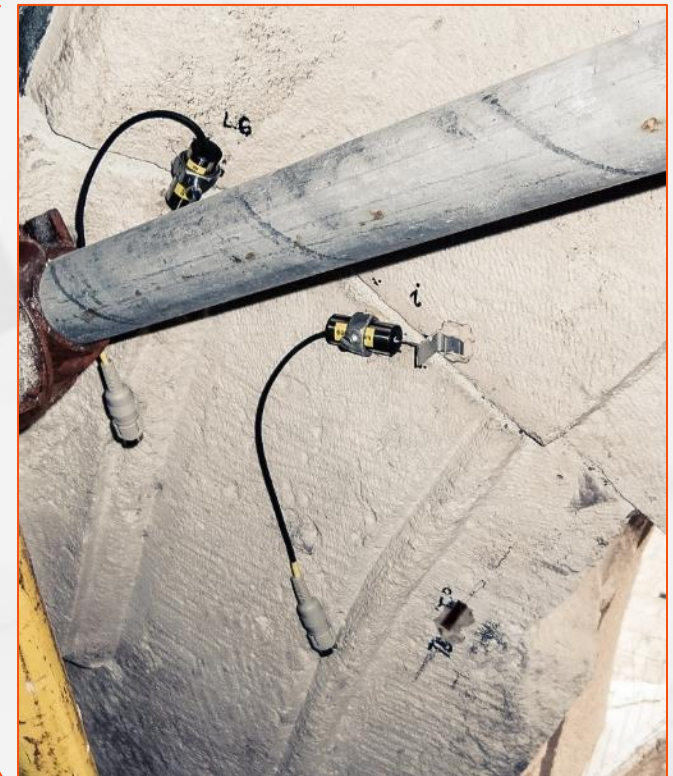
2] Continuous static structural monitoring based on LabVIEW and CopmaqDAQ designed to capture the displacements, strains and temperature at discrete nodes of a structure was installed.

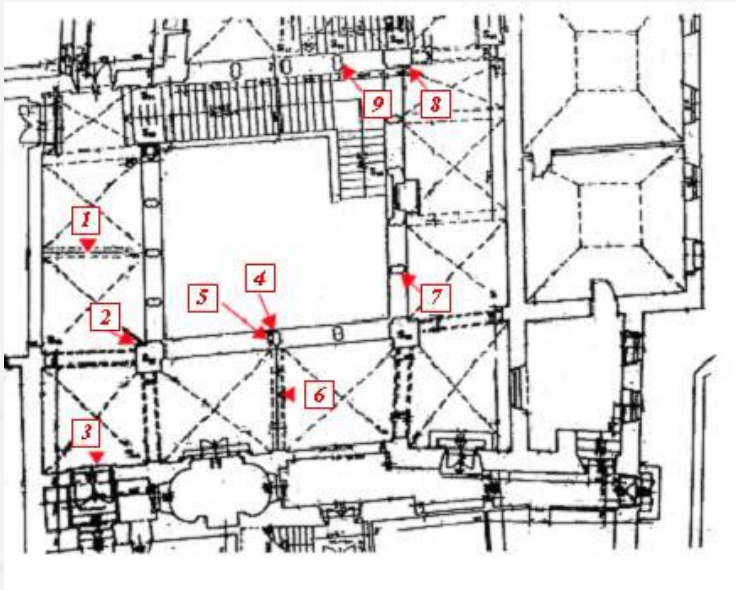
Measuring points

At nine representative and characteristic cracks sensors for monitoring of crack opening were installed. As the majority of sustained damages and cracks were located at the atrium area in the center of the palace, and further more at the small twin columns, that is where the most of the measuring points were located and most of the sensors installed. Two sensors (1st and 6th) were installed at the steel tie rods of the first floor in perpendicular directions.

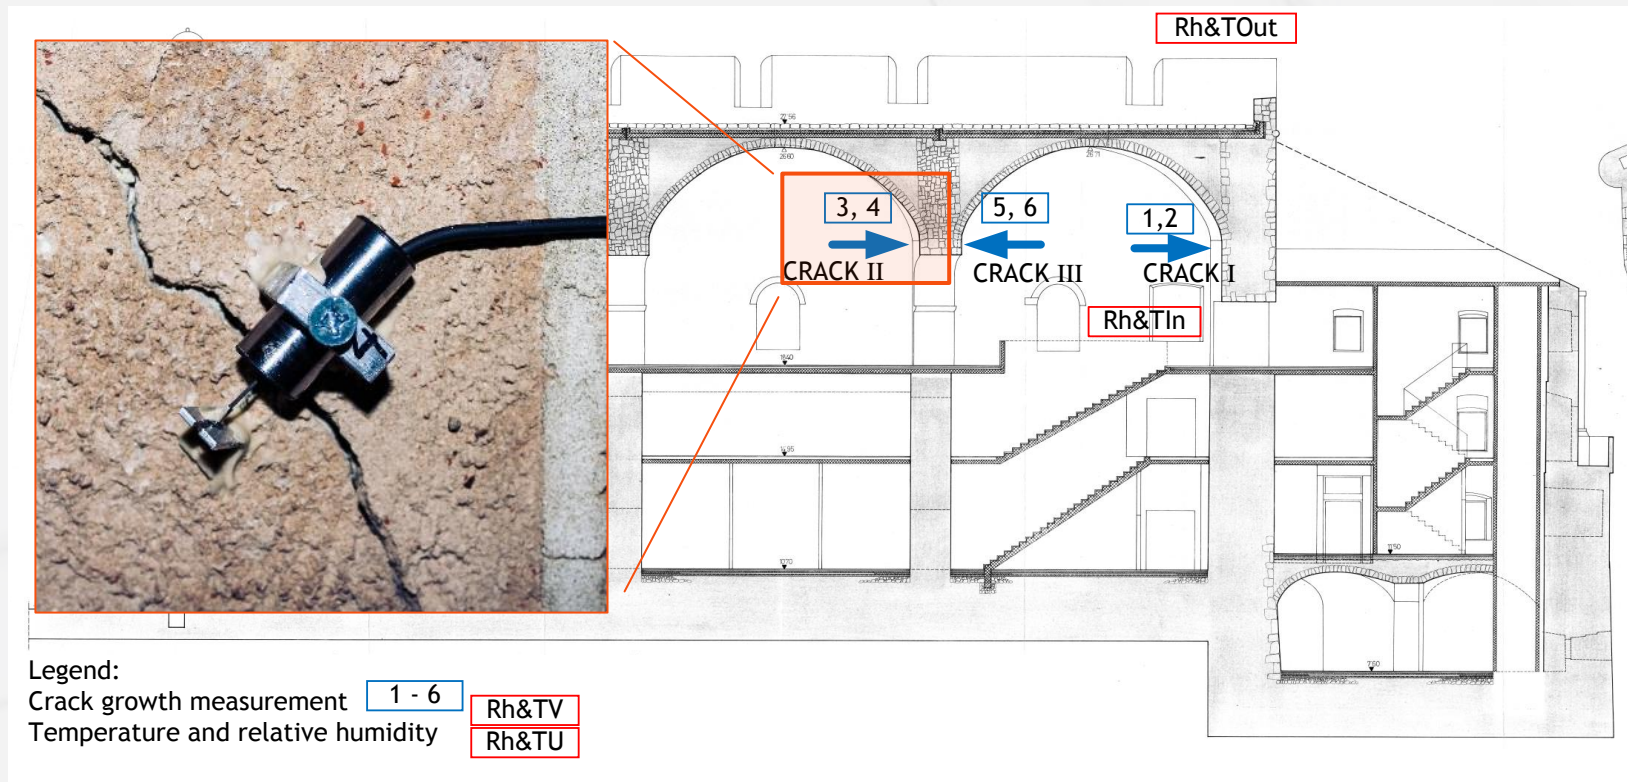
Eight inductive transducers were installed which are measuring growth and contraction of cracks on the vaults.

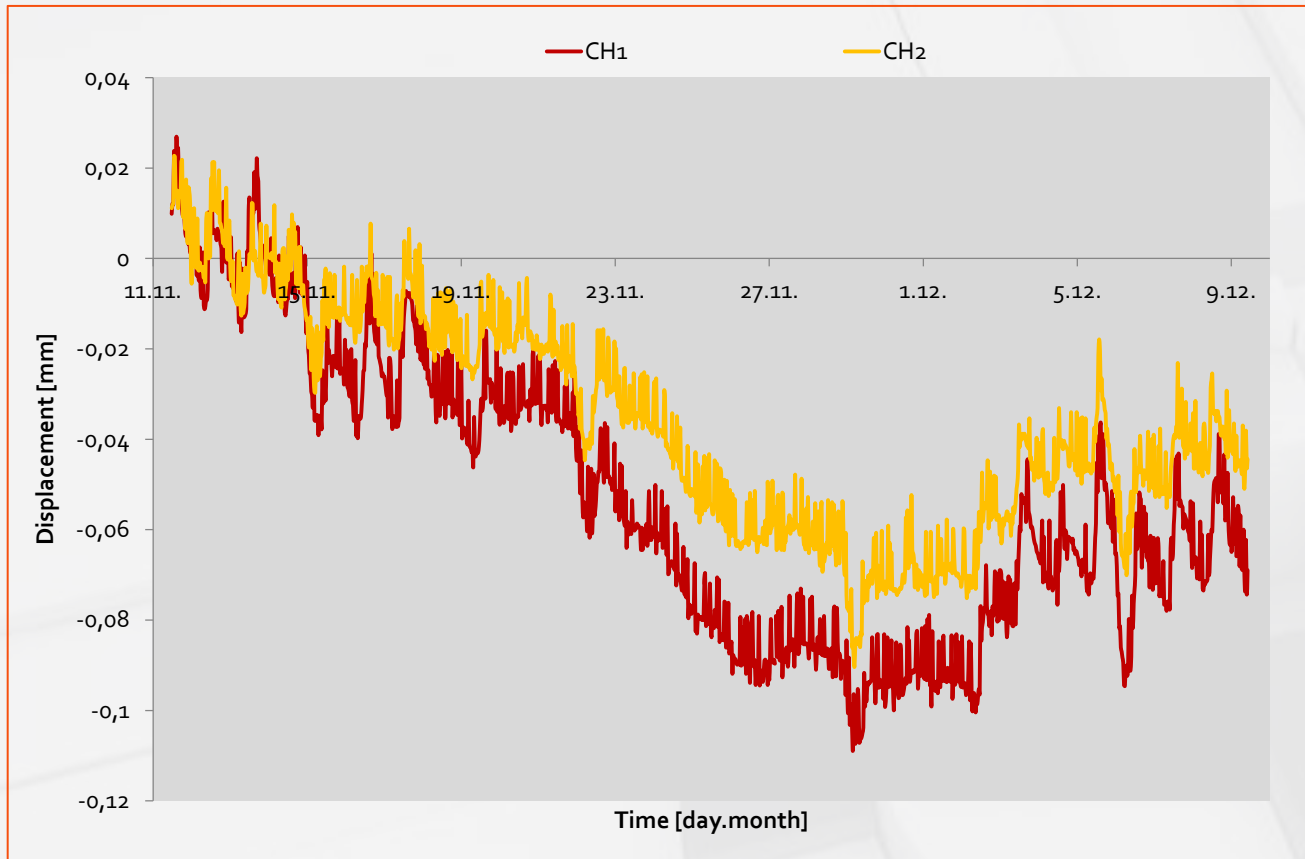
Monitoring was installed at the end of 2015. and no conclusions are shown in this presentation.
