Studio Arhing / Structural Engineering Office

- 1. Introduction damage to sacral and heritage buildings after the earthquake
- 2. Urgent measures
- 3. Documentation and Research / ANAMNESIS HISTORY
- 4. Assessment of the condition of the building structure / DIAGNOSIS
- 5. Technical solutions for repair and reinforcement / THERAPY

EPFL Lausanne / - Structural assessment and seismic retrofitting of sacral and heritage buildings / 02.02.2024

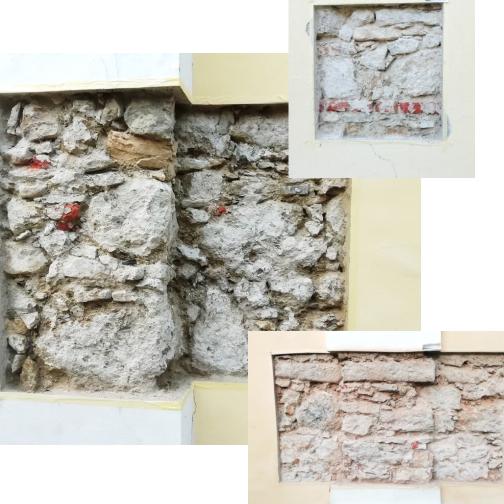
Exploratory probes on the load-bearing structure
