ES, IT'S An ENTIRE 13-STORY BUILDING IN CHINA

LYING ON THE GROUND.

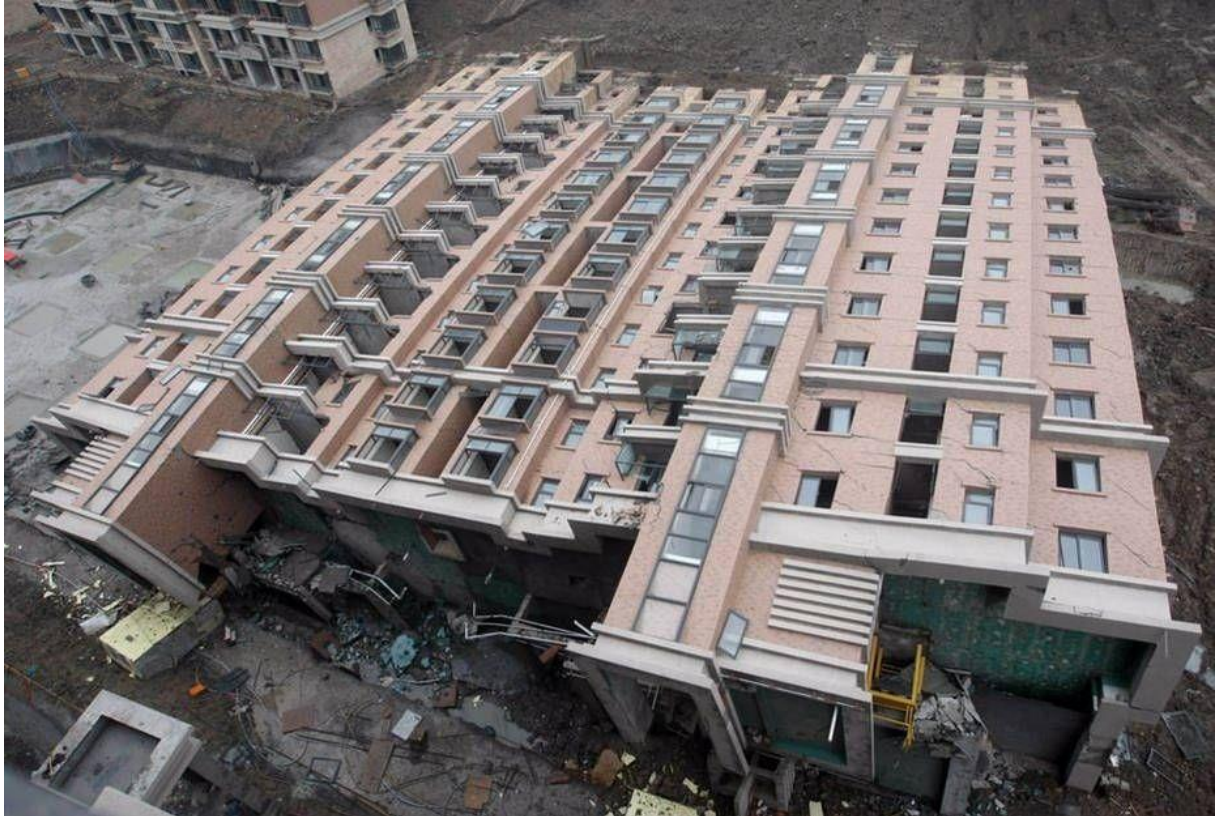
(1) An underground garage was being dug on the south side of the building, to a depth of 4.6 meters (15 ft).

(2) The excavated dirt was being piled up on the north side of the building, to a height of 10 meters (32 ft).

(3) They dug right up to the base of the building. Then the rains came.

(4) The building experienced uneven lateral pressure from north to south.

(5) This resulted in a lateral pressure of 3,000 tons, which was greater than what the un-reinforced pilings could tolerate. Thus, the building toppled completely

over in a southerly direction.

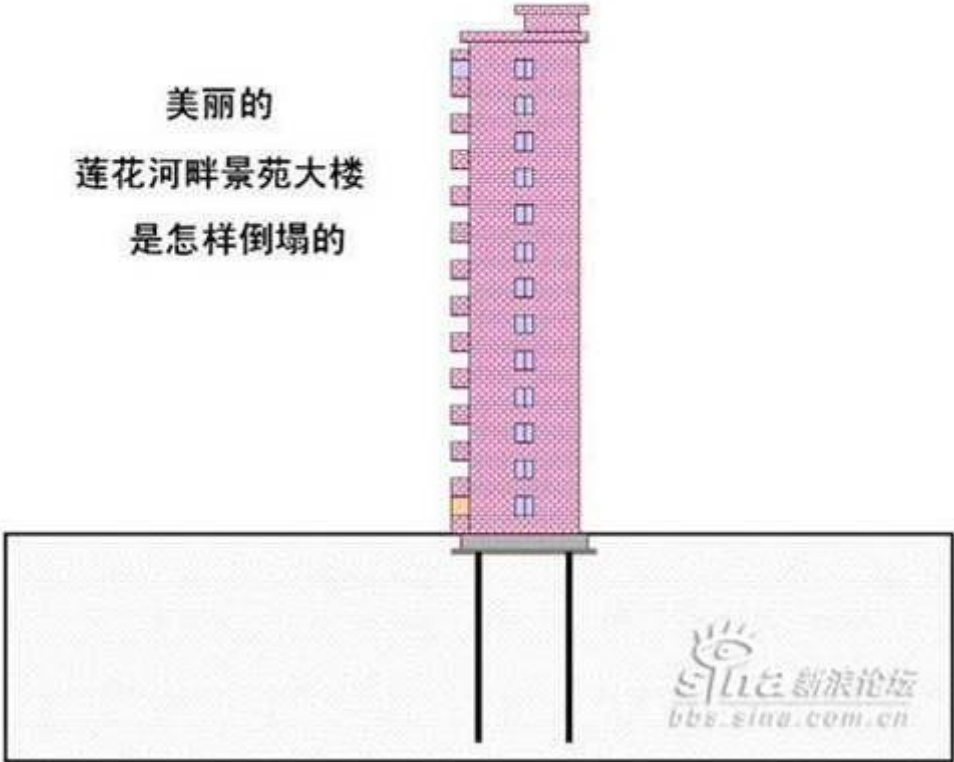
First, the apartment building was constructed.

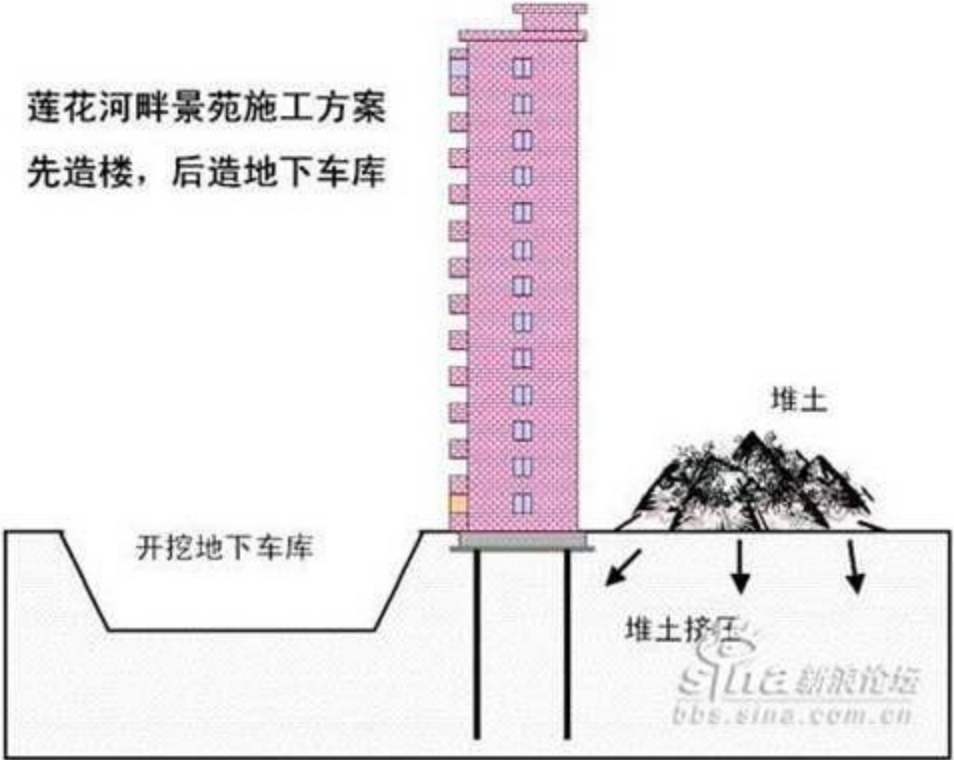
Then the plan called for an underground garage to be dug out.

The excavated soil was piled up on the other side of the building.

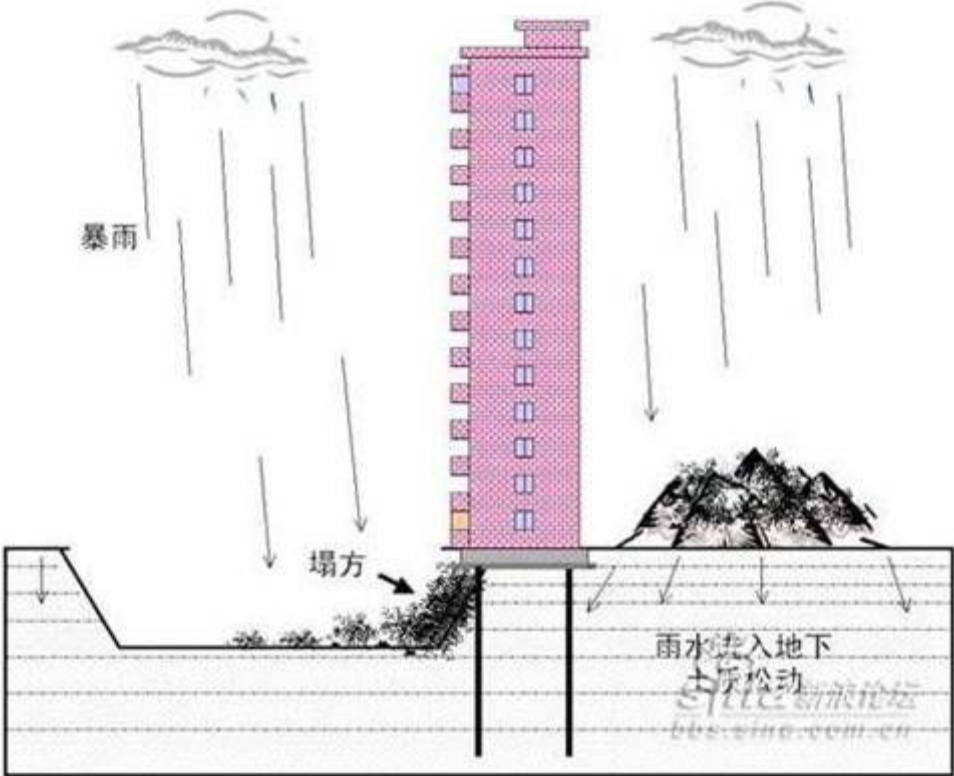
Heavy rains resulted in water seeping into the ground.

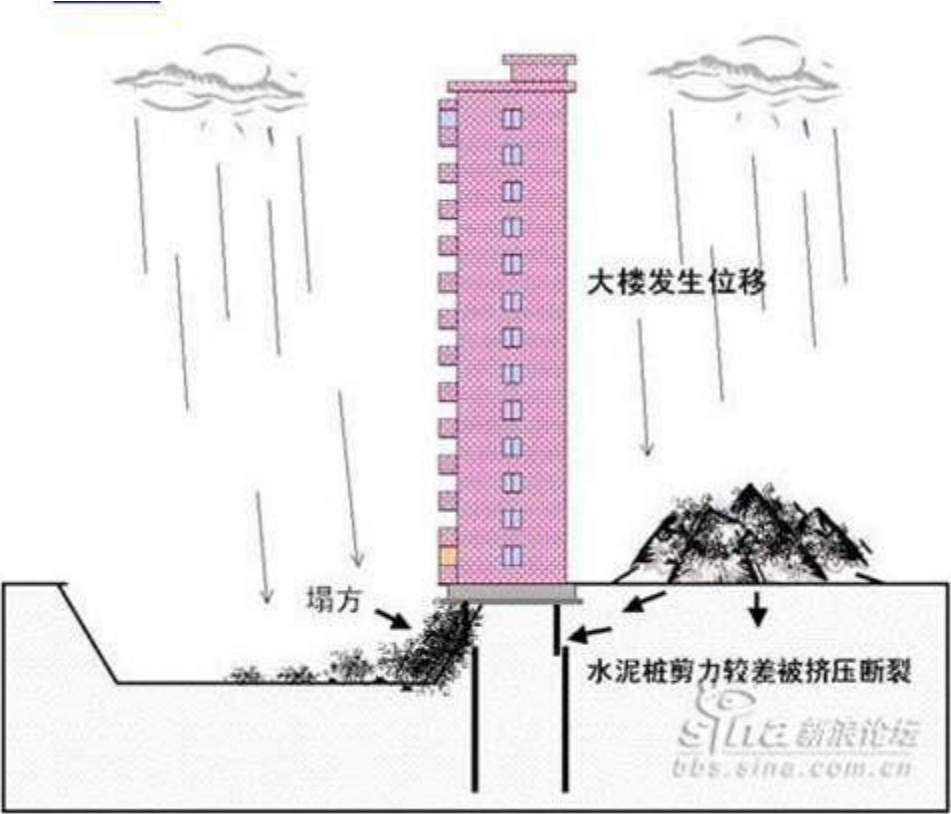
The building began to tilt. Then it began to shift, and the "hollow" concrete pilings were snapped due to the uneven lateral pressures.

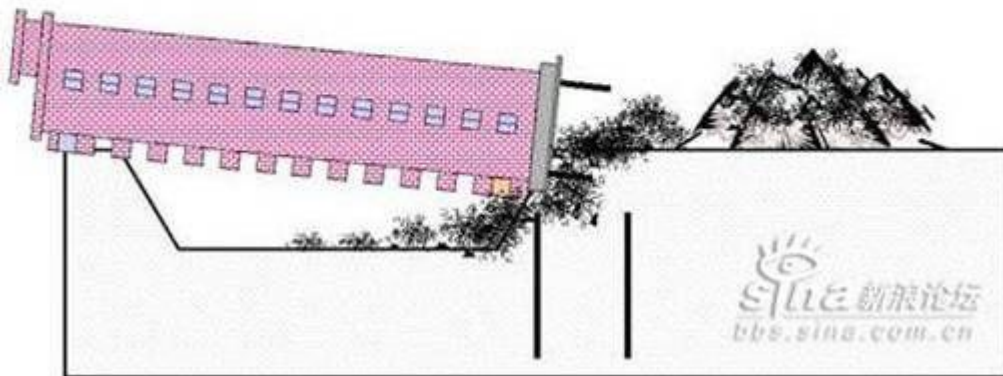
创造世界房屋倒塌奇迹

And thus was born the eighth wonder of the world.

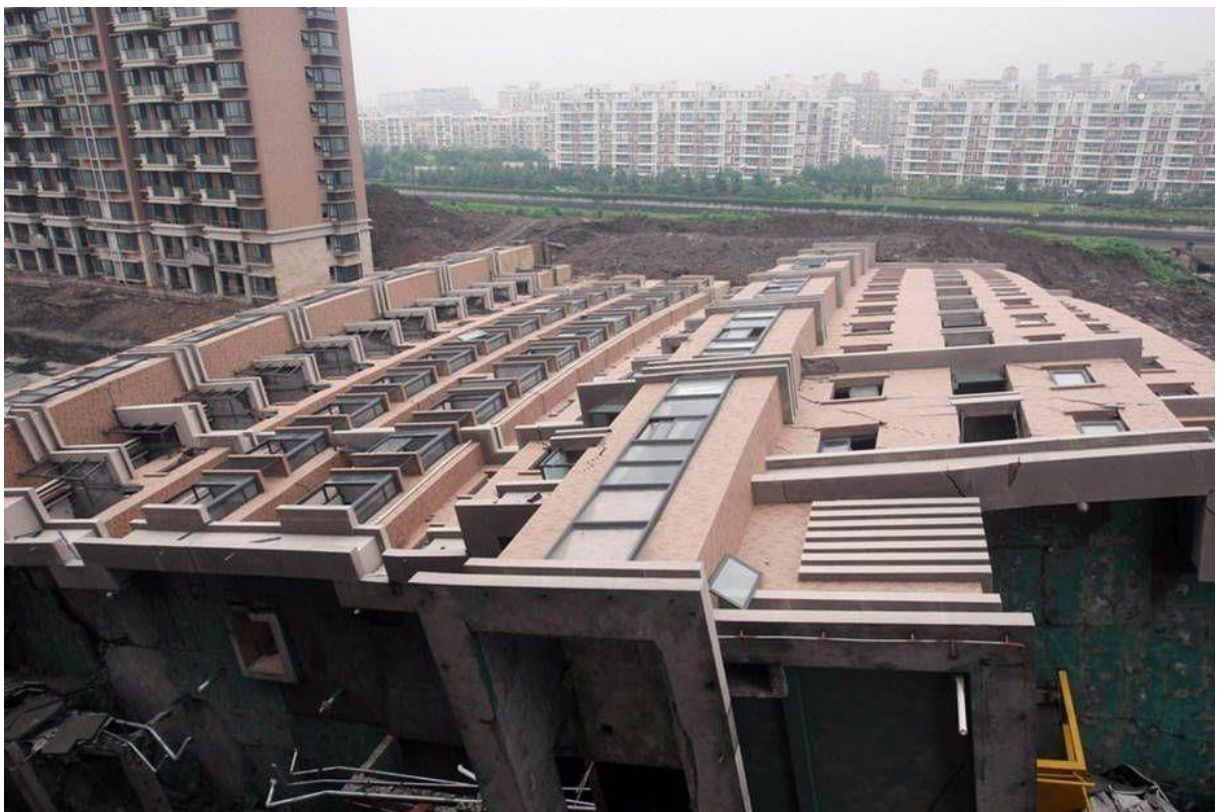
**If these buildings were closer together,
it would have resulted in a domino effect.**

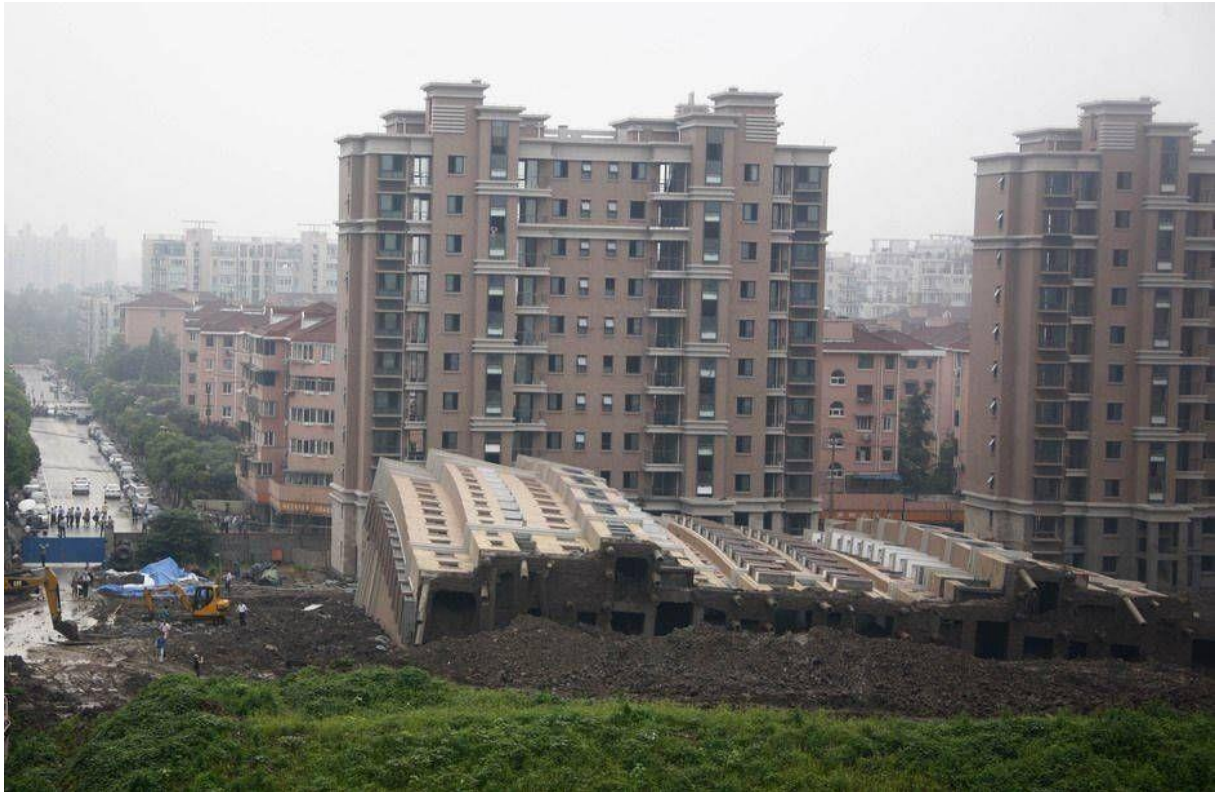
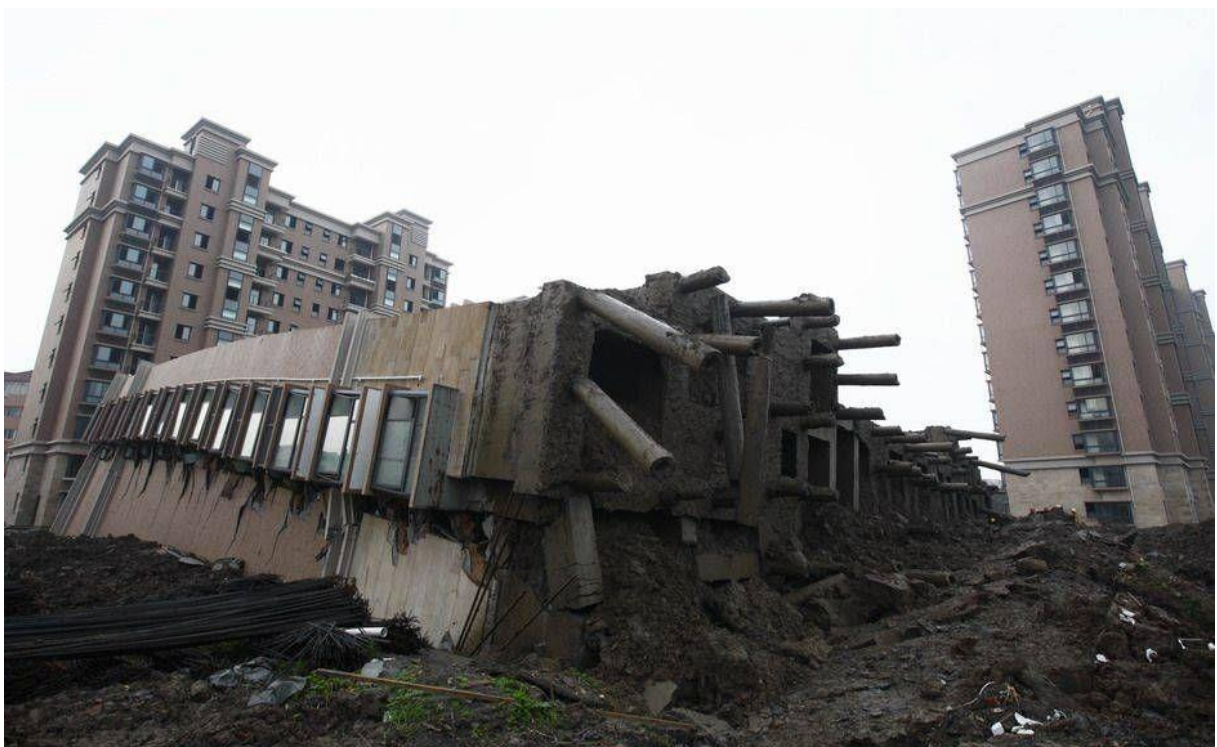
**Notice that there's NO rebar in the pilings!
Just some wire mesh.**

They built 13 stories on grade, with no basement, and tied it all down to hollow pilings with no rebar.
